## Pressurization failure, Boeing 737-436, G-DOCE

## Boeing 737-436, G-DOCE

<b>AAIB Bulletin No: 6/2004</b>	<b>Ref: EW/C2003/05/06</b>	<b>Category: 1.1</b>
<b>INCIDENT</b>		
<b>Aircraft Type and Registration:</b>	Boeing 737-436, G-DOCE	
<b>No &amp; Type of Engines:</b>	2 CFM56-3C1 turbofan engines	
<b>Year of Manufacture:</b>	1991	
<b>Date &amp; Time (UTC):</b>	30 May 2003 at 1630 hrs	
<b>Location:</b>	In flight near Lyon, France	
<b>Type of Flight:</b>	Public Transport (Passenger)	
<b>Persons on Board:</b>	Crew - 6	Passengers - 128
<b>Injuries:</b>	Crew - None	Passengers - 7 (Minor)
<b>Nature of Damage:</b>	Burnt wiring loom	
<b>Commander's Licence</b>	Air Transport Pilots licence	
<b>Commander's Age:</b>	34 years	
<b>Commander's Flying Experience:</b>	8,000 hours (of which 1,500 were on type)	
	Last 90 days - 100 hours	
	Last 28 days - 40 hours	
<b>Information Source:</b>	AAIB Field Investigation

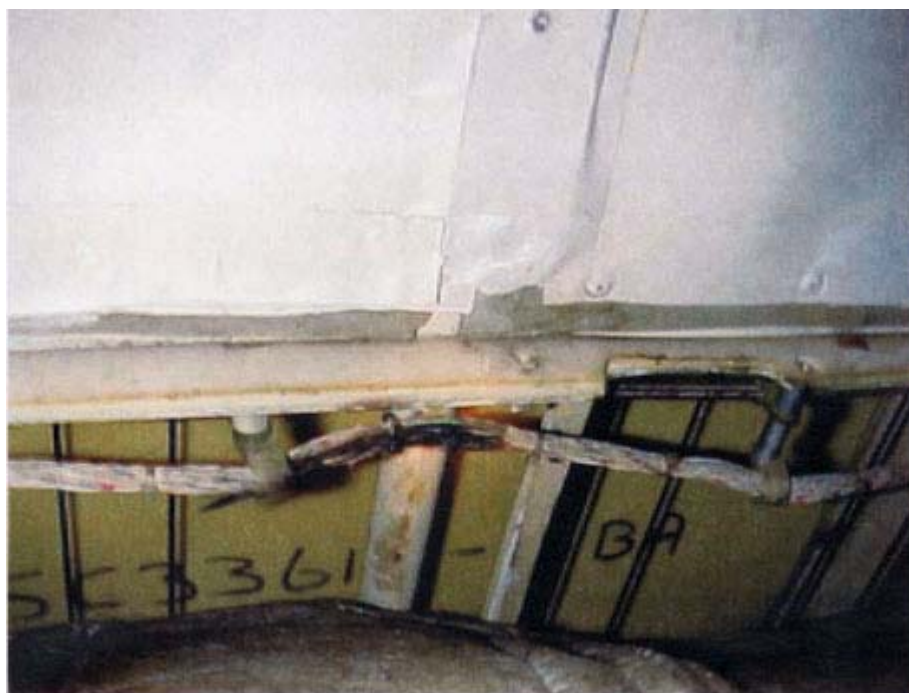
**Figure 1: Loom damage**

The replacement of the OFV failed to rectify the problem, and so the next course of action was to replace the pressure controller. The system, however, remained inoperative. The associated wiring was now inspected and it was during this check it was discovered that a wiring loom had become overheated and burnt. This was in an area just aft of the aft cargo hold where the wires ran across the top of the cargo hold but below the cabin floor. The burning damage on the loom extended from a 'p-clip', over a length of about 2 inches. In the centre of the damaged area was a 'zip' loom retaining strap, which had melted, and all damage was limited to the wiring loom, p-clip and 'zip' strap, shown in Figure 1. The wires were removed and the AAIB were then informed of the findings.

Figure 1 Loom Damage

The wire loom that was damaged, W298, contained all the wires between the pressure controller and the OFV. This meant that the wiring associated with all four modes of operation was included in the same loom. Wires which connected to the aft drain mast heater, the aft door warning system and the

The damaged wires were examined in detail, in conjunction with the AAIB, by a specialist organisation. It was concluded that the failure had most likely been initiated by long term fretting of the wire bundle at a fixed point in the aircraft, such as a 'p-clip' or 'zip' strap. The fretting had resulted in abrasion of the cable jacket and insulation, and exposure of the conductors, with subsequent short circuits leading to failures of the associated circuits and burning of the loom. The initiating area of the failure could not be established due to the damage, but copper deposits on the 'p-clip' indicated that it started either close to, or within, the 'p-clip' area. There was no evidence of 'carbon arc tracking'.

From the evidence it is clear that the de pressurisation event on G-DOCE resulted directly from a wiring failure in a loom at the rear of the aft cargo hold. The initiation of the failure was probably due to fretting of the wiring insulation against a 'p-clip' or 'zip' strap, which allowed the conductors to become exposed and short to each other. It is likely that this allowed erroneous signals to be sent to the OFV, causing it to start to open, thus increasing the cabin altitude. The AUTO system then failed and passed control to the STBY system. However, as the cabin altitude continued to climb, the STBY light extinguished which indicated that this system had also failed. As the wires for the STBY system run through the same loom as those for the AUTO system, it was likely that an erroneous signal was picked up by the pressure controller, causing it to fail the back-up system. AC MAN was then selected but, as the OFV AC feedback wire was damaged, the indicator on the PCP appeared to show that the valve was closed and not responding to any switch inputs, whereas the valve was probably operating. The QAR data showed that the OFV must have been partially closed, as the cabin pressure remained in excess of ambient during the ensuing descent; if the valve had remained in the position associated with the de-pressurisation, the cabin altitude would eventually have matched the aircraft altitude.

The results of the wiring loom examination revealed that its failure was most likely triggered by the abrasion of the insulation of two or more of the affected wires. This may have been caused by the 'p-clip' or the loom 'zip' straps in response to normal vibration and associated movement of the loom, especially if they had not been correctly installed. It is also possible that the loom may have been damaged whilst maintenance was carried out in the area, and this may have started the process which led to the conductors being exposed.

It is recommended that in order to prevent failure of the cabin pressure control system in the event of damage to wiring loom W298, the Boeing Commercial Airplanes should consider, on the Boeing 737-436 and similarly configured models, separating or protecting the wiring associated with the different modes of operation of this system, which connects the cabin pressure controller to the rear outflow valve, such that any single point failure of the loom would not result in effective failure of the pressurisation control system.
