In-flight smoke, Boeing 757-236, G-CPER

Aircraft Accident Report No: 3/2005 (EW/C2003/09/01)

Aircraft Type and Model: Boeing 757-236

Registration: G-CPER

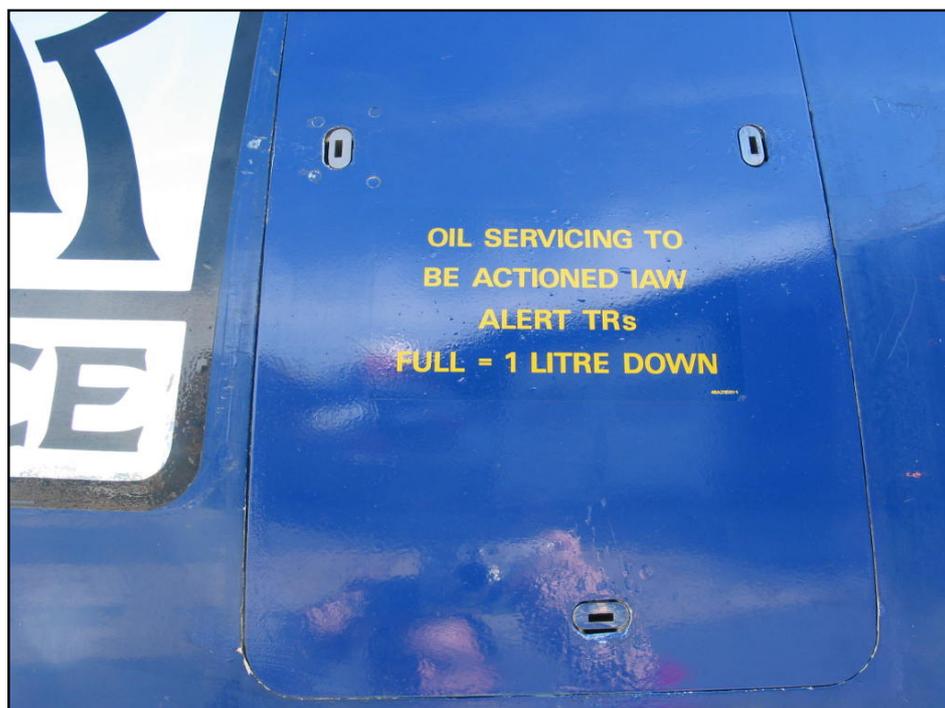
Figure 6

The next day, he went to re-check the engine oil levels, noting that both engines were now showing nearly 20 litres on the sight glass. He recalled from a Technical Newsletter, issued by the Powerplant Technical department, that overfilling the engine oils was known to cause oil smells in the cabin and that the engine oils should be filled to a maximum of one litre below the full graduation mark on the oil tank sight glass. The department had also issued Temporary Revision 12-593 to amend the Aircraft Maintenance Manual instructions for servicing the engine oils and had placarded the engine oil servicing access doors to reflect the new requirement (Figure 6). He decided that the oil quantities were excessive and proceeded to drain one litre of oil from each engine. After this the left and right engine oils were showing 18/19 litres on the EICAS display and 19/19 litres on the sight glass respectively. Satisfied that the quantities were now acceptable, he stamped the 'Daily Check' sheet tasks for the engine oils but did not record the draining of the oil in the Aircraft Technical Log, believing that the LAE would do so. In the event, the LAE did not, due to a breakdown in communication. Each had assumed that the other would record the adjustment of the oil levels in the Technical Log.

When asked whether he had consulted the Aircraft Maintenance Manual procedure for checking the engine oil levels, the technician stated that he had not. He considered it to be unnecessary, believing that he was correct in simply following the guidance in the Technical Newsletter.

B757 Engine oil service access door
