## Left MLG fire on landing, Boeing 777-200ER, AP-BGL

**Micro-summary:** While taxiing after landing, the left main landing gear was observed to be on fire.

**Investigative Body:** Aircraft Accident Investigation Board (AAIB), United Kingdom

**INCIDENT**

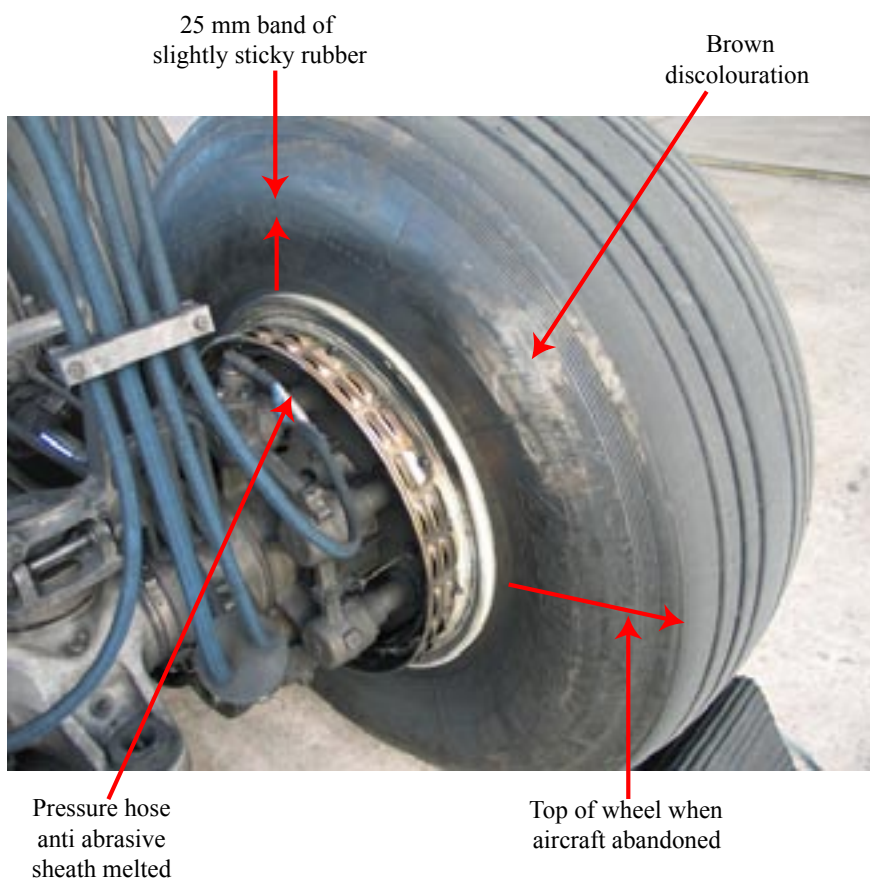
**Figure 5**

The only visible heat damage on the left MLG was melting of the anti-abrasion sheaths on the No 10 brake unit hydraulic pressure hose and temperature probe conduit.

The damage on each pipe was approximately 16 cm long and was on the side of the pipes facing the wheel. There was also slight damage to the inside of the No 10 tyre, consisting of a small brown area of discoloration at the 12 o'clock position, and two areas where the rubber had just started to turn sticky, indicating that these areas had been exposed to temperatures between 100°C and 150°C. Apart from this slight damage, the tyre appeared to be in good condition, Figure 5.

the path of the fire. Nevertheless, there was evidence of light sooting around the top of the No 10 inner wheel rim and on the lower part of the door attached to the MLG leg. The soot pattern indicated that the smoke from the fire passed over the inside of the No 10 wheel at the 11 o'clock position, looking inboard.
