Broken arm closing door, Boeing 757-200

Micro-summary: A flight attendant on this Boeing 757-200 broke her arm while closing the R4 door.

Investigative Body: Aircraft Accident Investigation Board (AAIB), United Kingdom

ACCIDENT

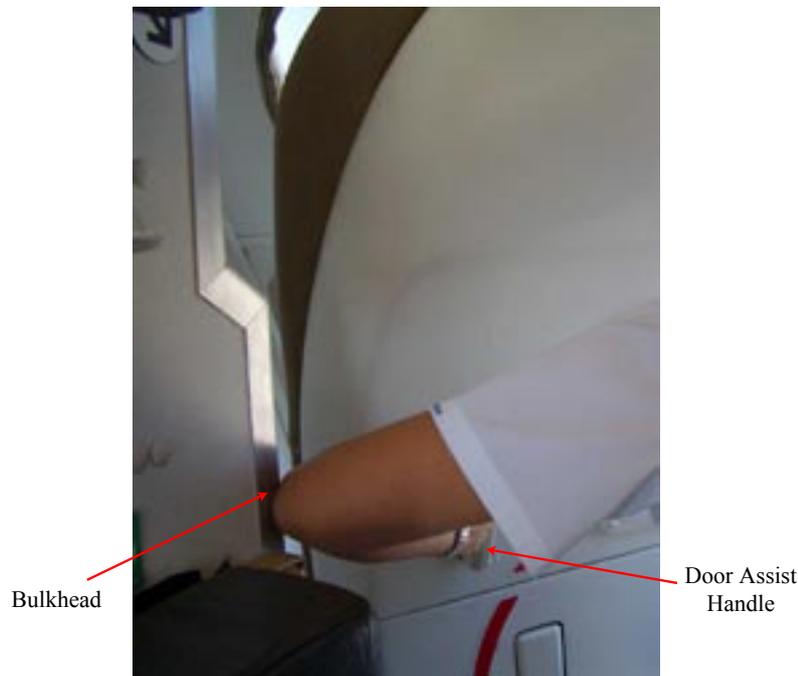
her left hand to bend around the door assist handle and her wrist to fracture. Figure 1 shows a reconstruction of how a person’s arm may become trapped. It was only once the door had moved into the fully closed position that the attendant was able to free her arm. Paramedics treated her at the aircraft before she was taken to hospital by the Duty Station Officer.

Reconstruction of a cabin crew member’s arm trapped between bulkhead and door assist handle
