## Landing gear fire during touch-and-gos, Boeing 757-236, G-BMRE

**Micro-summary:** While this Boeing 757-236 was performing touch-and-gos, flames were seen emanating from the landing gear.

**Event Date:** 2005-07-30 at 0819 UTC

**INCIDENT**

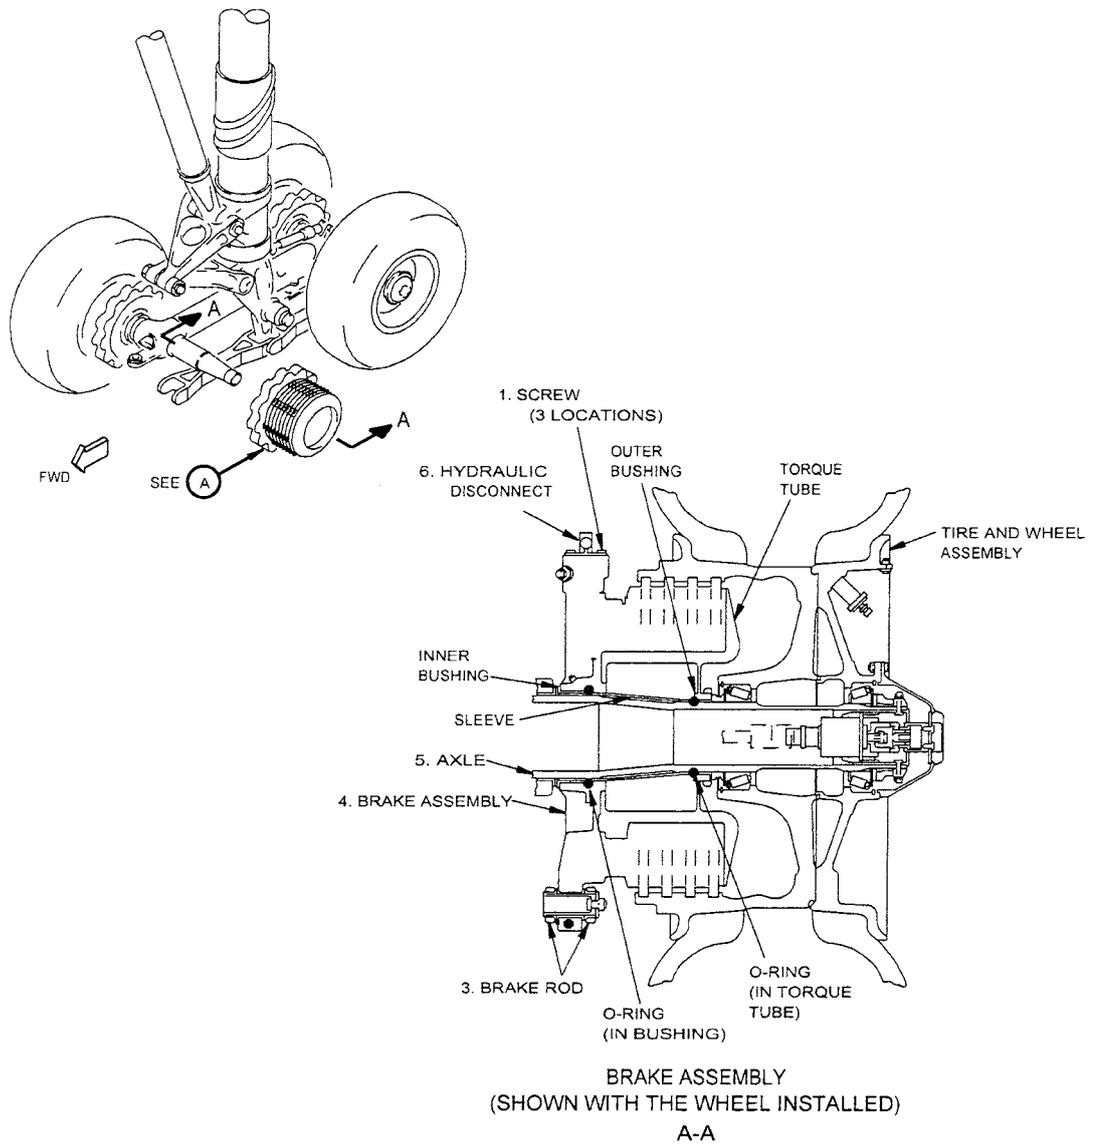
**Figure 1**

Boeing 757 Main Gear Brake Installation showing brake rod (item 3)

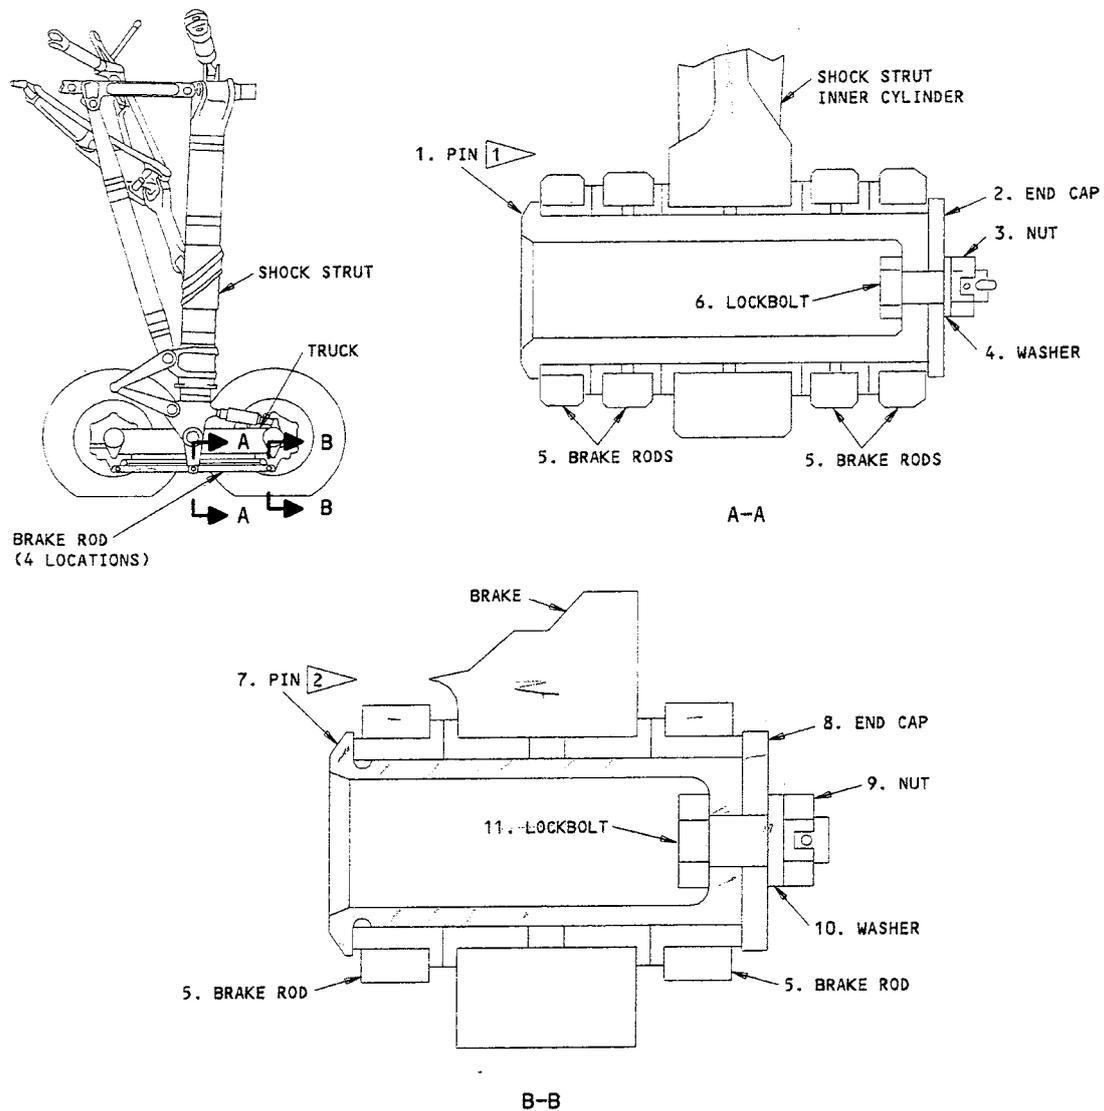
**Figure 2**

It was established that the brake rod pin end cap had not been fitted, which resulted in a situation in which the pin worked its way free from the brake assembly. This allowed the brake rod to hang vertically downwards and impact the ground during a landing, and the brake assembly to rotate and sever hydraulic and electrical lines. This sequence of events is corroborated by the operator's report in which it was stated that:

Detail of Boeing 757 Main Gear Brake Installation showing attachment of brake rod. Note end cap (item 8)

*'the brake rod was worn down to approximately 60% of its original length during the aircraft landing roll'. The rod, being made from steel, would be likely to have produced a wealth of sparks during the second touch-and-go and the subsequent landing.*
