Ground collision between a Boeing 777-200, N781AN and an Airbus A340-300, TC-JDK, at London Heathrow Airport, November 6, 2005

Investigative Body: Aircraft Accident Investigation Board (AAIB), United Kingdom

ACCIDENT

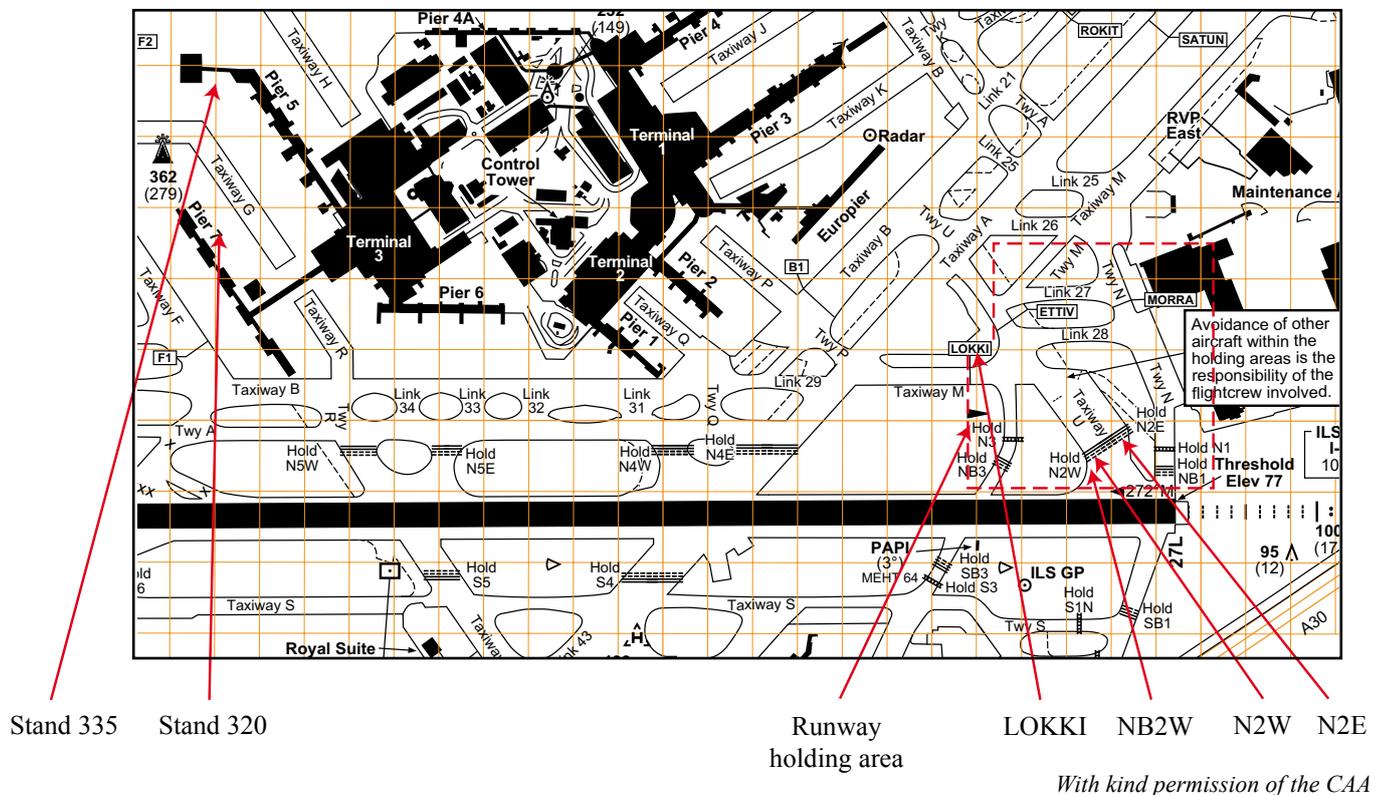
Figure 1

At the time of the accident it was daylight, the visibility was in excess of 10 km and it was raining. The B777 was cleared to taxi from Stand 320 at Terminal Three, via taxiways Echo and Alpha, to Holding Point LOKKI for departure from Runway 27L. Four minutes later the A340 was cleared to taxi from Stand 335, also at Terminal Three, via the same routing to holding point LOKKI, Figure 1.

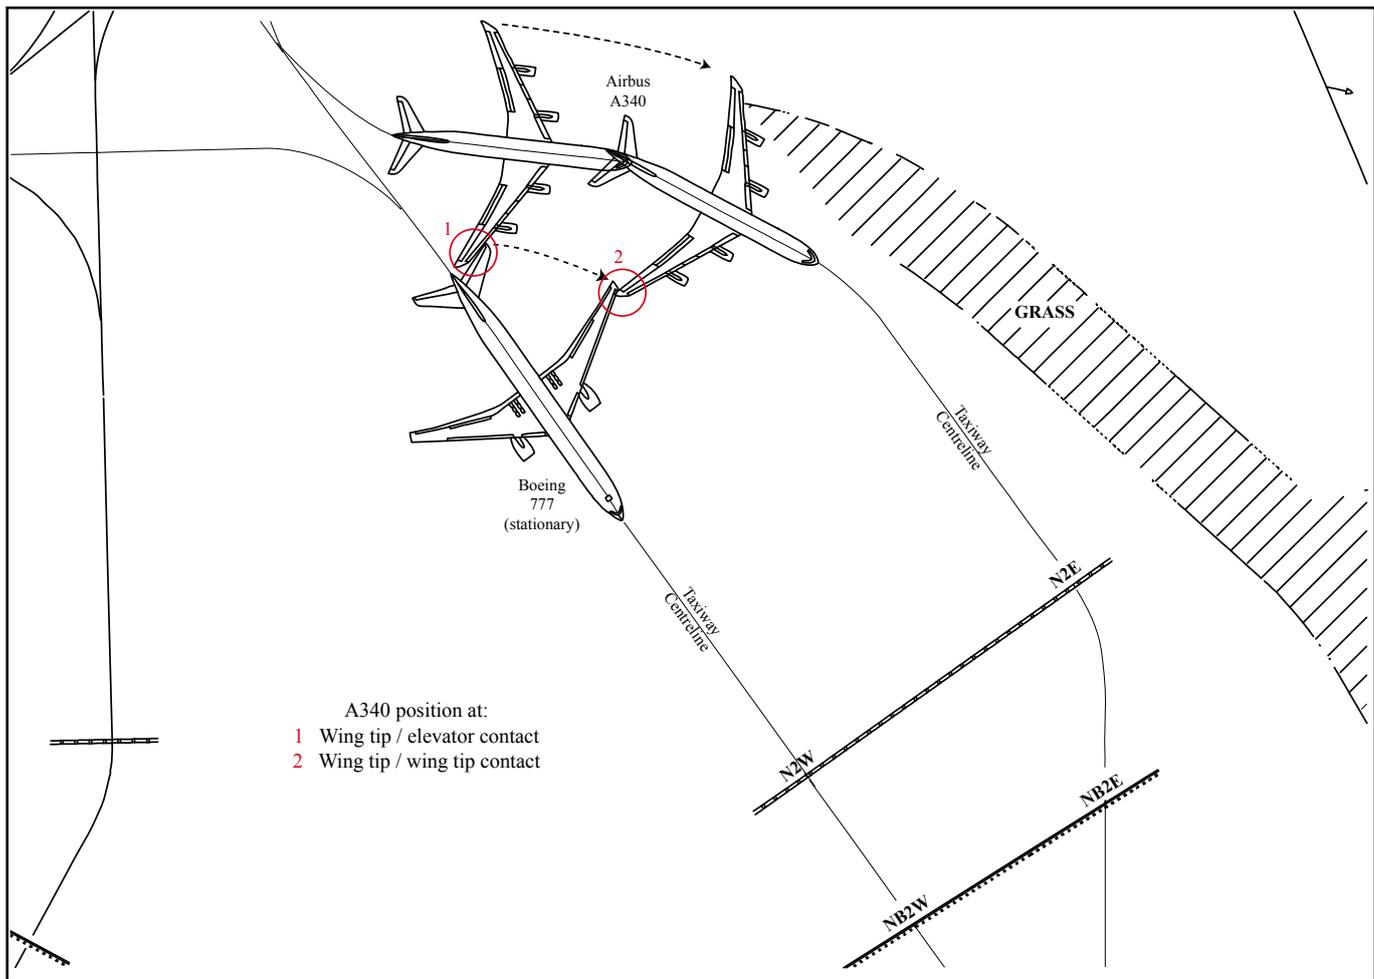
Figure 2

(A340) was instructed to taxi to N2E. As it passed behind the B777, the A340's right winglet made contact with the B777's left elevator and its left wing tip. The A340 had not reached the section of the line parallel to the parked B777. This accident happened at the same location as a collision between similar aircraft types reported in AAIB Bulletin 9/2005, reference EW/C2004/07/03.

Damage to the B777's left elevator and left wing tip appeared to have been inflicted by the upper part of the winglet of the A340. Damage to the A340 was temporarily repaired and the aircraft was dispatched. The B777 had been equipped with a replacement wing-tip fairing and was still awaiting delivery of a replacement elevator when examined by the AAIB.

Relative aircraft positions at points of contact

It is recommended that Heathrow Airport Limited review the current layout/design of the Holding Areas for departing aircraft, to ensure that wingtip clearance is maintained between manoeuvring aircraft.

It is recommended that Heathrow Airport Limited, in co-operation with National Air Traffic Services, review the current Air Traffic Control procedures applicable to the Holding Areas for departing aircraft, and any future layout of these Holding Areas, to ensure that adequate wingtip clearance is maintained between manoeuvring aircraft.
