Runaway Learjet 45, D-CNIK, March 17, 2006

Investigative Body: Aircraft Accident Investigation Board (AAIB), United Kingdom

ACCIDENT

Aircraft Type and Registration:	Learjet 45, D-CNIK	
No & Type of Engines:	2 Honeywell TFE731-20 turbofan engines	
Year of Manufacture:	2003	
Date & Time (UTC):	17 March 2006 at 2029 hrs	
Location:	London Gatwick Airport	
Type of Flight:	Public Transport	
Persons on Board:	Crew - 2	Passengers - None
Injuries:	Crew - 1 (Serious)	Passengers - N/A
Nature of Damage:	Fuselage and entry door plus damage to a parked motor vehicle	
Commander's Licence:	Airline Transport Pilot's Licence	
Commander's Age:	42 years	
Commander's Flying Experience:	9,500 hours (of which 2,450 were on type) Last 90 days - 54 hours Last 28 days - 26 hours	
Information Source:	AAIB Field Investigation

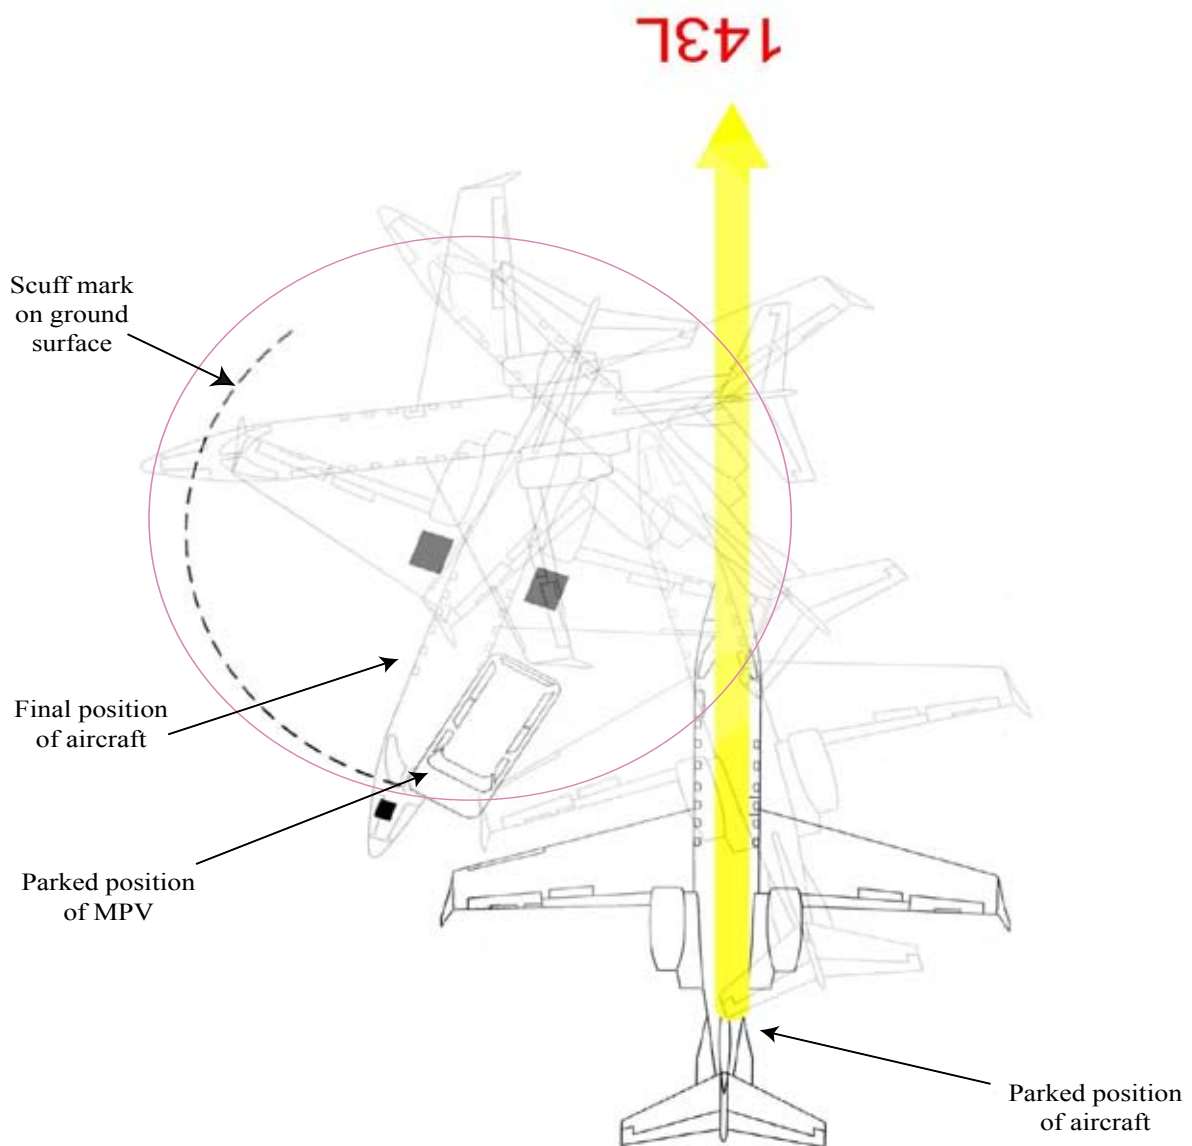
Figure 1

The aircraft had been parked with the nose wheel aligned with the painted central guidance line for stand 143L on a heading of 169°M. Alongside the aircraft was a Volkswagen 'Sharan' Multi-Purpose Vehicle (MPV) acting as a ground support vehicle (see Figure 1). The aircraft had moved forward and initially struck the left hand side of the MPV, and had then turned to the left around the rear of the ground support vehicle. It had then struck the right side of the MPV, coming to rest against the vehicle on a heading of 013°M, approximately 8.6 m from the centre of the stand marking. The MPV had been pushed sideways in the final impact and moved approximately 0.6 m, forcing the left front tyre off its rim.

At some stage during the aircraft movement the commander had fallen to the ground outside the aircraft. The trailing edge of the nose landing gear door had been bent by impact with the commander and there was a faint mark on the concrete surface of the stand that had been made by his clothing. The mark followed an arc corresponding to the path of the nosewheel (see Figure 1) as he was dragged by the aircraft.

Location of aircraft and ground support vehicle

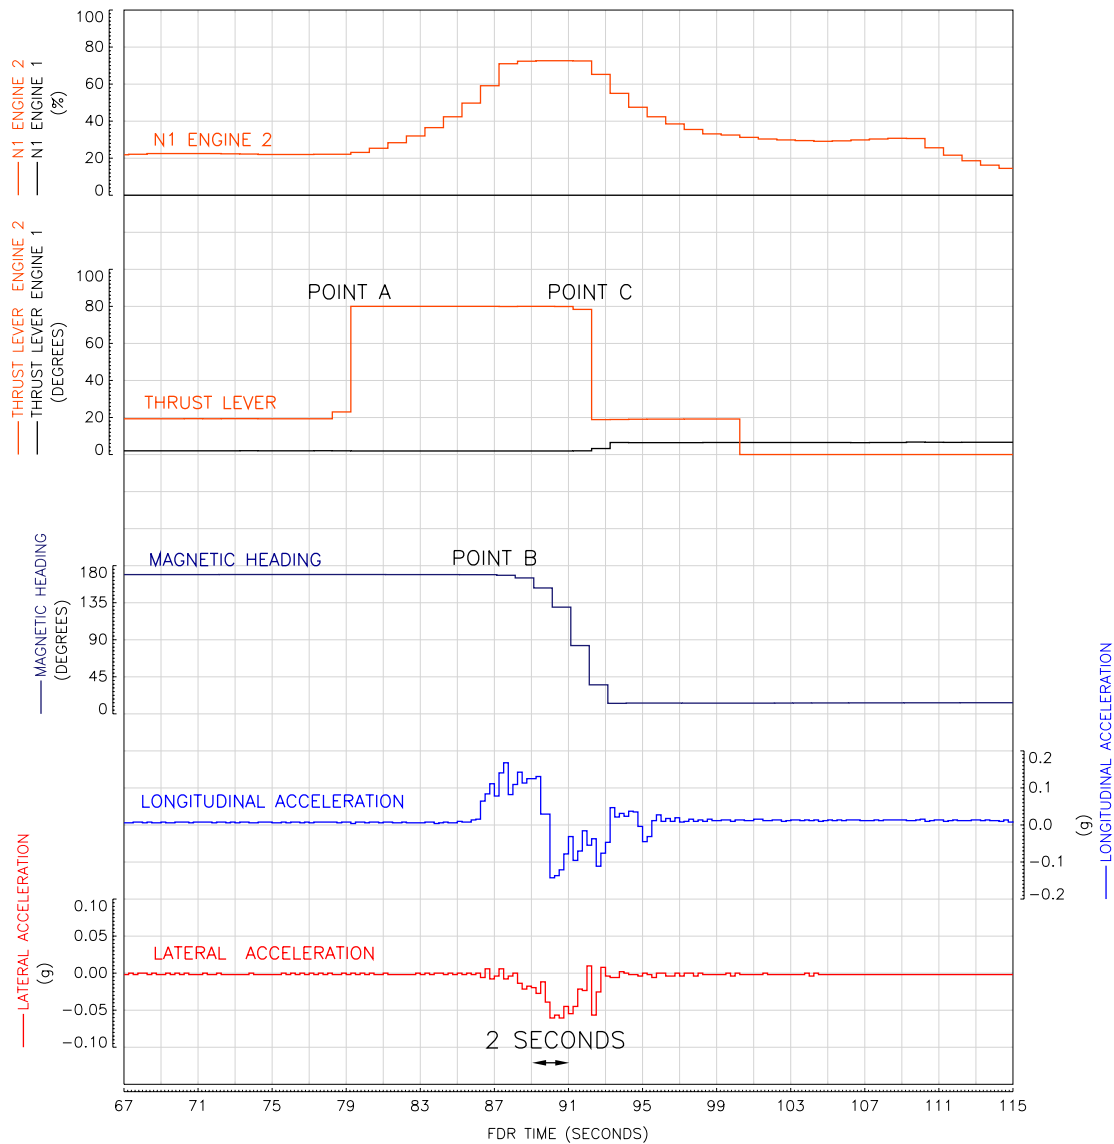
Figure 1 provides the salient parameters of the accident. The No 2 engine thrust lever was set to about 19° ¹ and shortly afterwards the No 2 engine N_1 shaft speed started to increase. As the engine was started there was a short conversation on the flight deck that lasted about six seconds. As the aircraft's avionics systems powered up the magnetic heading parameter became active, indicating that the aircraft was on a magnetic heading of 169° . The number two engine N_1 shaft speed continued to increase until it settled at idle thrust, which was about 21% N_1 . Some 10 seconds later the bleed air was heard to be selected ON.

The No 2 engine thrust lever remained at the idle thrust position until about 17 seconds later when it was quickly advanced to about 80° , some 12° before it would have entered the MCR² position. Just prior to and also

coincident with the movement of the No 2 engine thrust lever, a series of clicks was heard on the flight deck, but the exact origin of those noises could not be determined. The No 2 engine N_1 shaft speed started to increase from idle thrust until about eight seconds later it had reached 59%, at which time the aircraft began to move forwards. The N_1 speed increased until it reached 72%, at about which time the aircraft then started to accelerate rapidly forwards and turn to the left. About five seconds later the No 2 engine thrust lever was quickly moved to the idle position and the N_1 shaft speed started to reduce. Almost coincident with the No 2 thrust lever moving to idle, a noise was recorded that was similar to brakes being applied. About one second later the aircraft stopped turning. The aircraft had turned onto a magnetic heading of 013° having turned through 154° in 6 seconds.

Figure 2
Selected data from FDR and CVR
