Turbulence, Report on the accident to Airbus A330-342 B-HYA Within the Manila Flight Information Region on 18 July 2003

AIRCRAFT ACCIDENT REPORT 1/2005

**Report on the accident to
Airbus A330-342 B-HYA
Within the Manila Flight Information Region
on 18 July 2003**

**Hong Kong
May 2005**

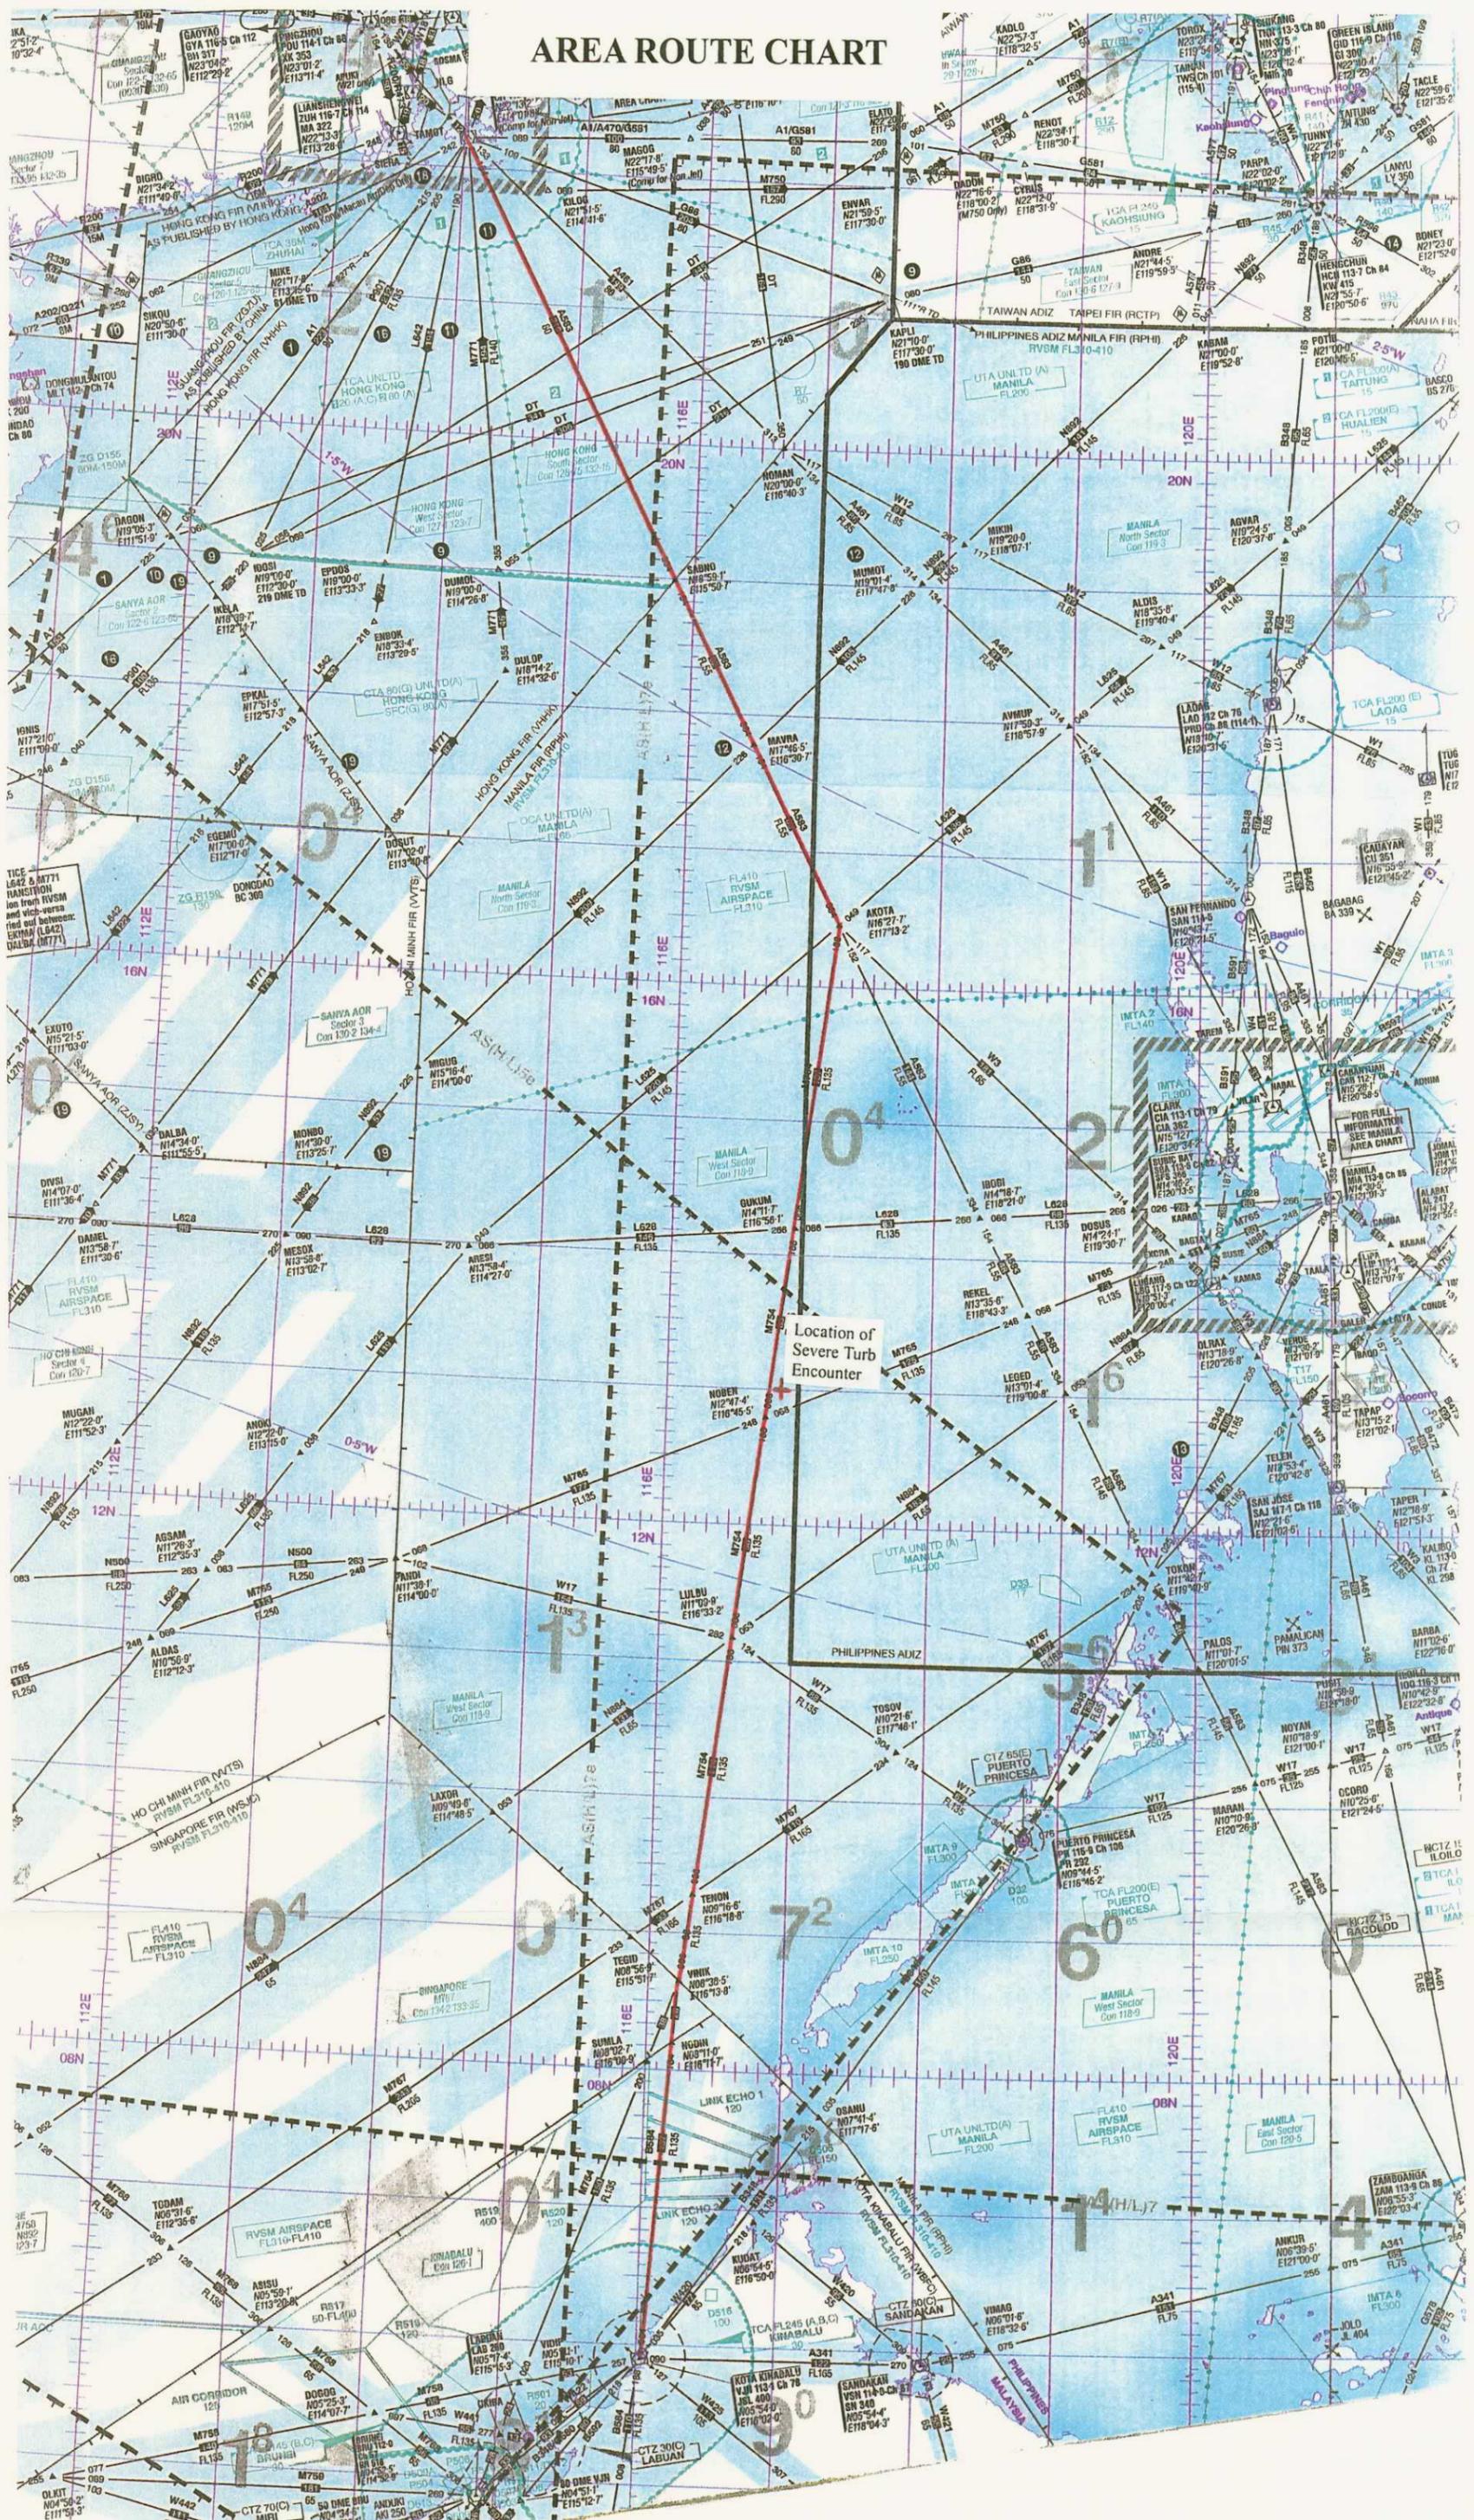
AREA ROUTE CHART

Location of Severe Turb Encounter

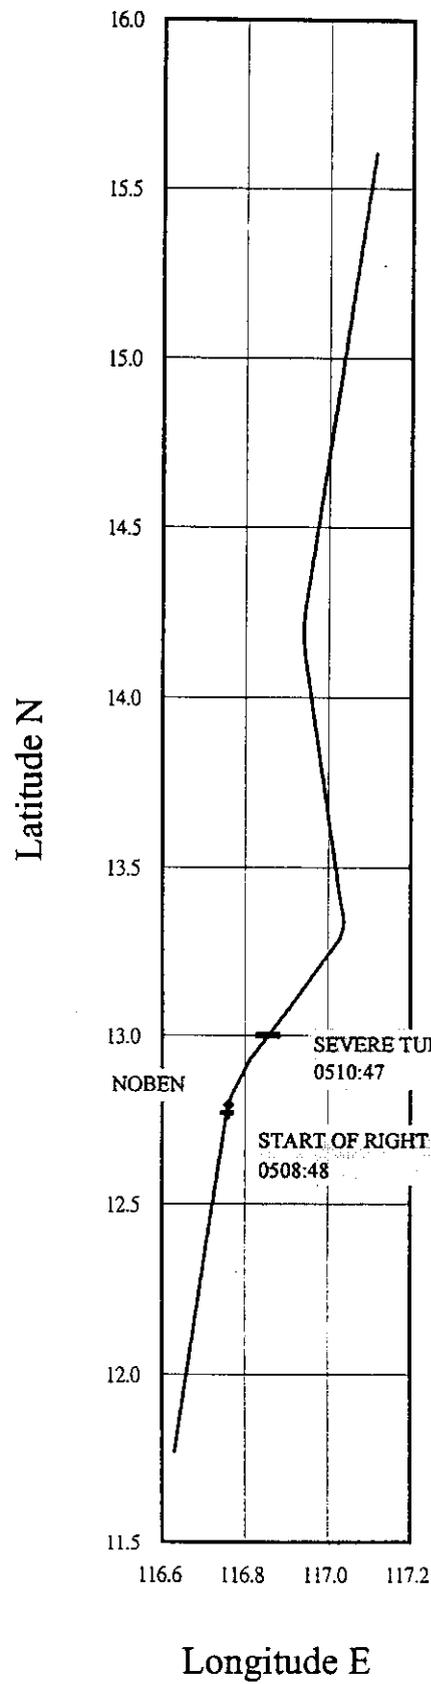
PLOT OF AIRCRAFT TRACK

Prior to NOBEN, with yellow and green weather returns observed on the radar, they requested permission from Manila ATC to deviate 10 NM to the right of track for weather avoidance. At 0510, shortly after commencing track deviation, the aircraft encountered severe turbulence. (Appendix 2 depicts the aircraft track at around the time of the turbulence encounter.)

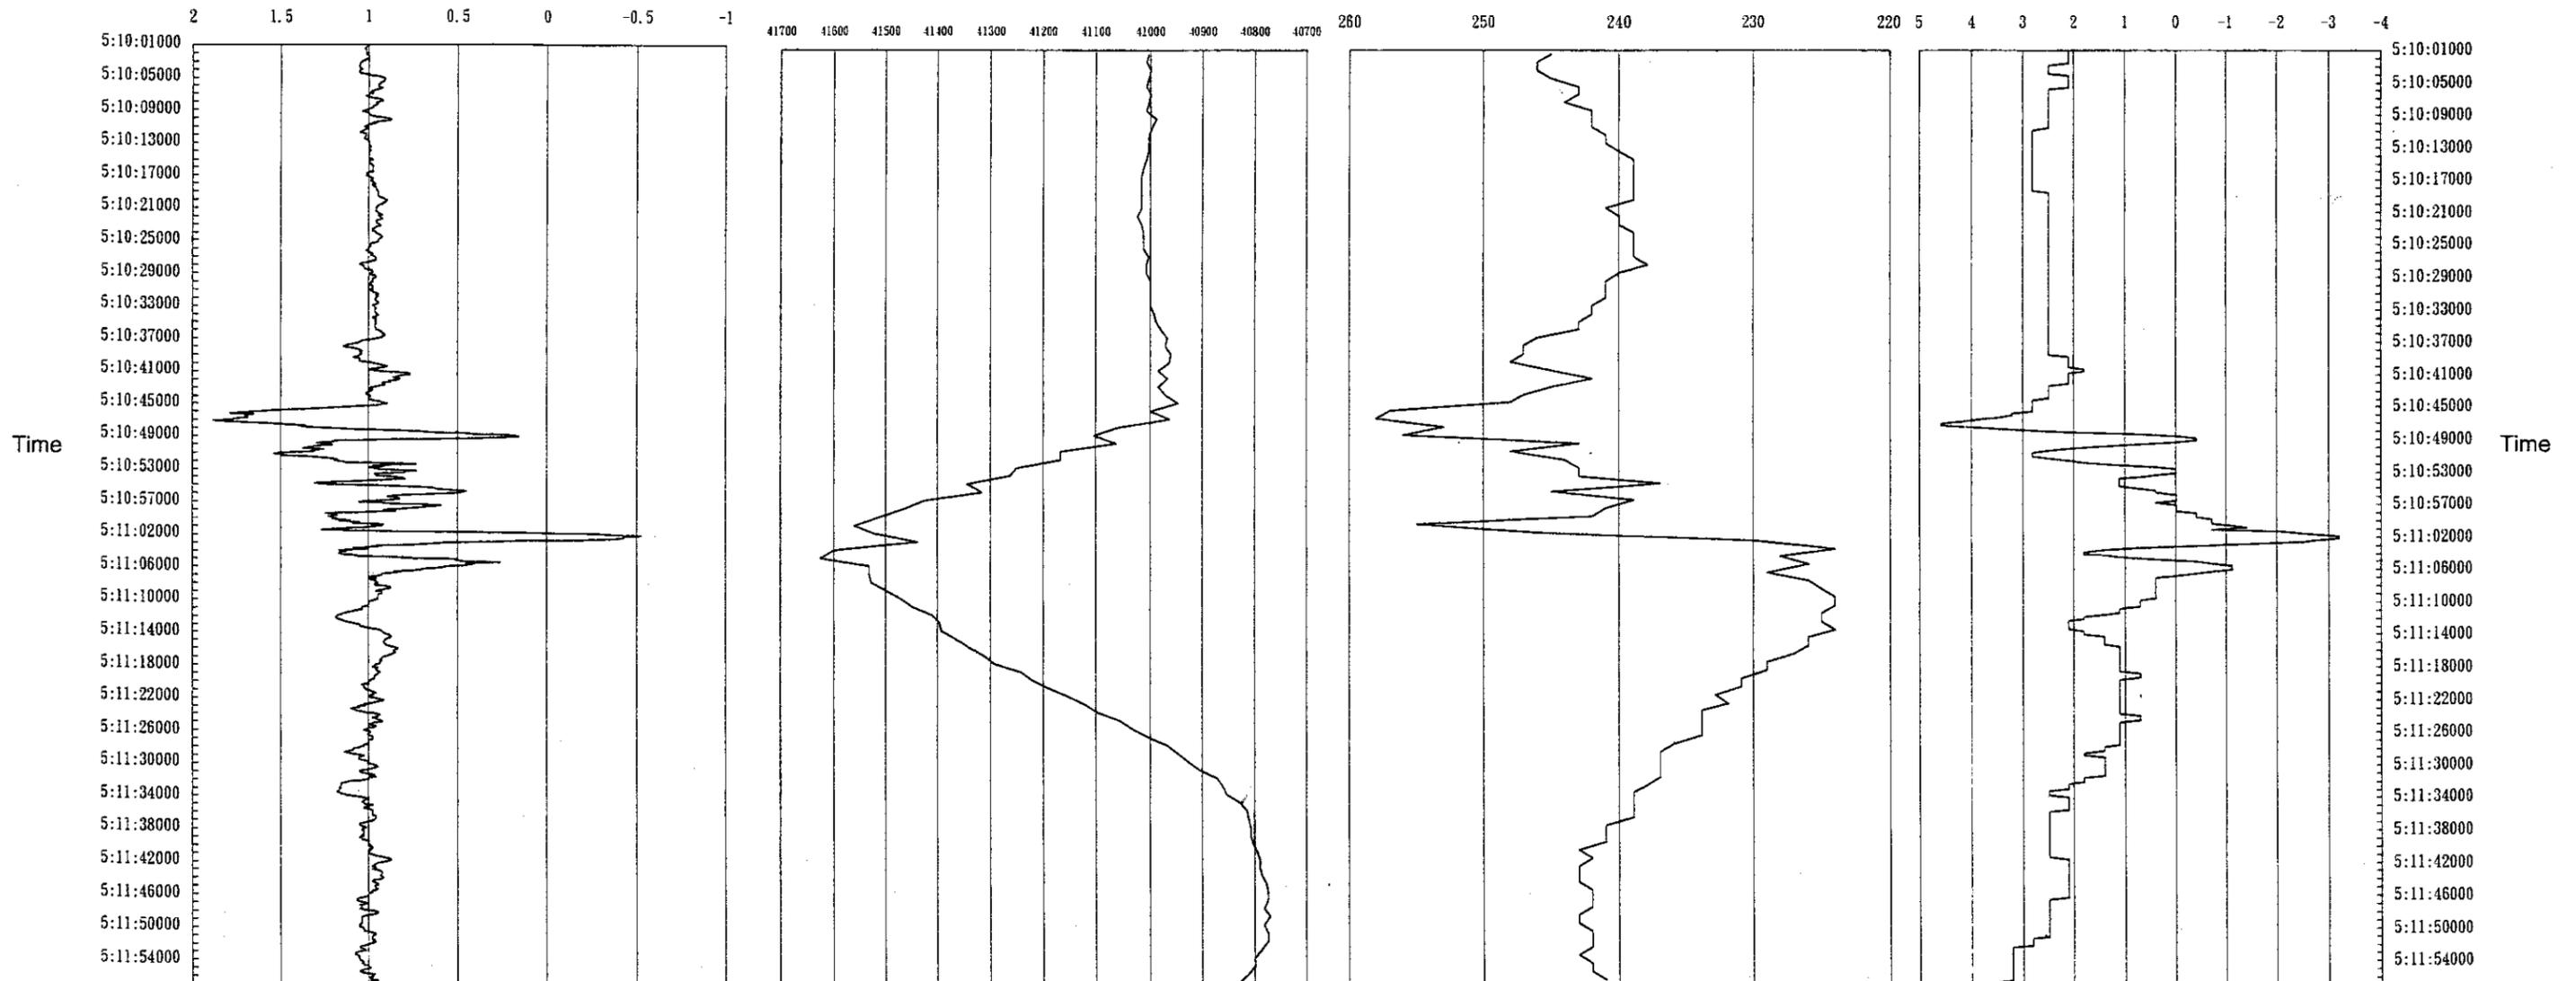
PLOT OF DFDR DATA

1.3.2. The sudden jolts experienced inside the cabin were indicated by excursions of vertical acceleration in the positive (+) and negative (-) sense recorded by the DFDR. The maximum vertical acceleration encountered was + 1.89 'G' during the first gust, while during the second gust the acceleration reached a maximum of + 1.27 'G' and a minimum of - 0.52 'G'. These excursions occurred over a period of 17 seconds. An engineering inspection was carried out after landing and revealed no structural damage to the aircraft. (Appendix 3 shows the DFDR Data Plot during the period of turbulence encounter.)
