Descent from cruise and crash into river, Aircraft Accident Report, Silkair Flight MI 185, Boeing B737-300, 9V-TRF, Musi River, Palembang, Indonesia, 19 December 1997

Aircraft Accident Report

SILKAIR FLIGHT MI 185

FINAL REPORT

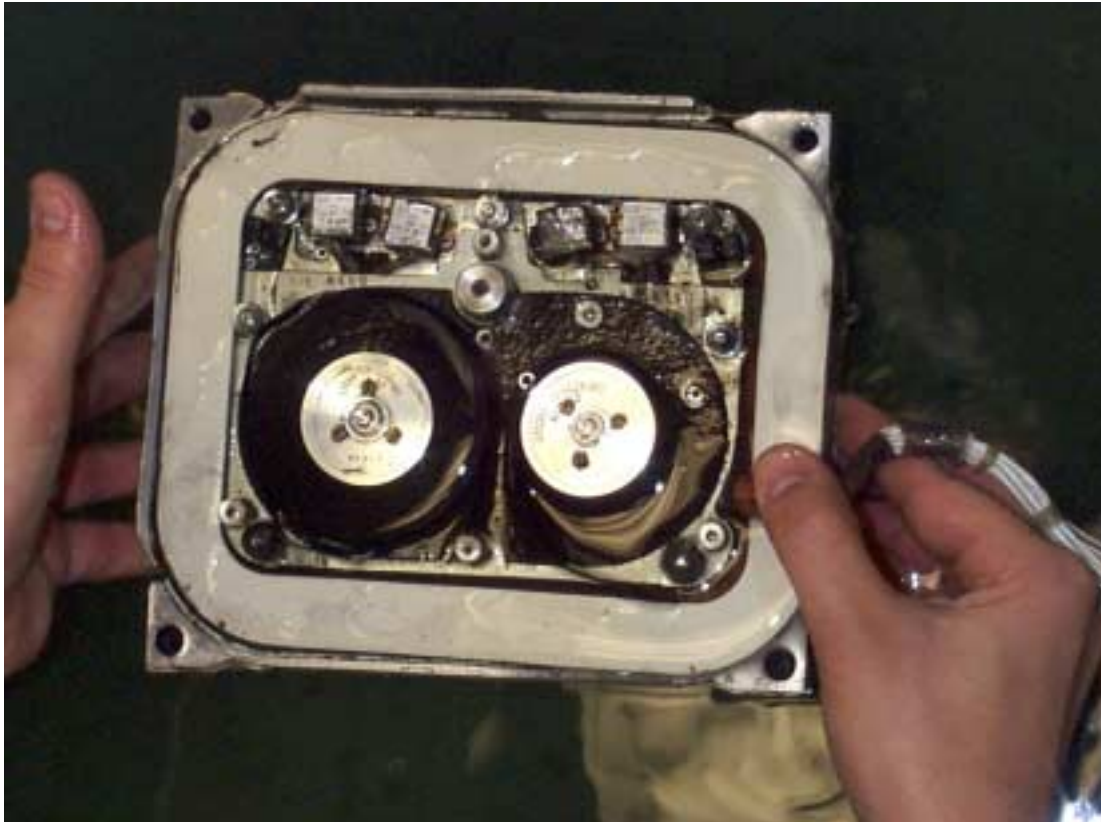
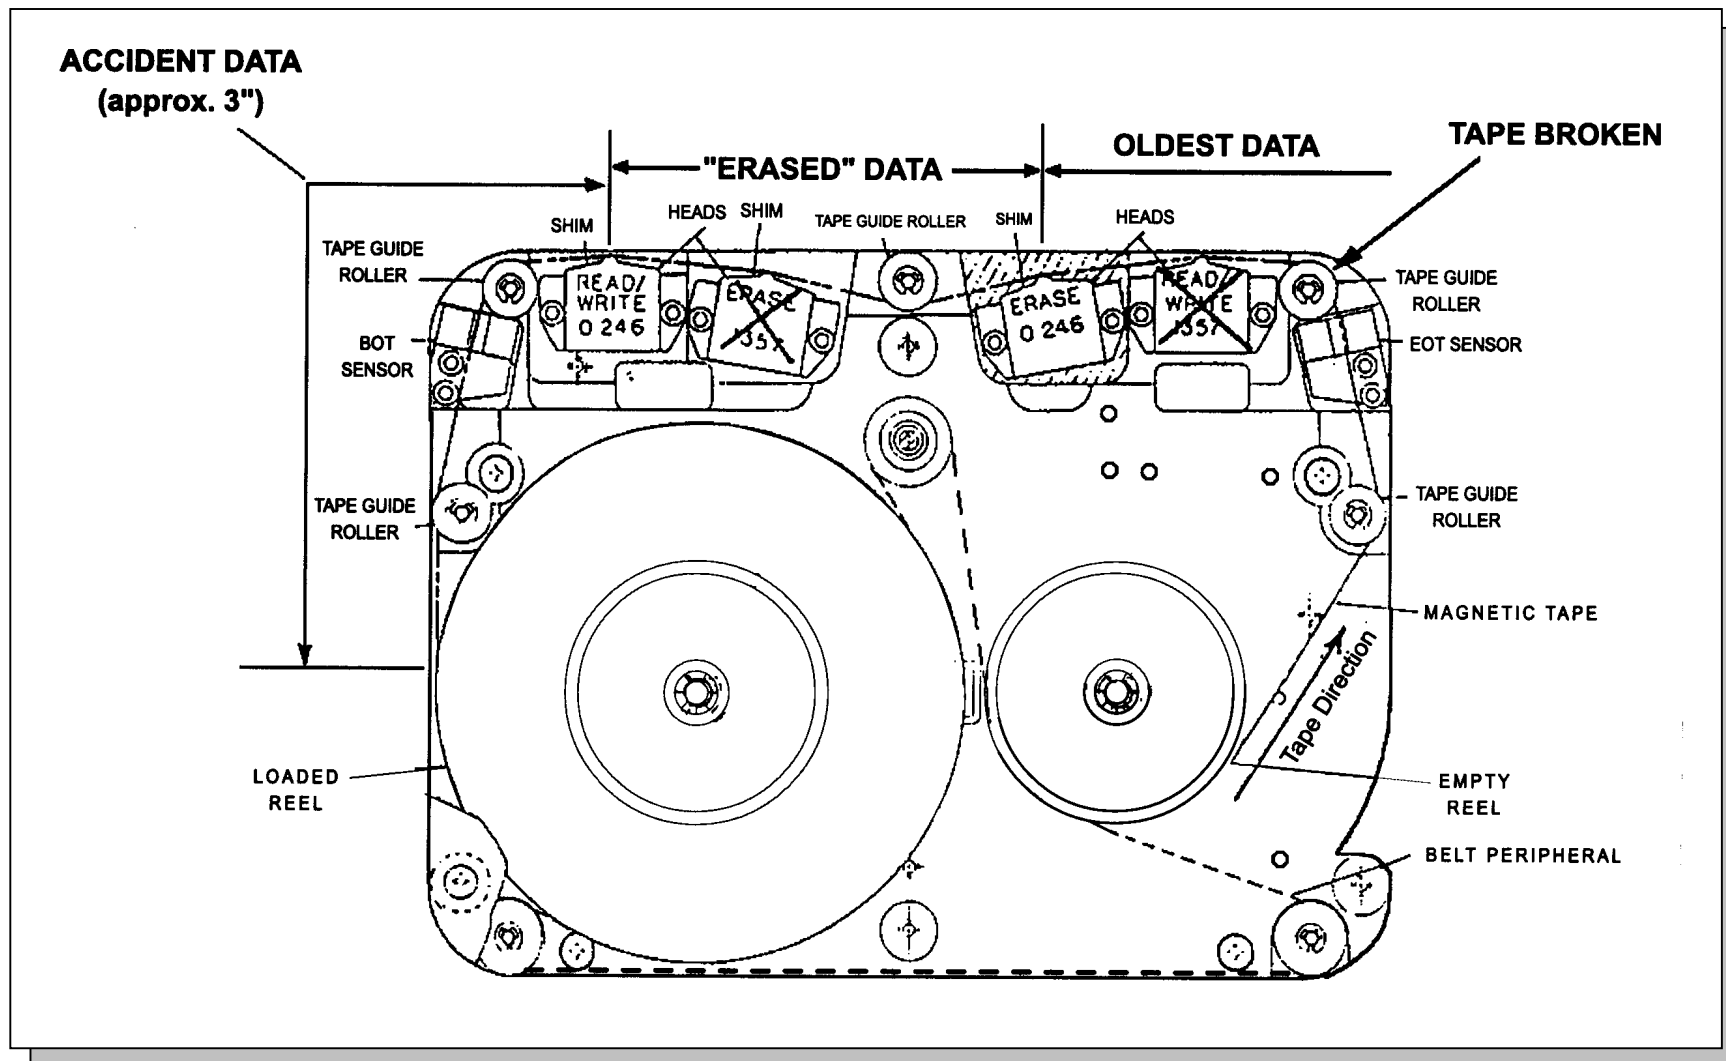
The FDR module was recovered by divers on 24 December 1997. The FDR's underwater locator beacon (ULB) was found detached from the FDR at the accident site. Two of the enclosure's four retaining bolts were broken. The enclosure was partially opened (Figure 4.a). The partial opening exposed the tape between the two tape reels, near the write and erase heads, see Figure 4.b and c.

Figure 4.b The tape inside FDR

Figure 4.c Sketch of FDR tape layout

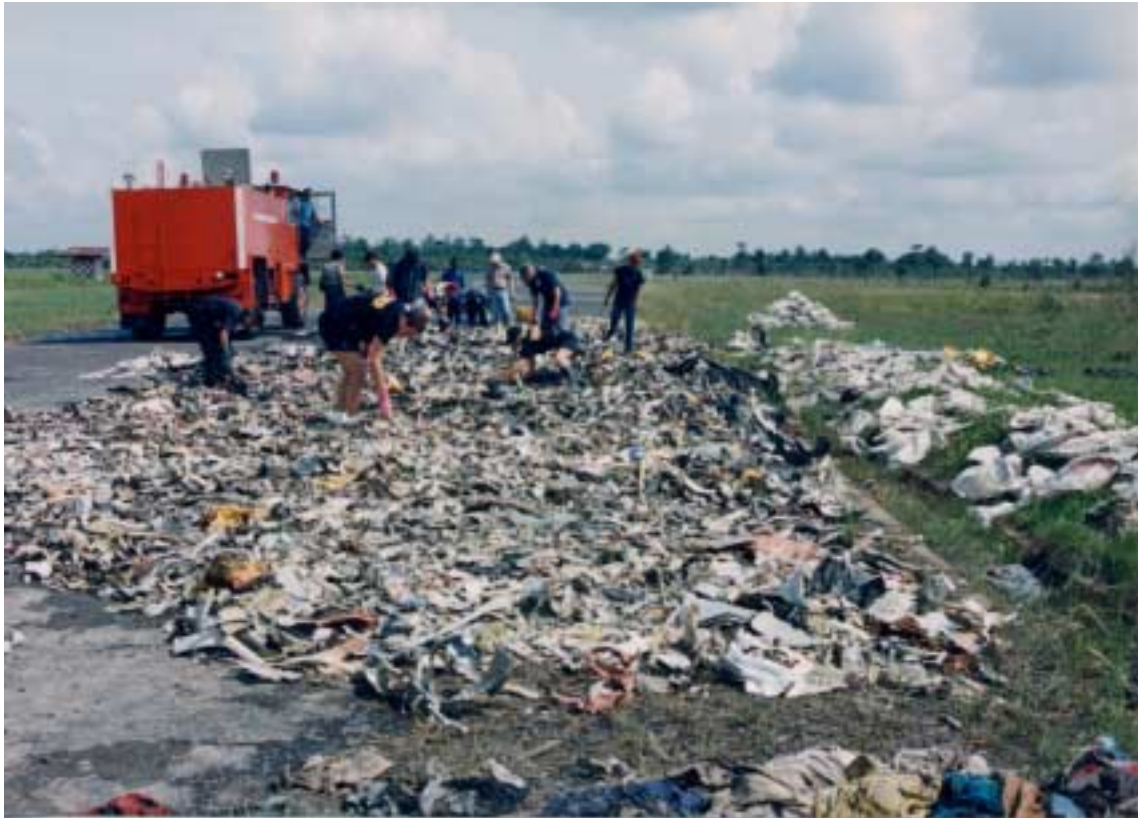
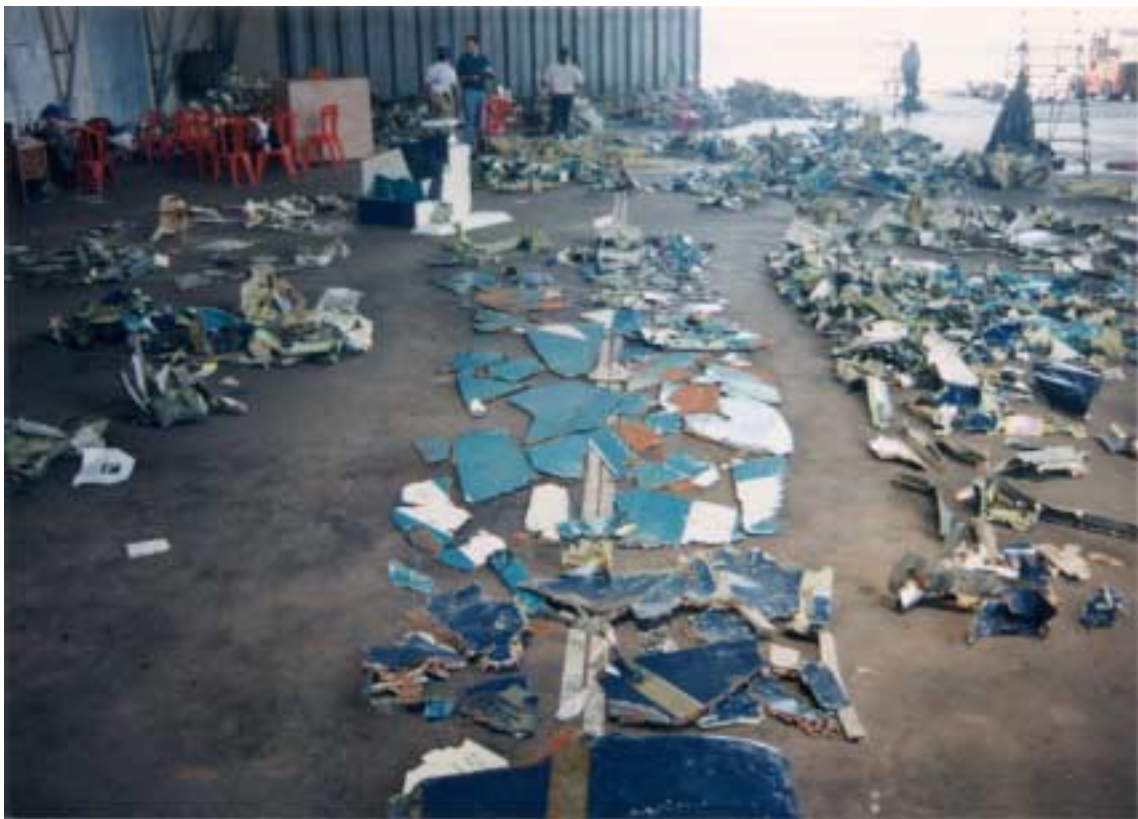
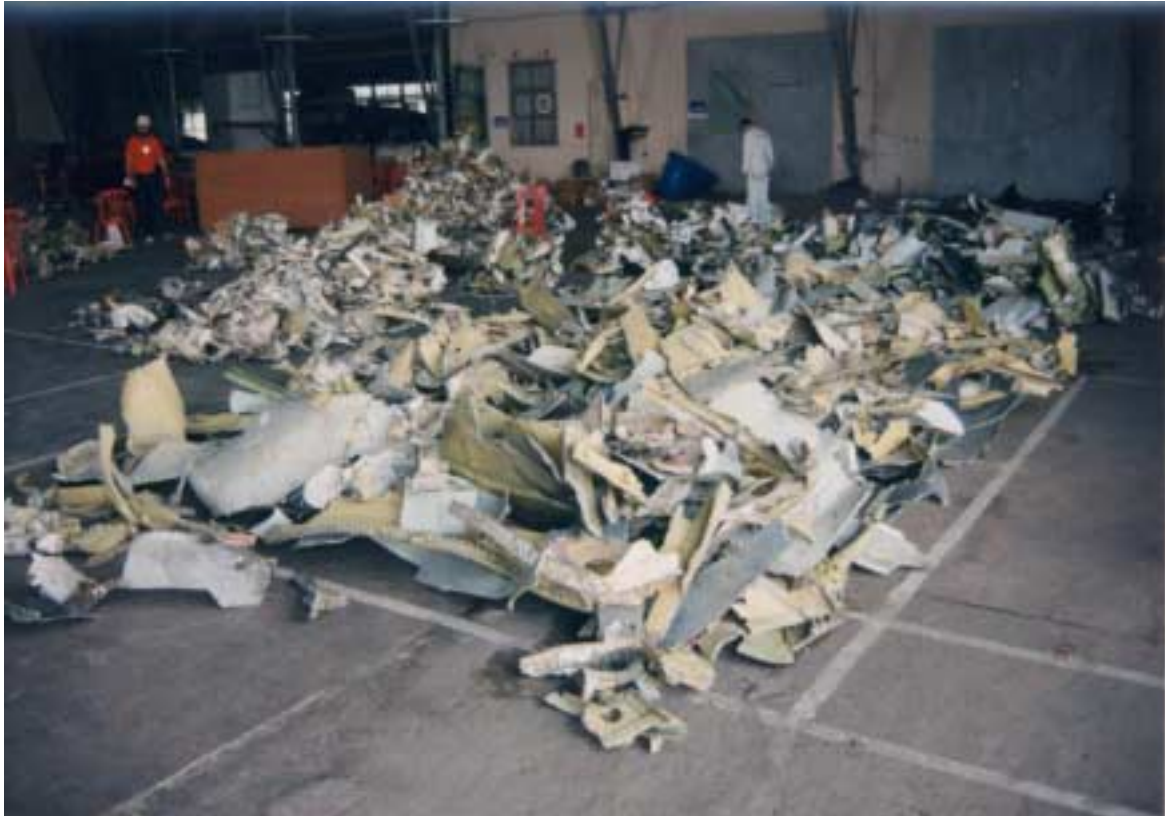
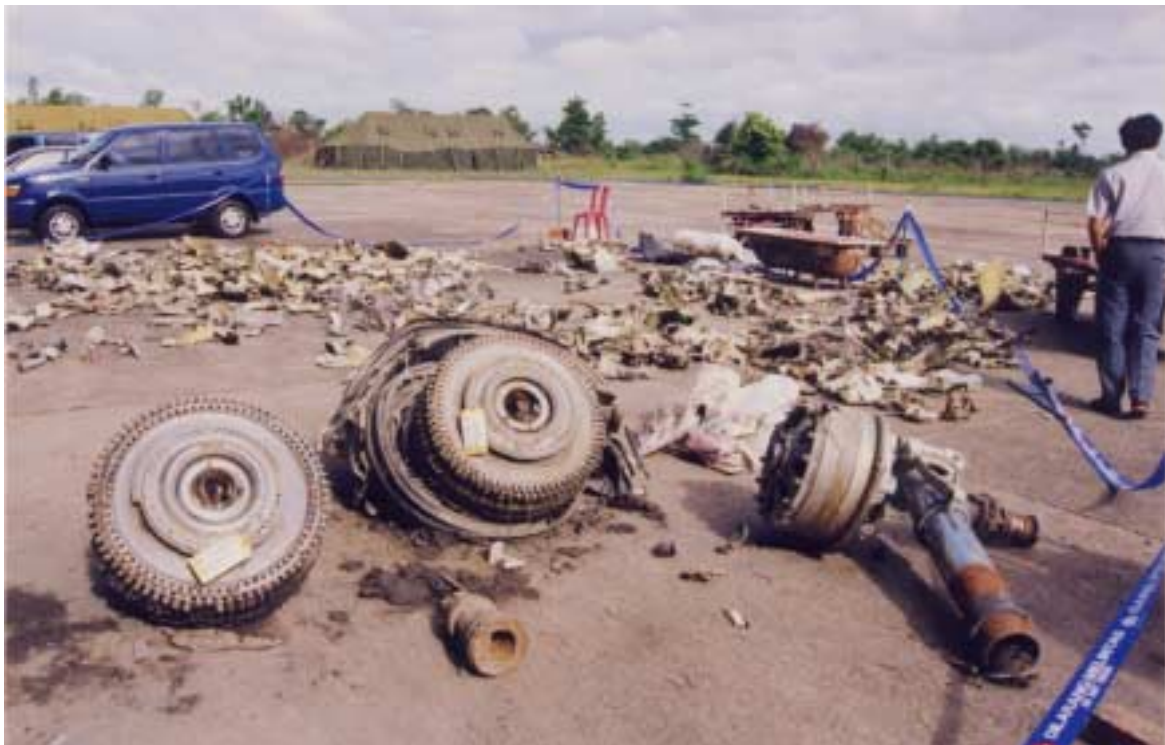
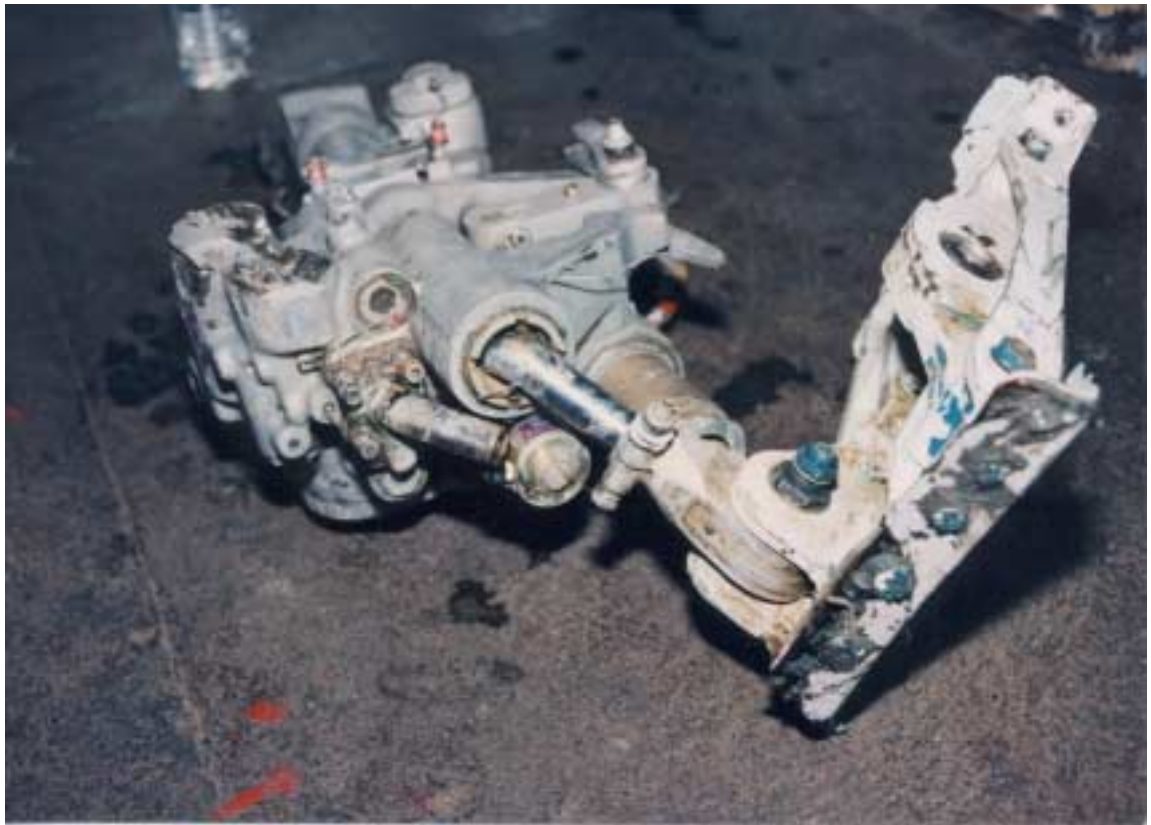
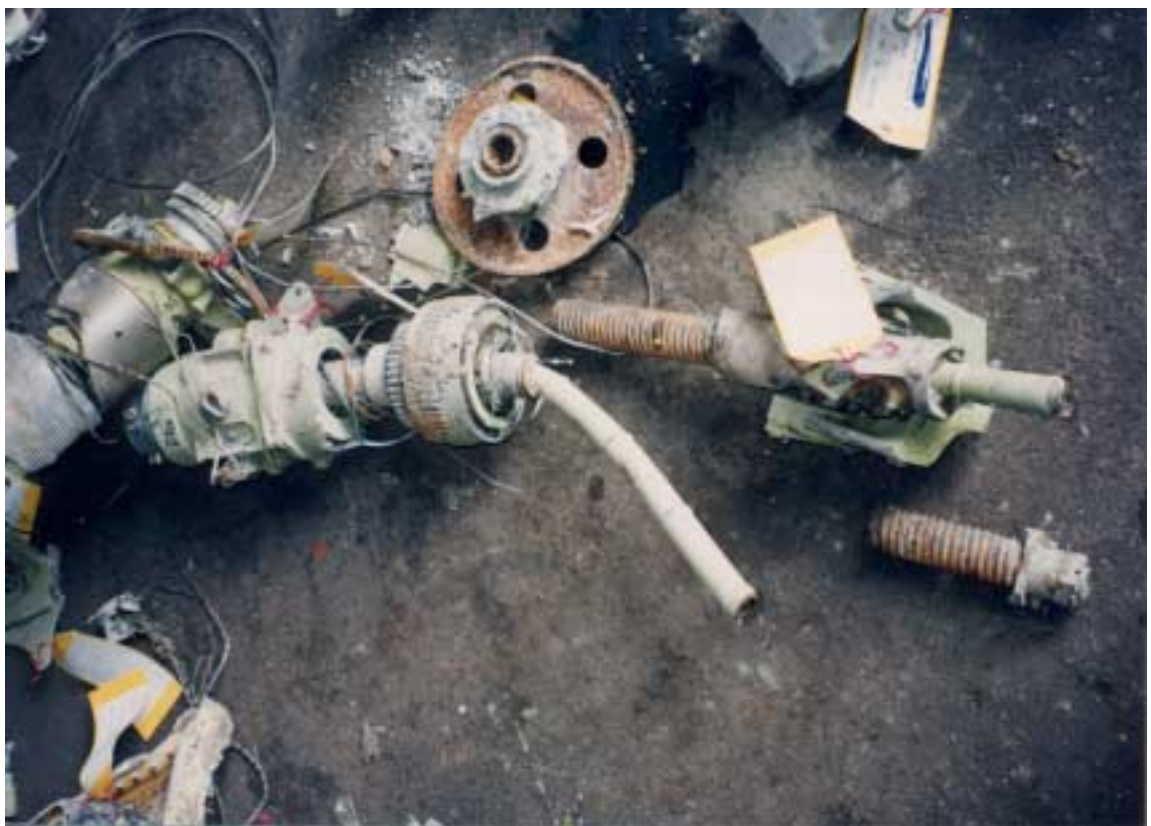
Figure 8 Picture of the wreckage recovered from the river

The aircraft parts found in the river were highly fragmented and mangled on impact, see Figure 8. As a result, all parts of the aircraft were mixed together on recovery, making sorting and identification of the many small pieces difficult. Particular attention was paid to finding parts of the control surfaces, actuators, electronic and avionics systems, engines, Section 48 (rear fuselage including aft pressure bulkhead) and the empennage (see Figure 10). The cockpit instrumental panel and circuit breakers panel were not recovered. The wing flaps, spoilers, ailerons, and leading edge slats and their supporting tracks, carriages and actuation systems were also accounted for. Cabin items such as seat structures, cushions, oxygen generators, etc. were also recovered and examined. Parts and components recovered were contaminated, stained and showing accelerated corrosion. River water and mud samples were taken to determine their effect on the condition of the recovered parts and components. Following cleaning, the parts were marked with the date and method of recovery (by diver or dredge). Where possible, parts were identified, part numbers noted and components were laid out in groups by sub-assembly, for example, wings, landing gears, etc. Empennage parts were laid out on the hangar floor in their approximate respective positions. Reconstruction was limited due to the degree of destruction of the aircraft.

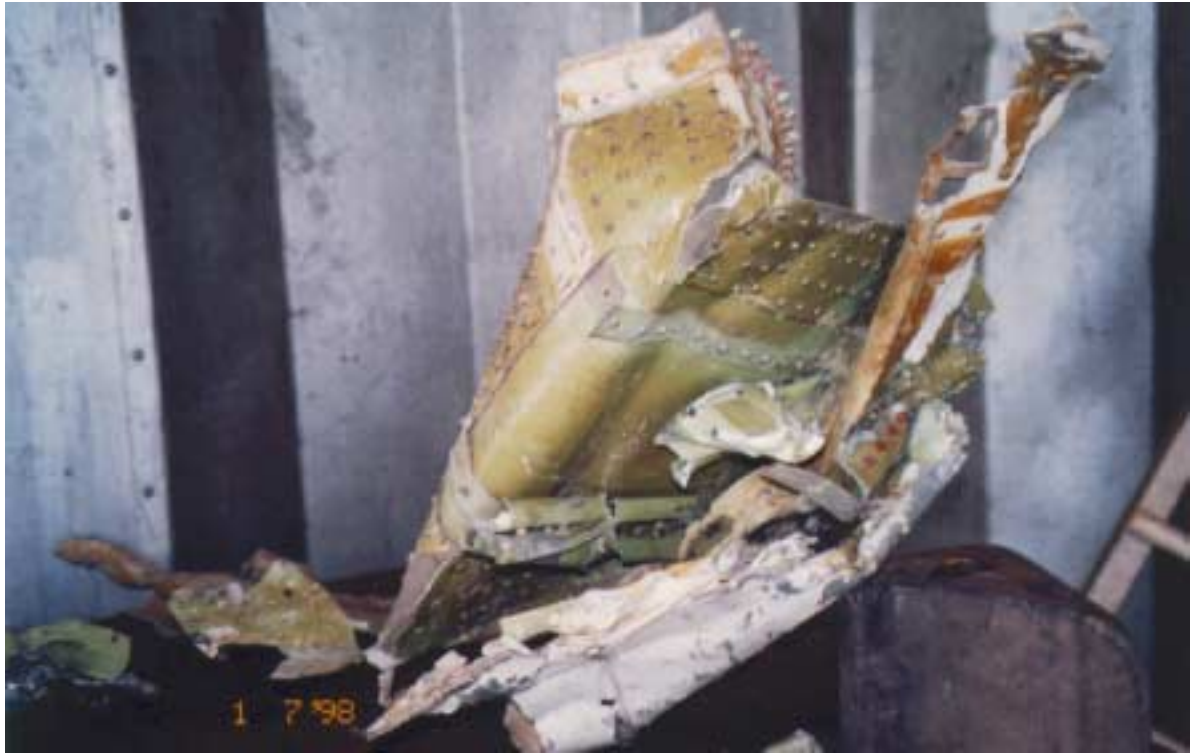
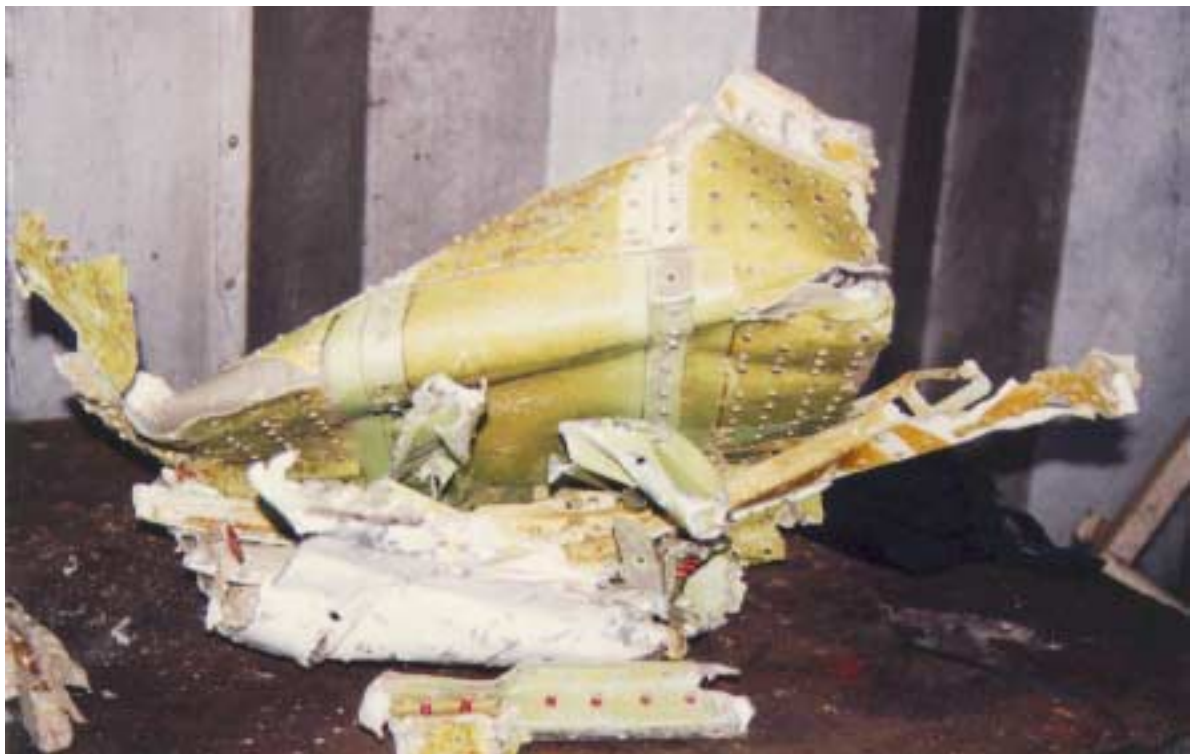
Figure 9 Picture of wreckage of the fuselage skin patch repair

The patch repair was just above the floor level and forward of the left hand aft passenger door between station 867 and station 907 and between stringer 14L and stringer 17L. The entire patch was found intact and was still attached to the surrounding skin, see Figure 9.

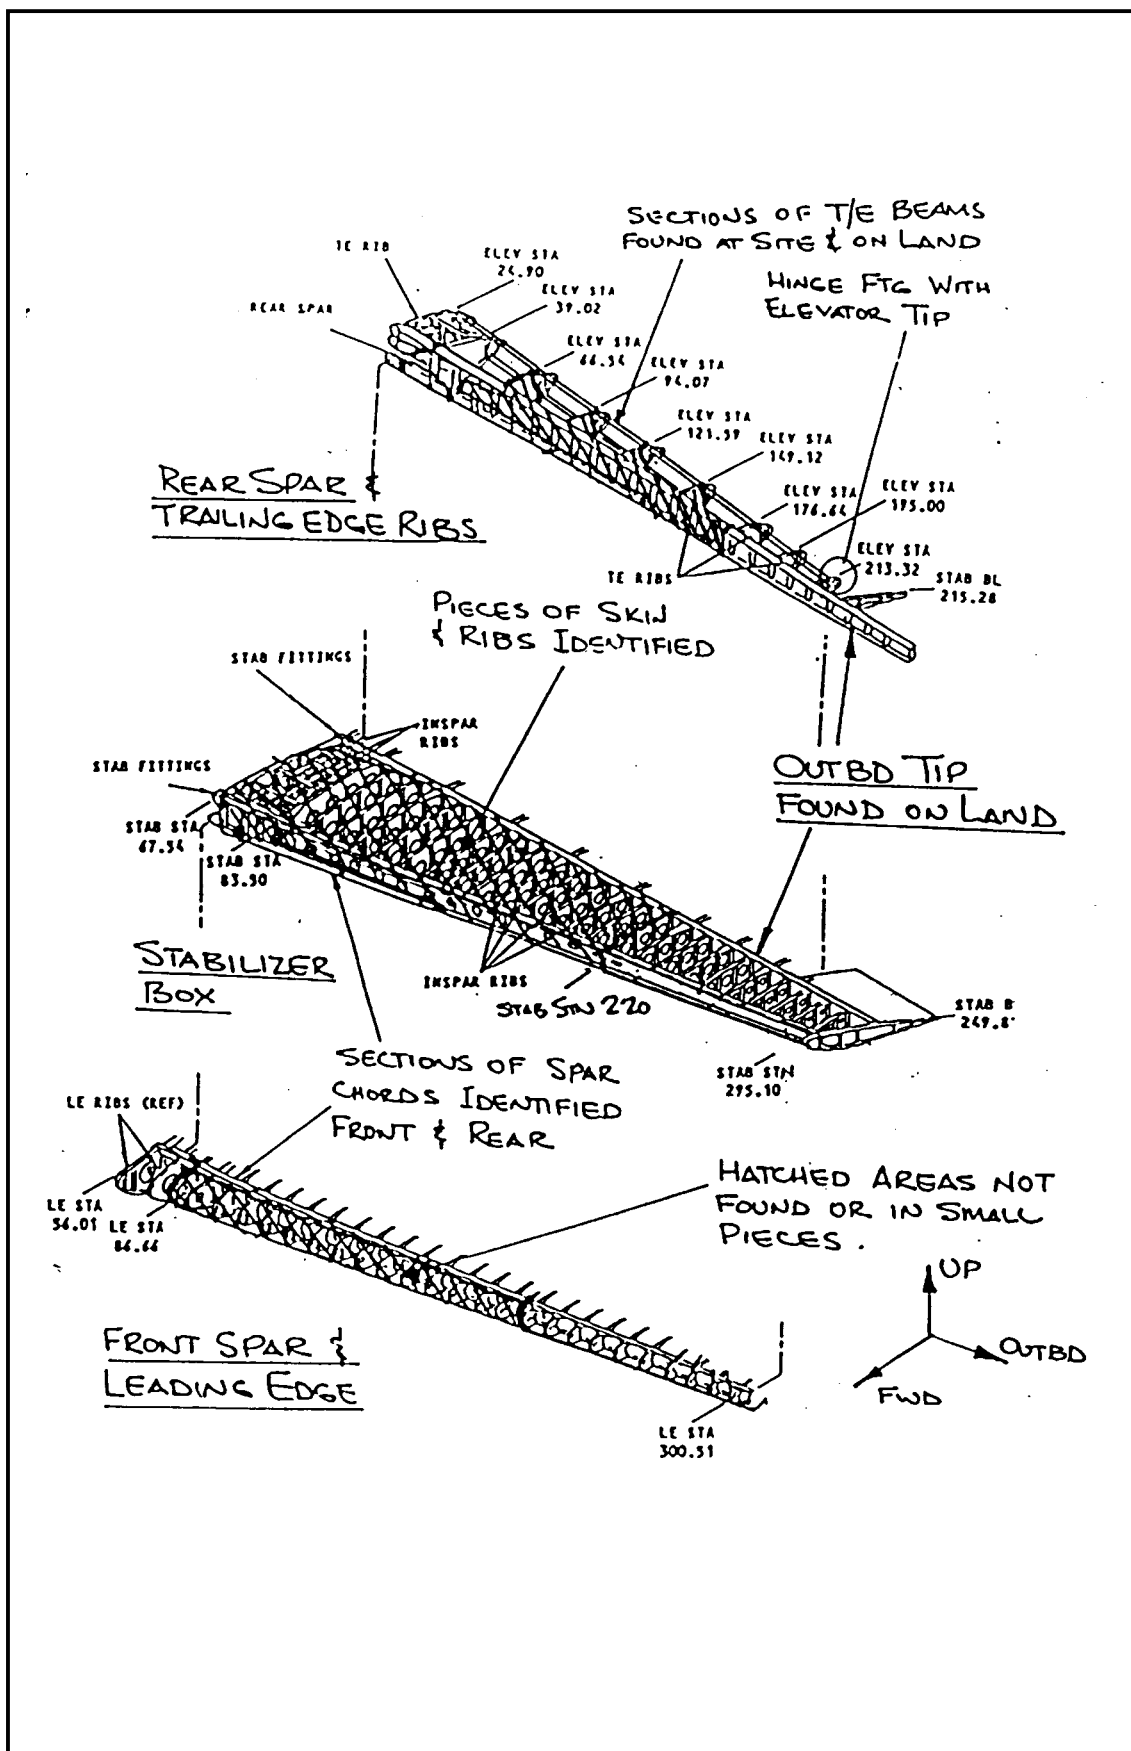
Figure 10.b Horizontal Stabilizer L.H. Side

Left hand horizontal stabilizer (Figure 10.b) - No impact marks were found or observed on the leading edge of this section. Both the front spar (upper and lower chords) and the rear spar upper chord were bent up near their fracture locations. The lower chord fracture was indicative of tensile failure but little deformation was observed. The rear spar web was crushed upward near the fracture location. The upper skin near the fracture was bent up. The upper skin of the leading edge and the interspar areas exhibited wrinkles. The rear spar web of the outboard left hand horizontal stabilizer section contained diagonal tension wrinkles, distortions and paint failures at several locations similar to the right hand horizontal stabilizer outboard sections. As on the right hand horizontal stabilizer, the

damage observed on the outboard left hand horizontal stabilizer section was consistent with high vertical and torsional loading. It is noted that the right hand horizontal stabilizer was severely deformed in the same approximate location as the left-hand horizontal stabilizer chord-wise break near station 221. The stabilizer front spar outboard of station 221 is a solid web, but inboard of this location, the front spar contains flanged lightening holes.

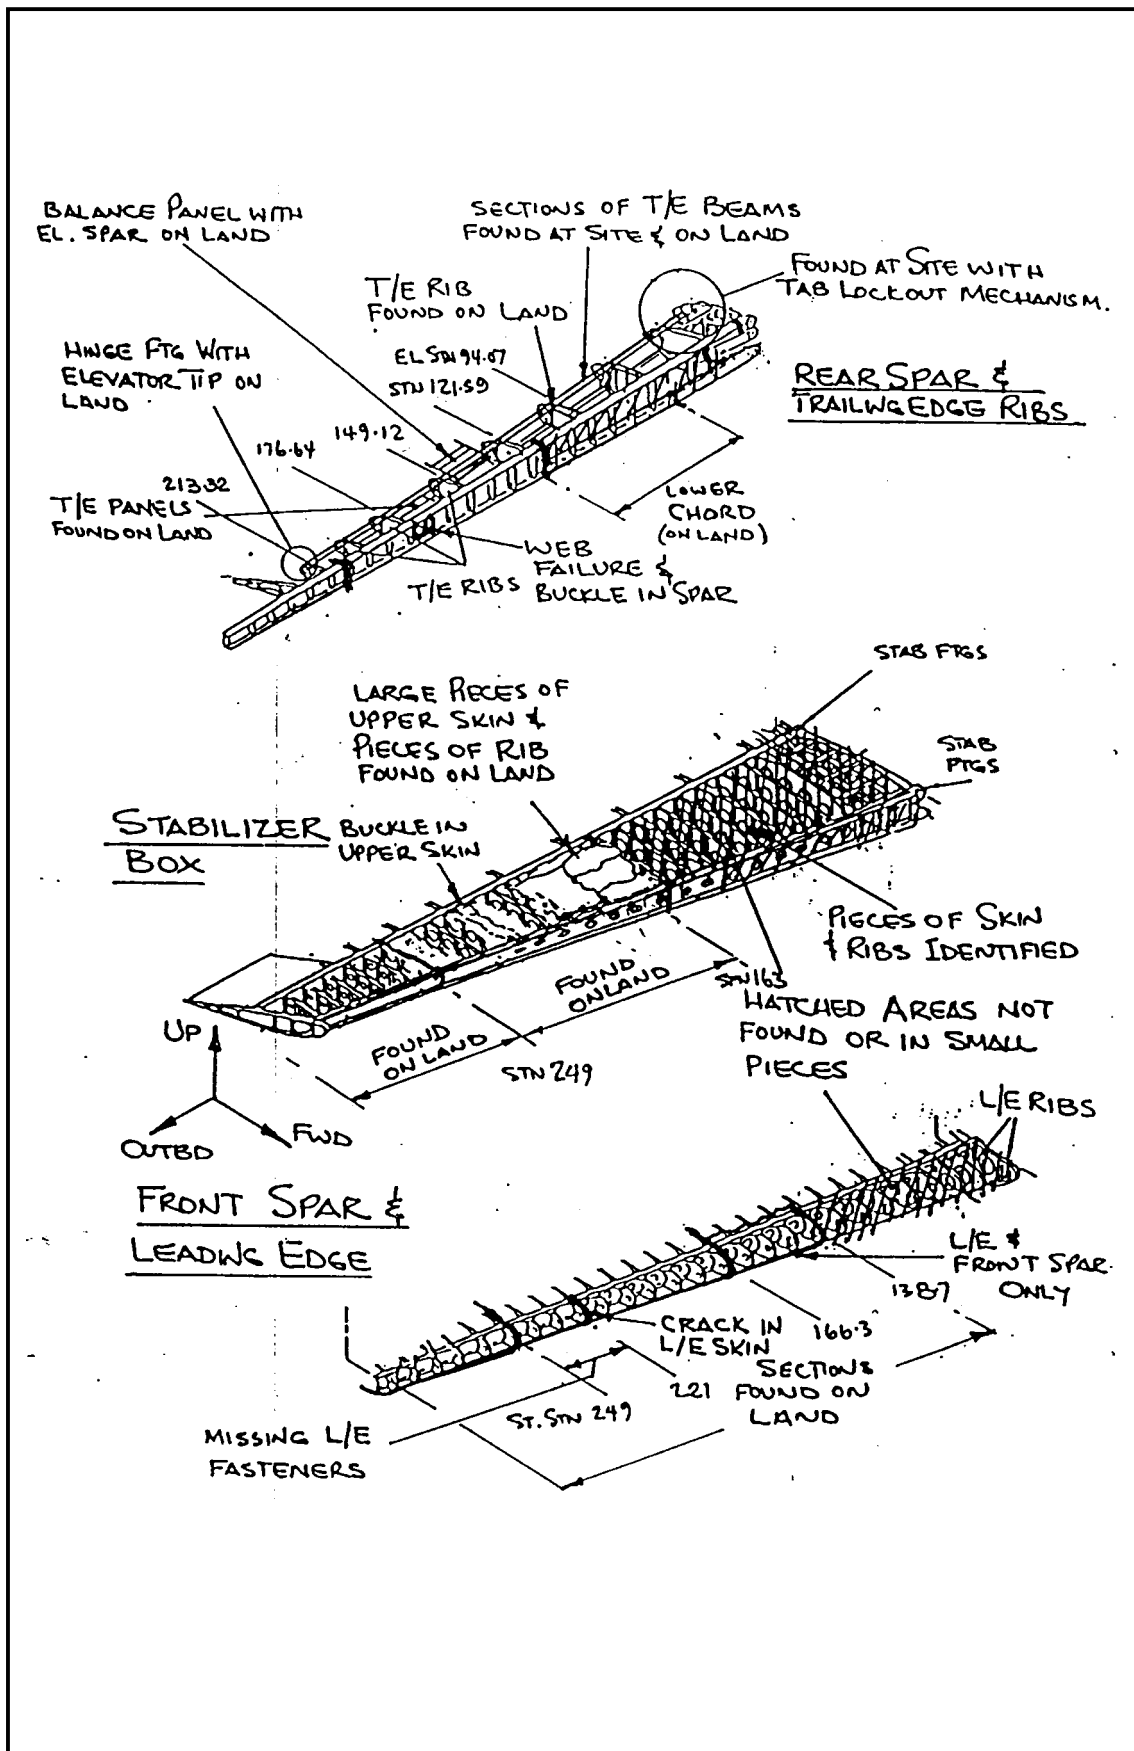
Figure 10.d Horizontal Stabilizer R.H. Side

Right hand horizontal stabilizer (Figure 10.d) - The leading edge of the two right hand horizontal stabilizer sections showed no impact marks. Distortion and wrinkles were noted in the outboard areas of the horizontal stabilizer leading edge and interspar ribs and skin.

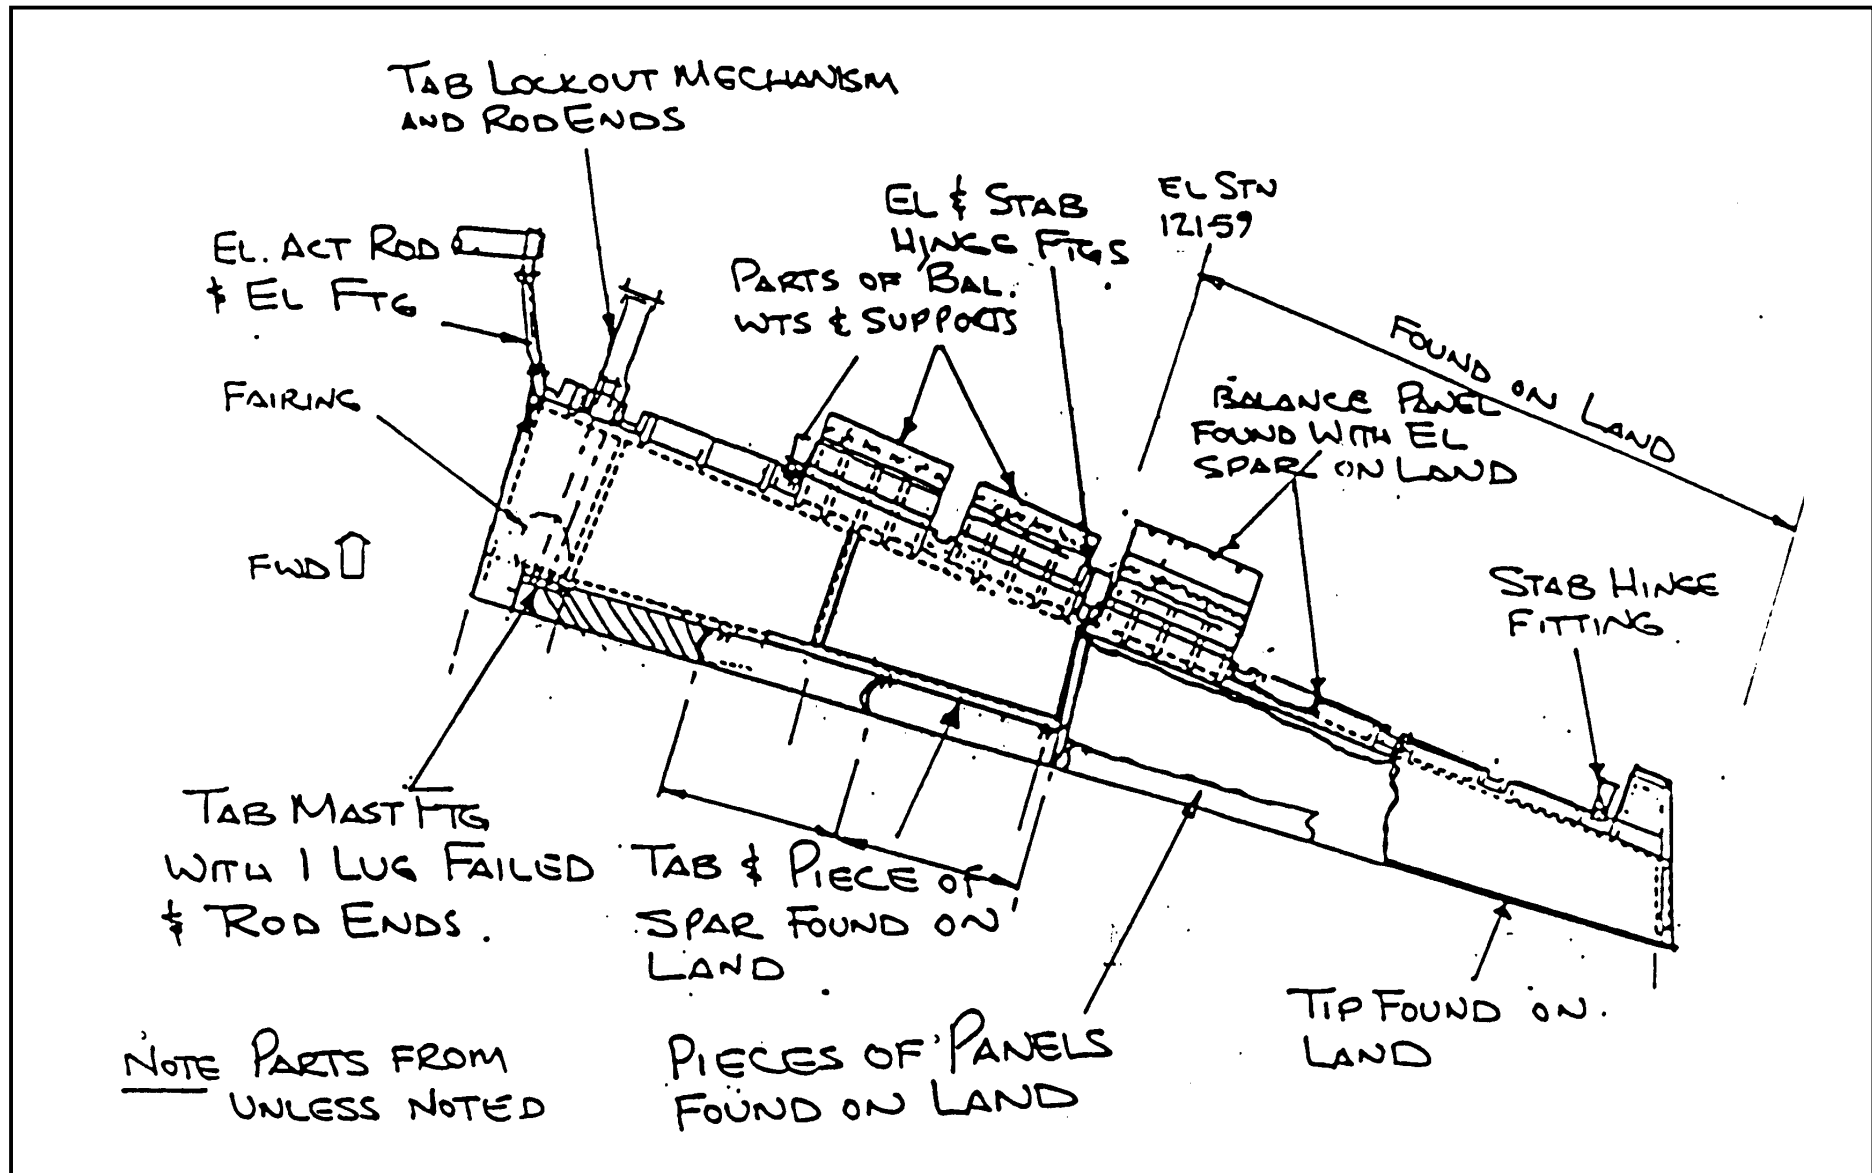
Figure 10.e R.H. Side Elevator

Right hand elevator (Figure 10.e) - All of the control tab pieces were identified except for the portion inboard of elevator station 66. The largest piece of the right hand elevator was the portion from the tip to elevator station 176, including the tip balance weight and elevator station 213 hinge fitting. All six elevator hinge fittings were identified. The hinges located at elevator station 121 and outboard were found on land. The elevator hinges and surrounding area at elevator stations 213 and 176 contained evidence of elevator over-travel in the up and down directions and twisting of the bearings or hinge plates. The bearing and the bearing plates of the elevator hinge at elevator station 195 were twisted as if the elevator outboard end moved upward relative to the horizontal stabilizer. Although the lower bolt was not found, evidence indicated that the bolt was present during the separation of the elevator. The balance weights in the balance bay and support structure were recovered from the crash site. The right hand elevator control tab rods were identified. Deformation of the rods at the right hand elevator showed that they

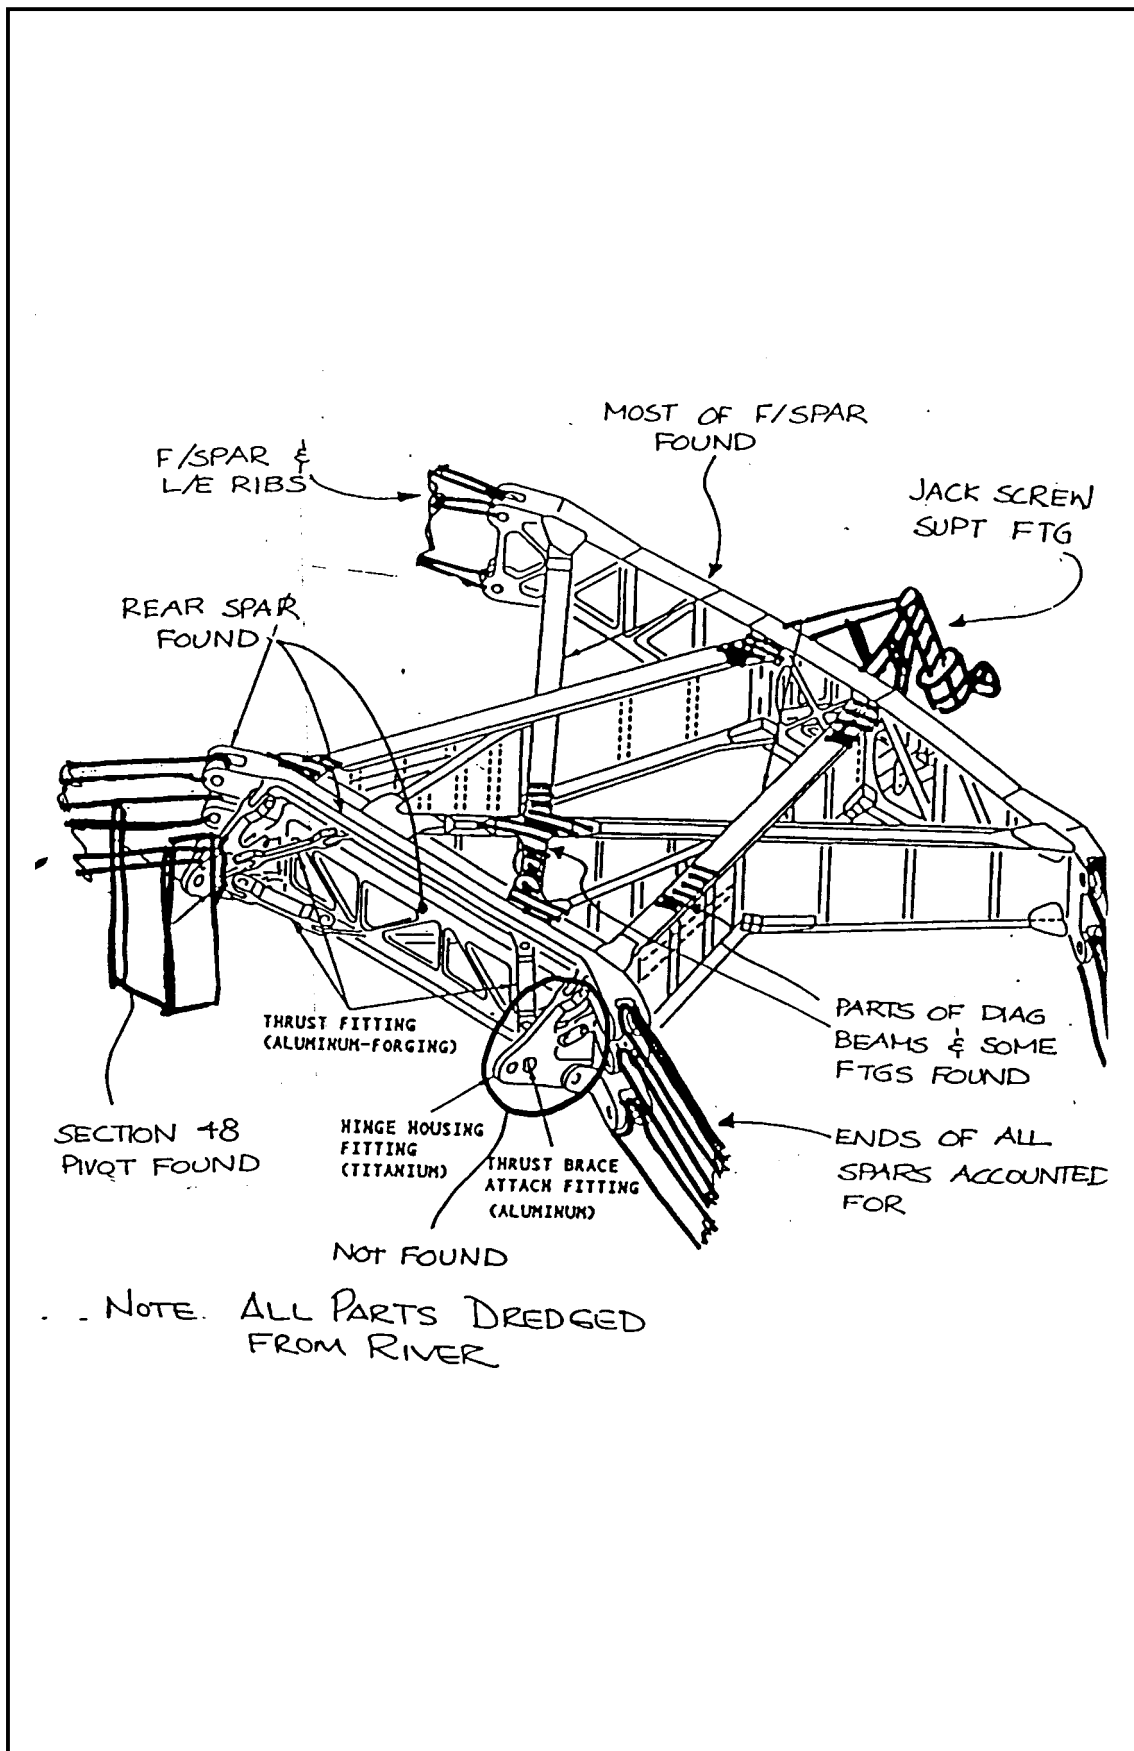
Figure 10.f Horizontal Stabilizer Center Section

The horizontal stabilizer center section (the so-called "Texas Star") structure and the horizontal stabilizer jackscrew were recovered from the crash site in the river. The majority of the front and rear spars were found and identified. The horizontal stabilizer center section has two hinge supports at the rear end about which the horizontal stabilizer is pivoted. The front end of the Texas Star structure is connected to a ball-nut on the jackscrew which is used to move the horizontal stabilizer (Figure 10.f).

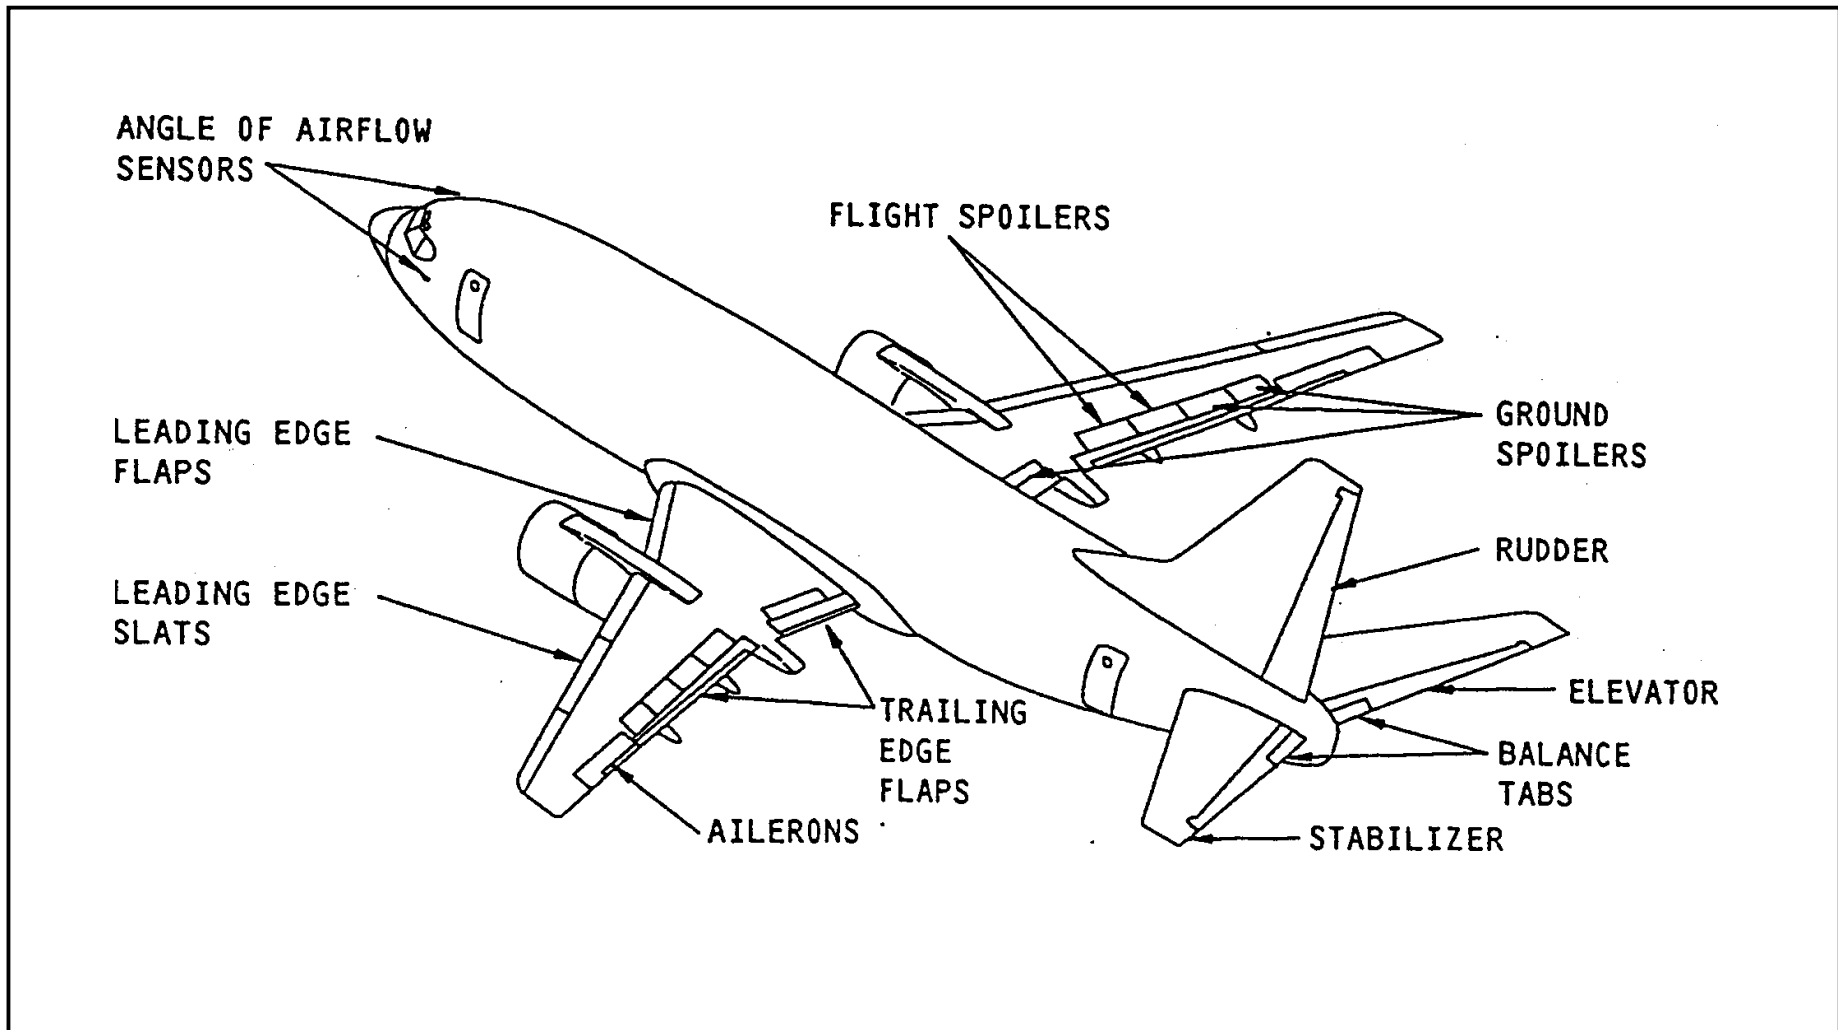
Figure 18 Flight Control Surfaces Location

Flight spoiler actuators – four units per aircraft: (*Items 7, 8, 9 & 10 in Appendix E*) All four flight spoiler actuators were recovered and examined. The actuators were found to be in the fully retracted position (see Figure 18).
