## Landing gear failure on takeoff, Airbus A300B4, EI-TLL, at Manchester International Airport, July 17, 1997

**AAIU Report No:- 1999/002**  
**AAIU File No:- 19970040**  
**Published 15/03/1999**

**Aircraft Type and Registration:** Airbus Industrie A300 B4, EI-TLL

**Nature of Damage:** Damage to left main landing gear, hydraulic lines and components

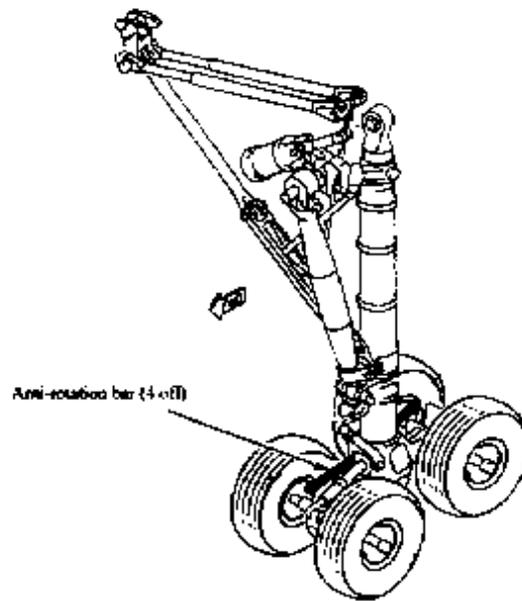
The anti-rotation bar itself was intact and undamaged apart from scraping due to runway contact. The holes in the retaining collars through which the bolts passed were distorted in compression due to excessive loads exerted by the bolts in a direction consistent with the bar moving laterally with respect to the aircraft centreline. When later obtained from Aerospatiale, the remains of the bolts which secured the collars showed clear evidence of shear failures caused by a very small number (possibly less than 10) of very high load reversals.

Fig 1 A300 B4 main landing gear showing arrangement of brake anti-rotation bars.

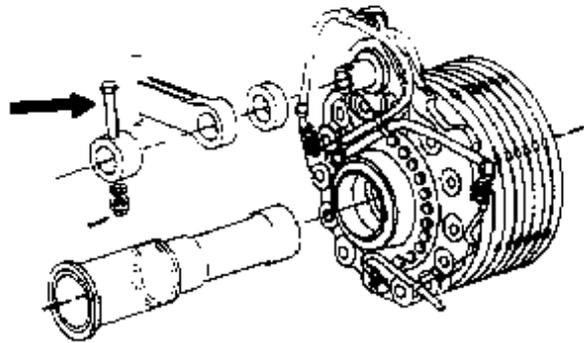
As mentioned above, the bolts from the other brakes were requested from the Maintenance organisation but in fact only four were received. Two of these were marked as coming from brakes 2 and 5 and the other two were not identified. The No 2 brake bolt appeared, from its dimensions, to come from the brake end of the rod and that from No 5 from the leg end. The two unidentified bolts appeared both to be from the brake ends, presumably from Nos 5 and 6. Whilst all the bolts examined showed signs of fretting corrosion on the shanks, the bolt identified as coming from No 2 brake had been plastically deformed in shear at the points where it passed through the retaining collar. All the bolts met the minimum hardness requirements specified by the manufacturer.

Fig 2 Detail sketch of brake anti-rotation bar retaining collar and bolt (arrowed)
