Flight control system failure, Airbus A320 EI-TLI, on 1998-10-18

Investigative Body: Air Accident Investigation Unit (AAIU), Ireland

AAIU Report No. 20001/002
AAIU File No. 19980055
Published.: 29/01/2001

Aircraft Type and Registration:	A320-231 EI-TLI
No. and Type of Engines:	2 X I.A.E. V2500-AI
Aircraft Serial Number:	405
Year of Manufacture:	1993
Date and Time (UTC):	18 Oct 98 14.24 hrs
Location:	23 NM SE Dublin Airport
Type of Flight:	Public Transport
Persons on Board:	Crew 2/5 Pax 168
Injuries:	None
Nature of Damage:	Hydraulic Oil Leak
Commanders Licence:	Airline Transport Pilot's Licence
Commanders Age:	32 years
Commanders Flying Experience:	5140 hours (590 on type)
Information Source:	Aircraft Operator. AAIU Field Investigation

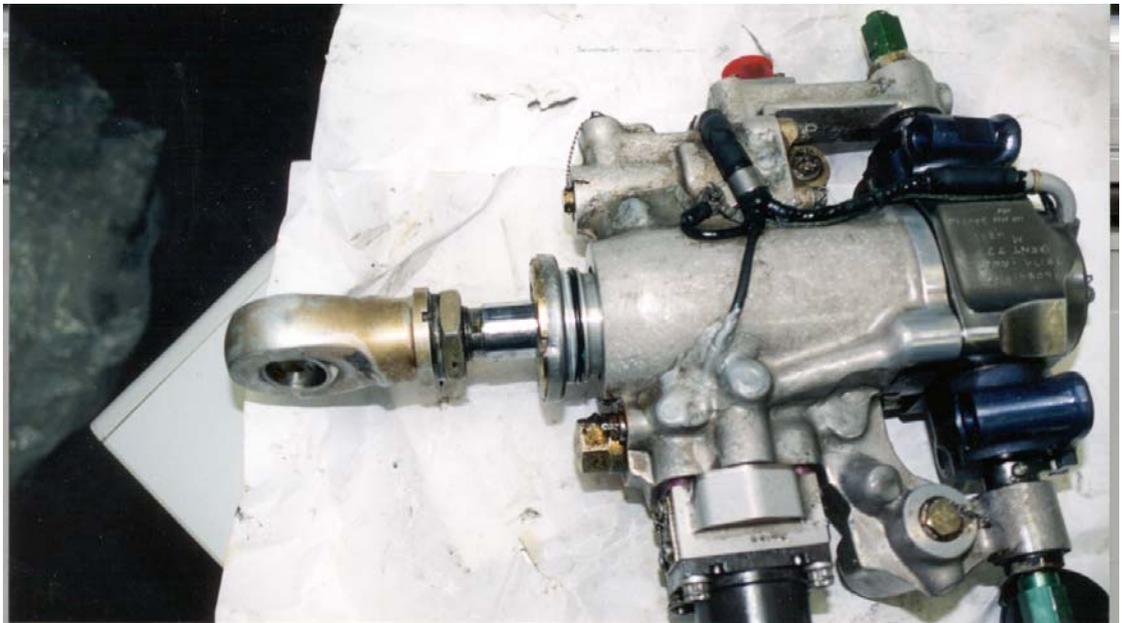
On 18th October 1998 the aircraft was on a flight from Rome to Dublin when at 23 NM from Dublin Airport a warning appeared on the aircraft's monitoring system that the hydraulic pressure in one of its hydraulic systems had reduced to a low level. At the same time the aircraft was struck by lightning. The Captain disconnected the autopilot and took over control of the aircraft. Directional control was difficult. "PAN" call (emergency) was then declared and ATC advised of weather conditions at Dublin Airport. The crew noted that No. 3 spoiler on the starboard was stuck in the up position. The aircraft was becoming more difficult to control as the approach speed was reached and a higher speed was selected. The roll to the right became severe at touchdown and full left aileron was used in the landing. Ground spoilers then deployed in the normal way and the aircraft continued the ground roll. On landing it was discovered that No.3 spoiler starboard side remained up and that the spoiler actuator was leaking hydraulic oil.

Investigation of defective actuators, forming part of the servocontrol, confirmed that the bearing breakage was a fatigue failure resulting from an excessive out of squareness of the actuator housing. The manufacturers identified a 337 unit batch affected by the improper machining of the actuator housing backface and cited that there may have been more. In fact the figure was nearer to 500. A modification, consisting of installing a reinforced bearing able to withstand the geometric variation of the housing, was issued by the manufacturers in Oct 94.

Photograph showing defective servocontrol.

Service Bulletin SB320-27-1086 was issued to cover this modification of servocontrols of spoiler No.2 and 3 (compliance recommended) and SB320-27-1087 was issued for spoiler No.1 in January 1995 (compliance desirable). The former bulletin was to be carried out on the complete fleet prior to the latter bulletin. Revision 3 of the former was issued in Nov.’95 and Revision 2 of the latter in April ‘96. These bulletins were applicable only to servocontrols from serial numbers 0639 to 3086
