Excessive right aileron required on Boeing 737-400, EI-BXB, at Dublin Airport.

AAIU Report No. 2000/008
AAIU File No. 19980066
Published: 02/08/2000

Aircraft Type and Registration: B737-400, EI-BXB

Location: RWY 28 Dublin Airport

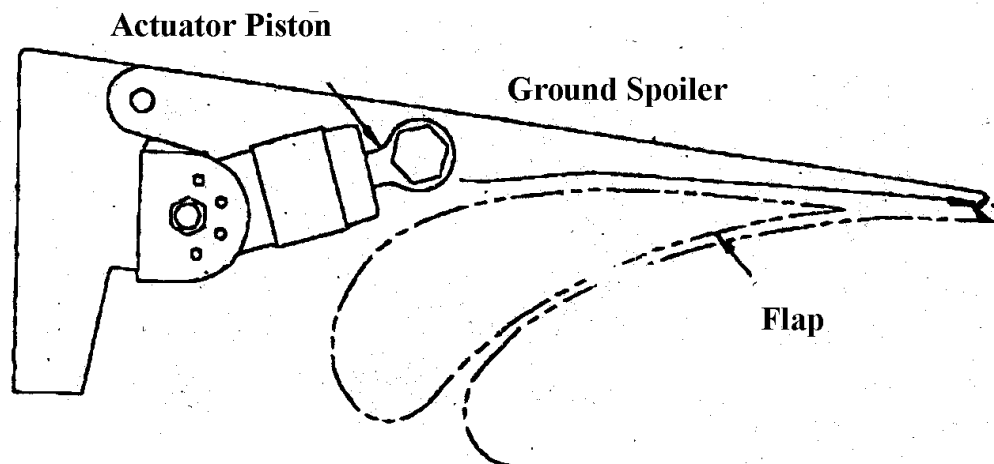
Fig 1 (Above) Spoiler Configuration EI-BXB

Spoiler panels are installed to supplement the ailerons for lateral control and also to provide increased drag and reduced lift when used as speed brakes. Five hydraulically powered spoilers are installed on each wing. They are numbered from left to right for identification, 0 to 4 on the left wing and 5 to 9 on the right wing.

Spoilers used in flight are 2,3,6 and 7. The remaining six (0,1,4,5,8 and 9) are used on the ground only as lift dumping i.e. when landing. The failed spoiler was one of these. The ground spoilers have two positions, fully retracted (see sketch) or fully raised. The fully raised position for all the ground spoilers is 60 degrees. Ground Spoilers "0" is actuated directly by a single-acting actuator. Hydraulic power is supplied by aircraft System A. The ground spoiler is attached to the wing structure by four hinge fittings aft of the rear spar and is located forward of the outboard flap. The actuator is attached directly to the spoiler and wing structure at the centre of the spoiler. When the spoiler is down, the down limit is provided by bottoming the piston in the actuator. When activated, the actuator piston extends fully and pushes the spoiler 60° into the airflow thus increasing the drag and reducing the lift. If the rod end separates from the actuator, the spoiler will move to an intermediate position that is neither fully retracted nor fully raised. The position of this aerodynamic neutral point varies with flight conditions and flap settings.

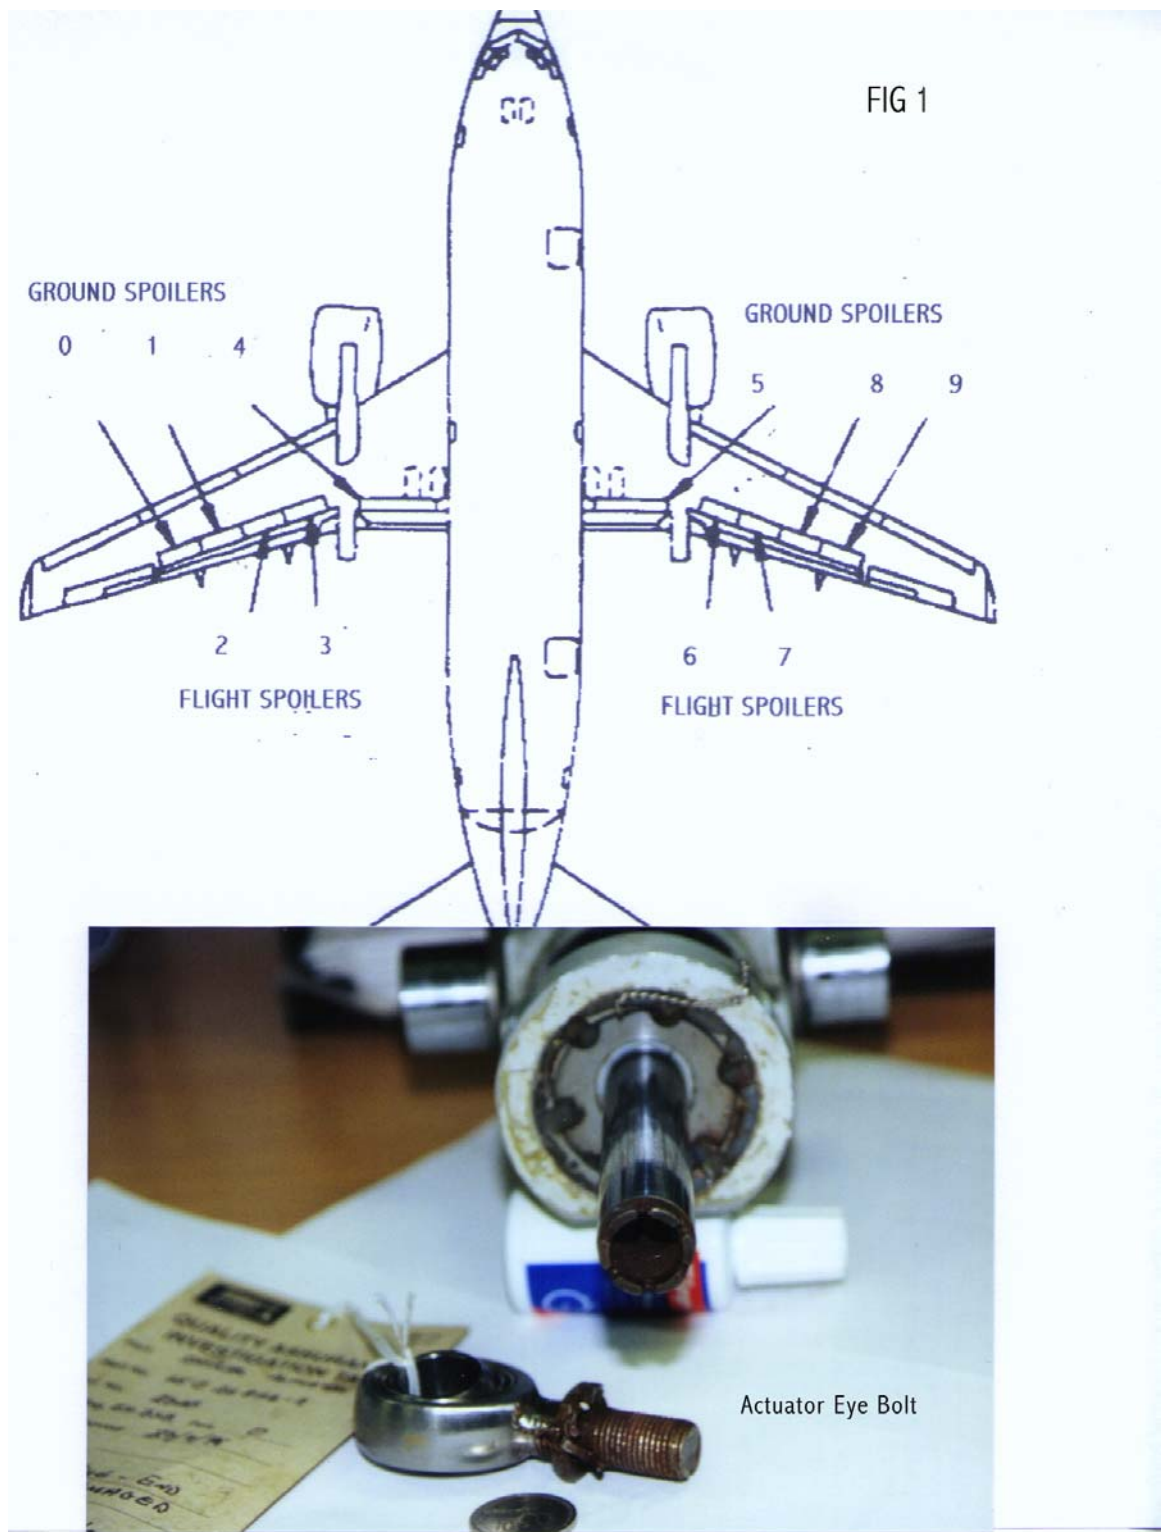
Fig 2 (Below) Position "0" Ground Spoiler Actuator EI-BXB

On examination of the aircraft the cause of the problem was traced to the outboard spoiler on the LH wing (position "0"--see Fig. 2). The spoiler was found with its control surface disconnected from its actuator. The spoiler actuator was found to have had the eye-end separated from the actuator shaft. This was caused by severe corrosion on the threaded portions of the shaft and on the eye-end. The actuator had been installed since delivery in Oct 1989.

The threads of the piston rod and rod end were corroded and damaged. The ball of the spherical bearing could not be rotated by hand. Corrosion products were present in the keyway of the rod end.

This incident was caused by corrosion on the threads of the eye-end bolt and internal corrosion on the threads of the actuator shaft. The eye-end departed from the shaft in flight and caused the spoiler to deploy of its own accord and interfere with the airflow over the wing. The onset of corrosion was facilitated by the absence of sealant.

Shop procedure would henceforth include the use of the additional compound on the threads of the piston shaft bore as mentioned by the aircraft manufacturer's notice of November 1991

The review and analysis in conjunction with the aircraft manufacturers focused attention on all outboard actuators. Outboard actuators were replaced with actuators that were put through the revised workshop process that included the application of the above compound in the shaft bore in addition to the sealant at the eye-end.
