## Aircraft collision with fuel truck, involving a Boeing 737-200, EI-CKR, at Dublin Airport, on 2 April 1999

*AAIU Report No. 1999/018*  
*AAIU File No. 19990016*  
*Published 30/11/1999*

**Aircraft Type and Registration:** Boeing 737-200 EI-CKR  
**Date and Time (UTC):** 2 April 1999 at 08.54 hrs  
**Type of Flight:** Public Transport  
**Persons on Board:** 130  
**Injuries:** Nil  
**Nature of Damage:** No damage to the aircraft  
**Information Source:** Aer Rianta Duty Officer, Dublin Airport

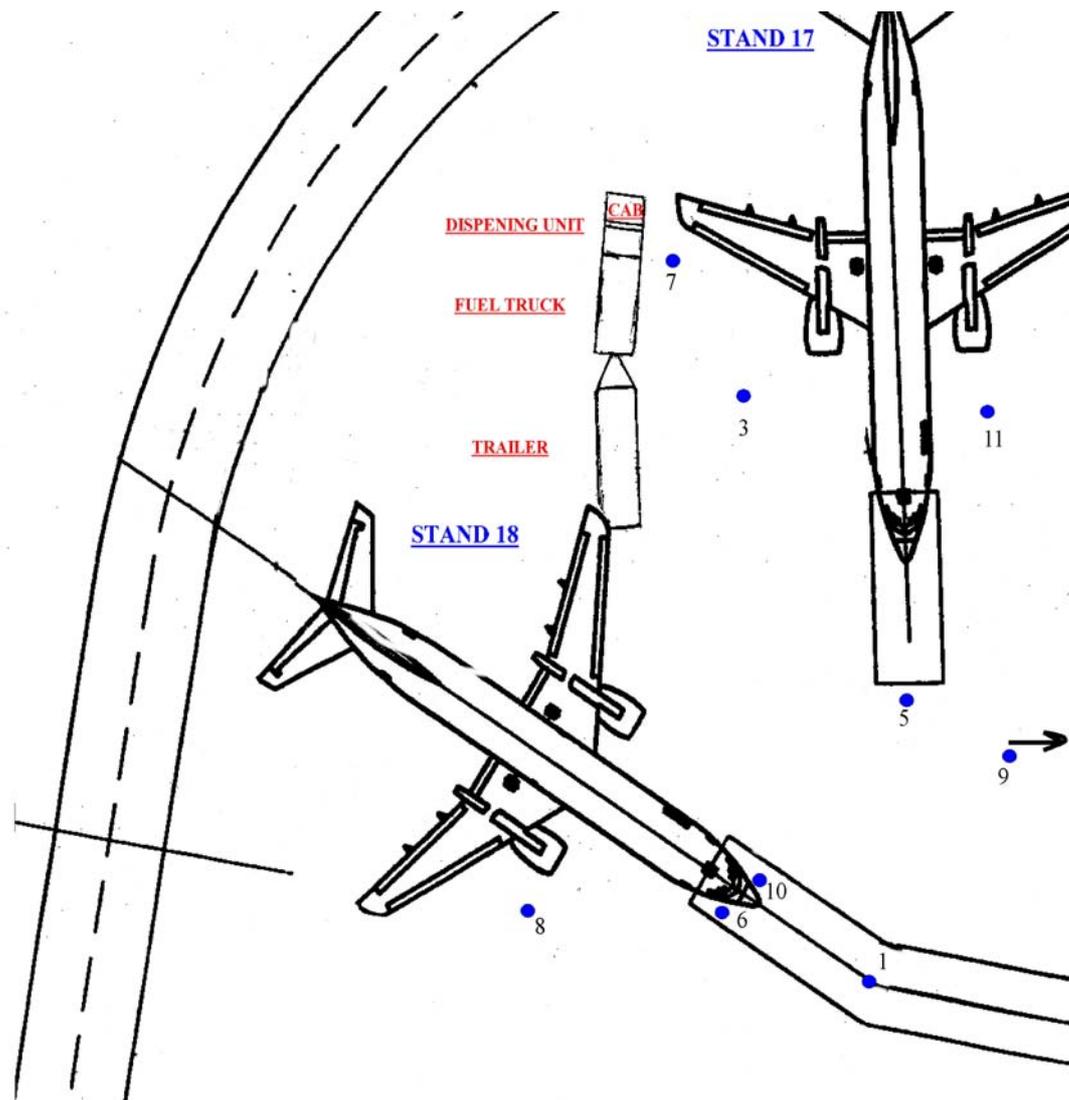
**Fig 1**

Personnel who were on or in the general vicinity of the stand at the time in question were interviewed, over a number of days, after the accident. See FIG 1. for probable location of witnesses.
