Runway overrun, MD-11 World Airways (N272WA) at Shannon Airport, September 18, 1999

Investigative Body: Air Accident Investigation Unit (AAIU), Ireland

AAIU Report No. 2001-006

Name of Operator:	World Airways
Aircraft Type and Registration:	MD-11, N-272 WA
No. and Type of Engines:	Three, P&W PW 4462
Aircraft Serial Number:	48437
Year of Manufacture:	1993
Date and Time (UTC):	18 September 1999, 0524 hours
Location:	Shannon Airport, Co. Clare
Type of Flight:	Public Transport - Passenger
Persons on Board:	Crew - 14 Passengers - 317
Injuries:	Crew - Nil Passengers - Nil
Nature of Damage:	Minor Damage to Right Main Wheel Tyres
Commanders Licence:	Airline Transport Pilot (FAA)
Commanders Age:	52 years
Commanders Flying Experience:	8307 hours (incl 2672 hours as Captain on type) Last 90 days - 150 hours Last 28 days - 78 hours Last 24 hours - 5.3 hours
Information Source	ATC Watch Manager, Shannon Airport. AAIU Field Investigation.

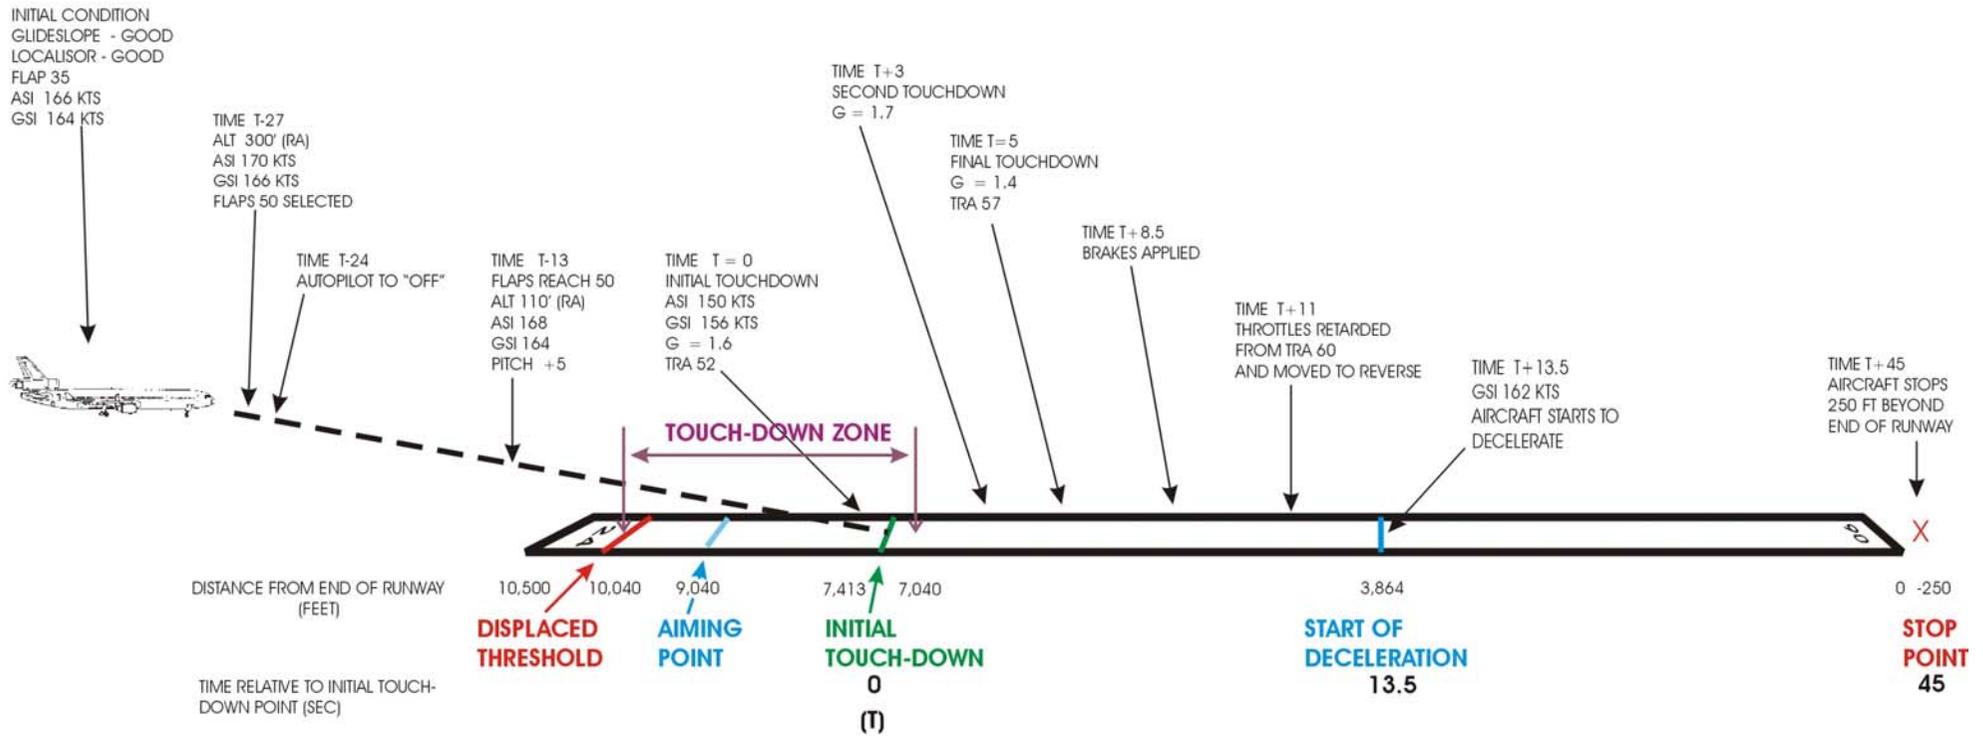
VISUAL REPRESENTATION OF LANDING OF MD-11 N-272WA
ON RUNWAY 24/06 AT SHANNON 18 SEPT 1999

- a. the late selection of 50° flap,
- b. the threshold airspeed of 162 kt
- c. touchdown 1,600 ft past the normal 1000 ft touch down point
- d. application of power during the initial touchdown and landing roll; and
- e. the non-deployment of the ground spoilers which, in turn, precluded the use of the autobrakes.

The late selection of 50° flap destabilized what had otherwise been a stabilized approach, placing the aircraft in a position from which a normal touchdown and landing roll-out could not be effected within the remaining landing distance available.

The Operator reviews its flight training programme to re-emphasize the following points;

- a. The stabilized approach concept, definition and requirements,

The importance of executing a missed approach if the approach becomes destabilized; and
- b. The PNF's role in assuring that ground spoilers are deployed after touchdown. **(SR 13 of 2001)**
