## Pressurization emergency, Boeing 737-800 EI-CSC, October 7, 2000

**Micro-summary:** A pressurization system operation problem on climb results in the Boeing 737 returning to origin.

*AAIU Report No. 2001/0018*  
*AAIU File No. 2000/0061*  
*Date Published: 30 November 2001*

<b>Aircraft Type and Registration:</b>	Boeing 737-800, EI-CSC
<b>No. and Type of Engines:</b>	2 x CFM 56 – 7B
<b>Aircraft Serial Number:</b>	29918
<b>Year of Manufacture:</b>	1999
<b>Date and Time (UTC):</b>	7 October 2000, at 1300 hours approx
<b>Location:</b>	During climb-out from Stansted Airport, UK
<b>Type of Flight:</b>	Public Transport, (Scheduled)
<b>Persons on Board:</b>	Crew - 2 Pilots, 4 - CCM's    Passengers - 177
<b>Injuries:</b>	Crew - Nil                                  Passengers - Nil
<b>Nature of Damage:</b>	None
<b>Commanders Licence:</b>	Airline Transport Pilot's Licence (UK)
<b>Commanders Age:</b>	44 Years
<b>Commanders Flying Experience:</b>	6392 hours
<b>Information Source:</b>	Report submitted by Operator AAIU Investigation

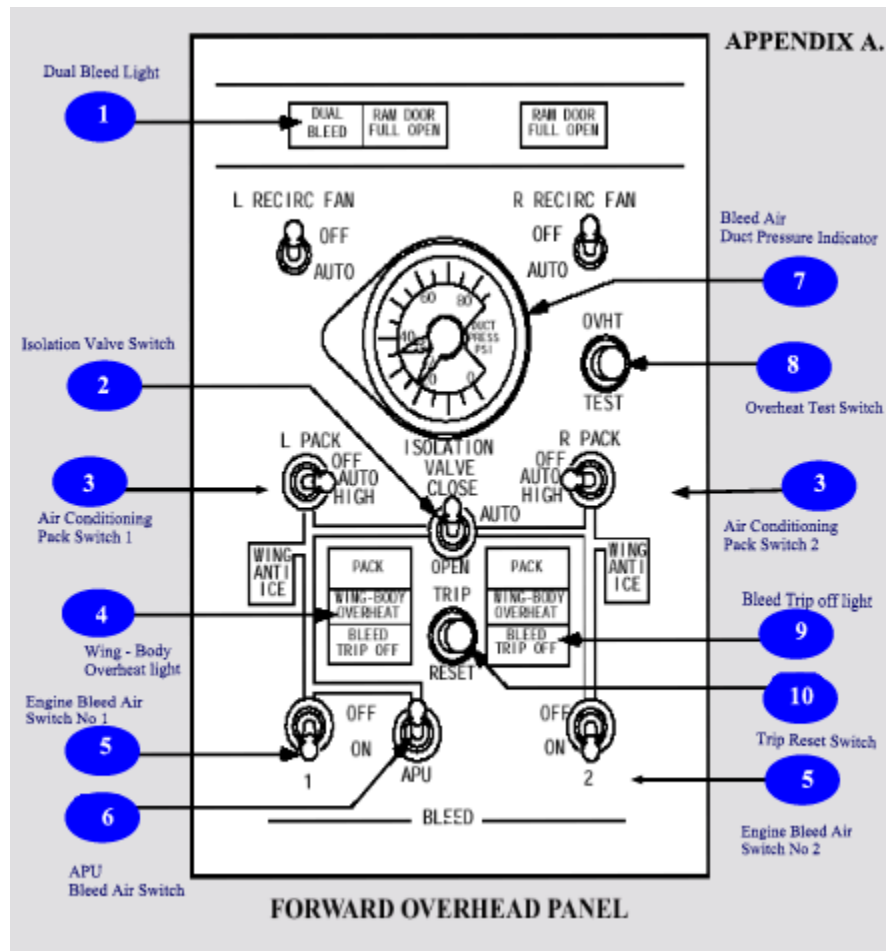
A diagram of the forward overhead panel is presented as **Appendix A** to this report.

An amber “Auto Fail” light on the forward overhead pressurisation panel provides an indication to the flight crew that a failure has occurred in the automatic pressurisation control. The “Auto Fail” will come on if any of the following conditions occur:

- Loss of DC Power
- Controller fault in the operational Controller
- Excessive rate of cabin pressure change (2,000 sea level ft/min)
- High cabin altitude (above 15,800 ft)

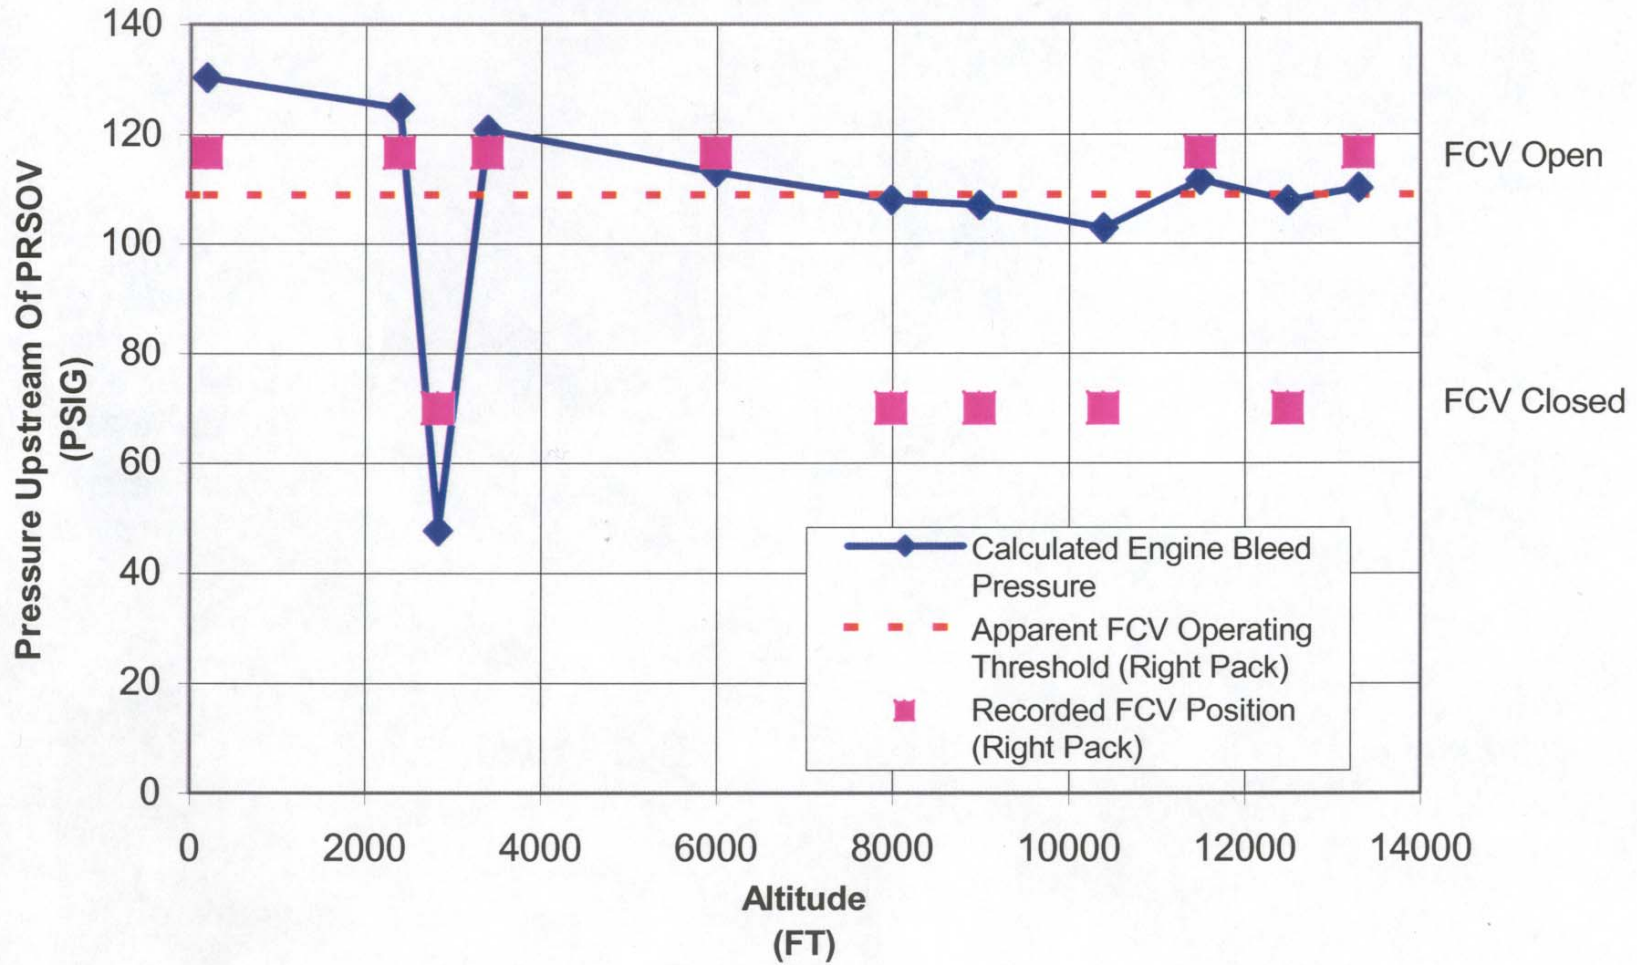
### 737-800 EI-CSC Engine Bleed Pressure and Right Pack FCV Indications

In order to determine the actual leakage rate past the closed PRSOV the engine bleed pressure upstream of the PRSOV was calculated. A graph presented as **Appendix C** to this report shows engine bleed pressure and recorded FCV position at several discrete altitudes selected from the DFDR data. The graph shows that when the engine bleed pressure is above approximately 109 psig, the FCV was recorded as open. Below that pressure, the FCV was recorded as closed. Therefore, the recorded positions of the FCV are very likely the result of expected system operation with the PRSOV commanded closed and the FCV commanded open.

The above scenario presumes that the right pack switch was selected “On” throughout the climb. The close correlation between the engine bleed pressure and FCV position suggest that this assumption is correct. It is possible that the left pack switch was also selected “On”, but that the left FCV didn’t open due to variability in operating characteristics of the left and right FCV.
