Loss of nosewheel on Ryanair Boeing 737-204 at Dublin Airport, Ireland, on December 3, 2000.

FINAL REPORT

AAIU Report No: 2003-006
AAIU File No: 2000/0063
Published: 2 May 2003

Operator: Ryanair
Manufacturer: Boeing
Model: 737-204
Nationality: Ireland
Registration: EI-CJH
Location: Dublin Airport
Date/Time (UTC): 3 December 2000, 10.30 hours

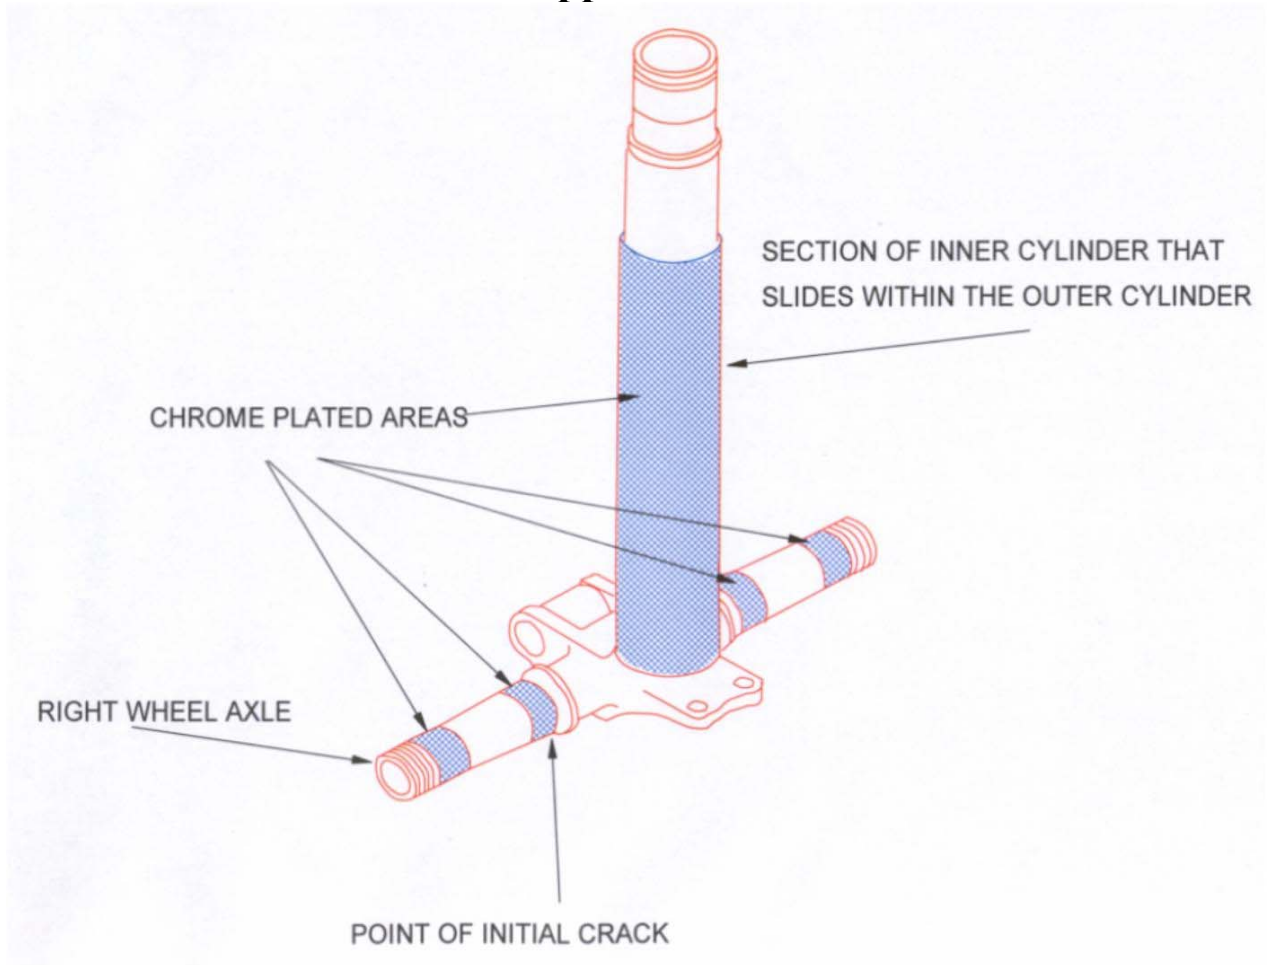
Appendix A

The A.A.I.U. team arrived shortly after the event and inspected the damaged nose undercarriage on the aircraft and the separated wheel and axle. The axle was found to have failed at a point corresponding to the inner face of the inner nose wheel support bearing.

A preliminary visual inspection of the fracture surface indicated that a crack had originated at the bottom (6 o'clock) portion of the axle (See **Appendix A** and **Appendix B**). Initial visual inspection indicated a crack of a fatigue nature.

SKETCH OF INNER CYLINDER

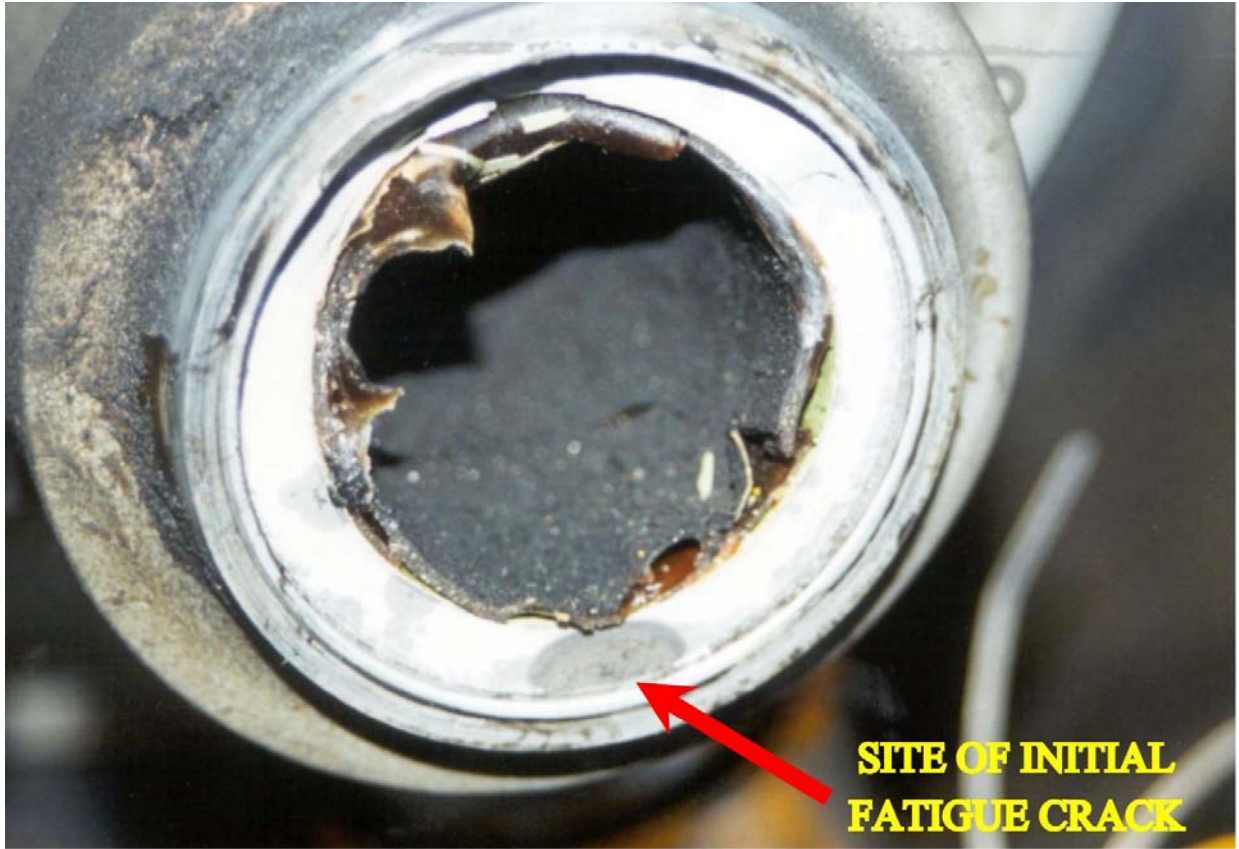
Appendix B

1.16.2 **Appendix B** shows the fracture surface of the failed axle. The component is orientated as it would be in service. The initial fracture can be clearly seen at the bottom. The examination indicated that the crack initiated at the bottom outer surface of the axle and slowly grew until it reached a surface length of about 14 mm and a depth of about 6 mm, which is slightly less than the wall thickness of the axle. When the crack reached this size, it then spread rapidly, causing the axle to fail.

- 2.1 The metallurgical examination shows that the right hand axle was subjected to localised overheating, in the area of the failure. This overheating may have occurred during grinding operations to remove damaged, scored or worn chrome plating. Alternatively, the overheating could also have occurred in the post-replating grinding, when the axle was being ground to achieve the final dimensional requirements. However the absence of burn marks on the cadmium plating would indicate that the overheating probably occurred when the damaged plating was being removed. The cause of the localised overheating was, most probably, due to an excessive rate of grinding or insufficient application of cooling, or a combination of both these factors, during the grinding operation.

- 2.2 The axle suffered overheating damage in the 6 o'clock position, which is the point of maximum bending-induced tensile loads in the axle. These loads result from normal landing impacts in the vertical direction.

- 2.3 The result of the localised overheating was to cause change in the temper of the steel from normal tempered martensite to over-tempered martensite (OTM). Another effect of the localised overheating was to produce heat-induced cracks in the surface of the steel.

- 2.4 The heat-induced cracks in the surface of the steel served as initiation sites for the fracture that was propagated by fatigue. The axle was then liable to failure at a service life well below the specified service/overhaul life.

- 3.2.1 The failure of the axle was caused by overheating which occurred while the axle was undergoing grinding during a shop visit.

PHOTO OF AXLE FRACTURE
(INNER CYLINDER END)
