## Accident involving turbulence and Aer Arann ATR-42-300 on descent to Donegal International Airport, Ireland, on December 2, 2001.

# FINAL REPORT

*AAIU Report No.:2002/007*

<b>Operator:</b>	Aer Arann
<b>Manufacturer:</b>	ATR
<b>Model:</b>	ATR 42-300
<b>Nationality</b>	Irish
<b>Registration</b>	EI-CPT
<b>Location</b>	Mt Errigal, Co. Donegal
<b>Date/Time (UTC)</b>	2 Dec 2001 at 1300 hrs

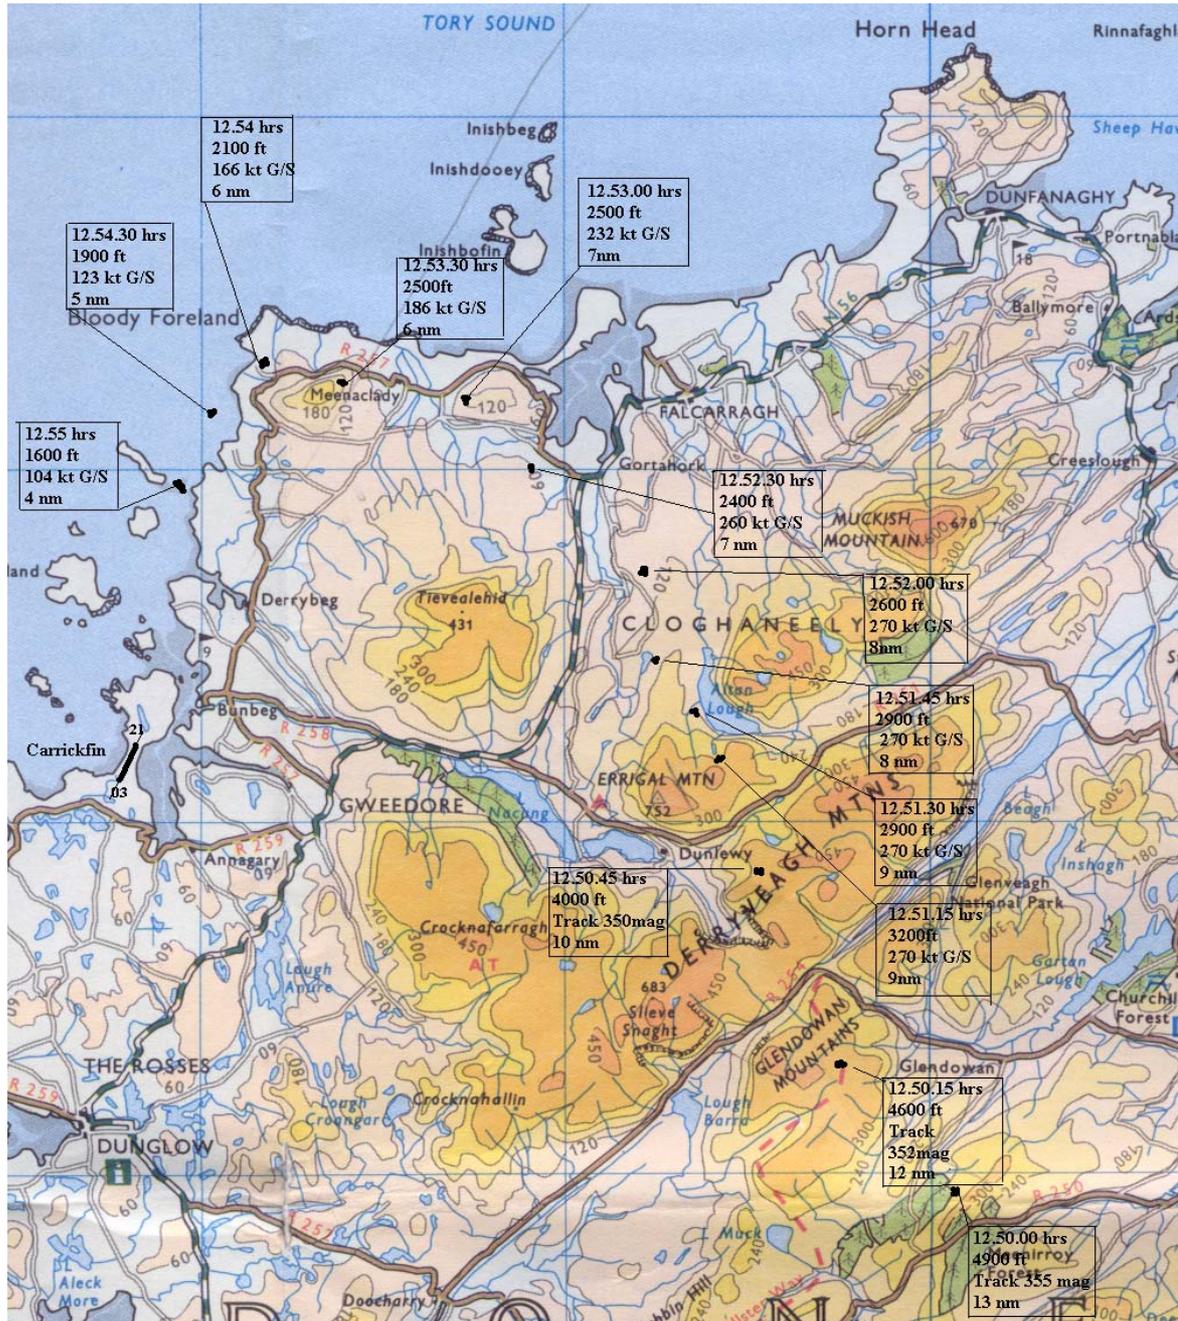
## APPENDIX C

With a touchdown time of 12.58 hrs recorded by Donegal ATC after the landing on RWY 21, the plot of bearing and distance recorded at Shannon indicates that turbulence could have occurred to the North of Mt. Errigal between 12.51:15 hrs and 12.51:30 hrs.

Radar Track of EI-CPT from 12.50 hrs until touchdown on RWY 21, EIDL, at 12.58 hrs. (Stated accuracy +/- 0.5 nm)

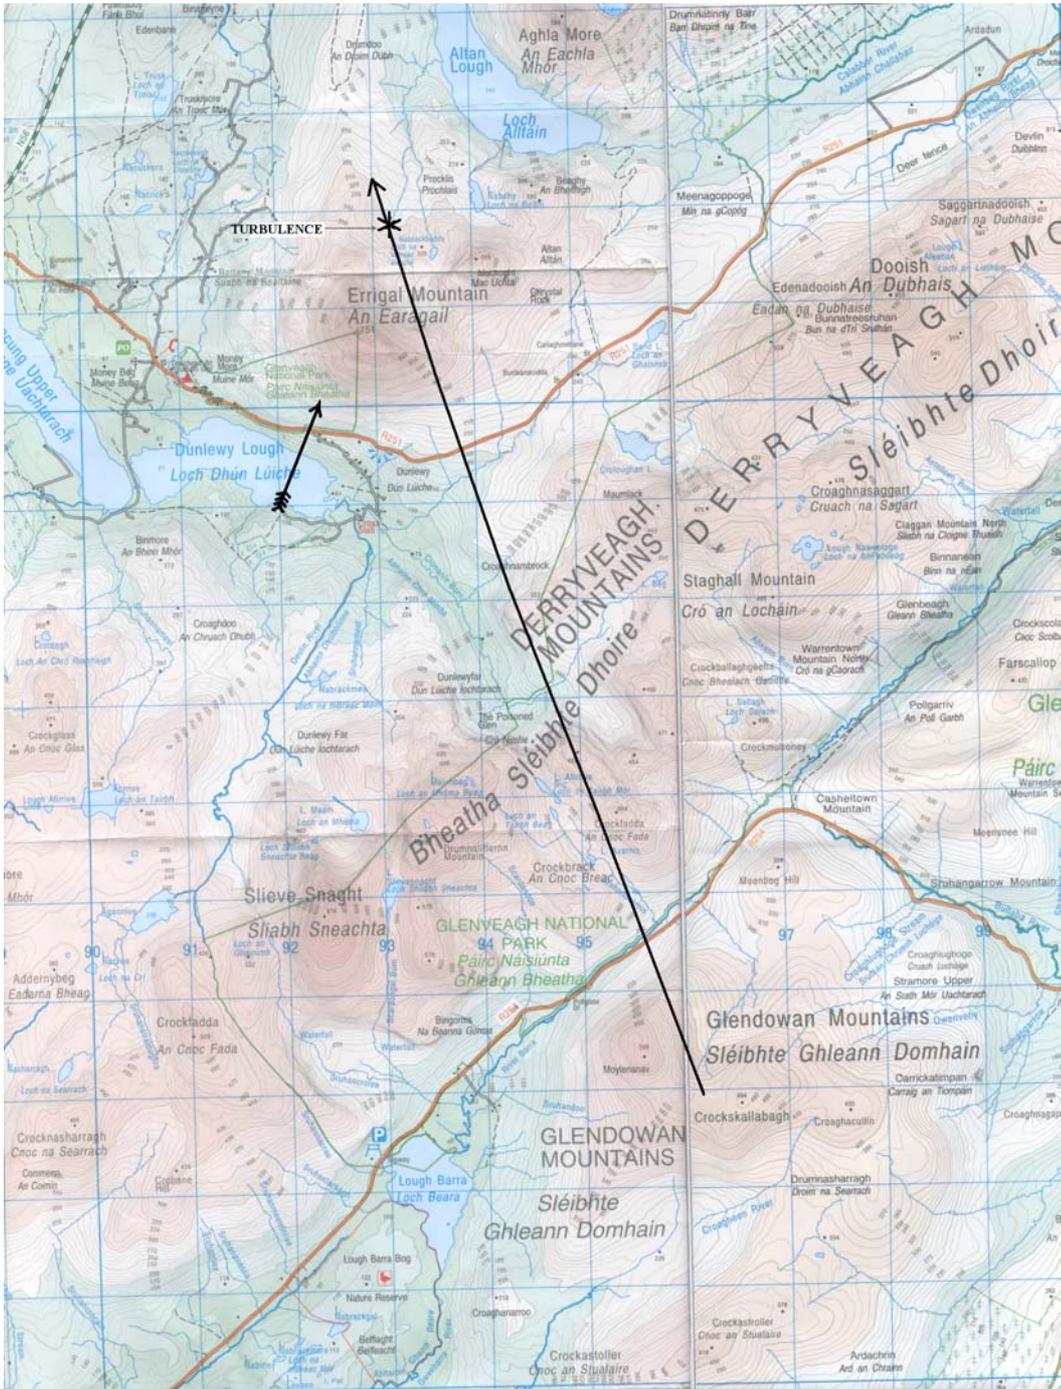
## APPENDIX D

After the aircraft passed the high ground, the RA height increased to 1600 ft. The FDR frame number 18095, corresponding to an elapsed time of 29 min 51 sec since take off (at frame number 3767), recorded maximum normal G force due to turbulence, of +3.9 G to -2G as the RA recorded 1630 ft. The estimated time was then 12.50:51 hrs. Turbulence occurred just 6 seconds after passing Mt. Errigal (**See Appendix D**) and

less than 1km NNW of that peak. The pressure altitude recorded at that time was 2756 ft and the radar altitude 1637 ft, giving the terrain a height of 1119 ft (341m) above sea level at that point.

Approximate track of EI-CPT derived from its FDR and showing the location at which turbulence took place. The wind as shown is that for a height of 2000ft given by the Met Eireann aftercast for the area.

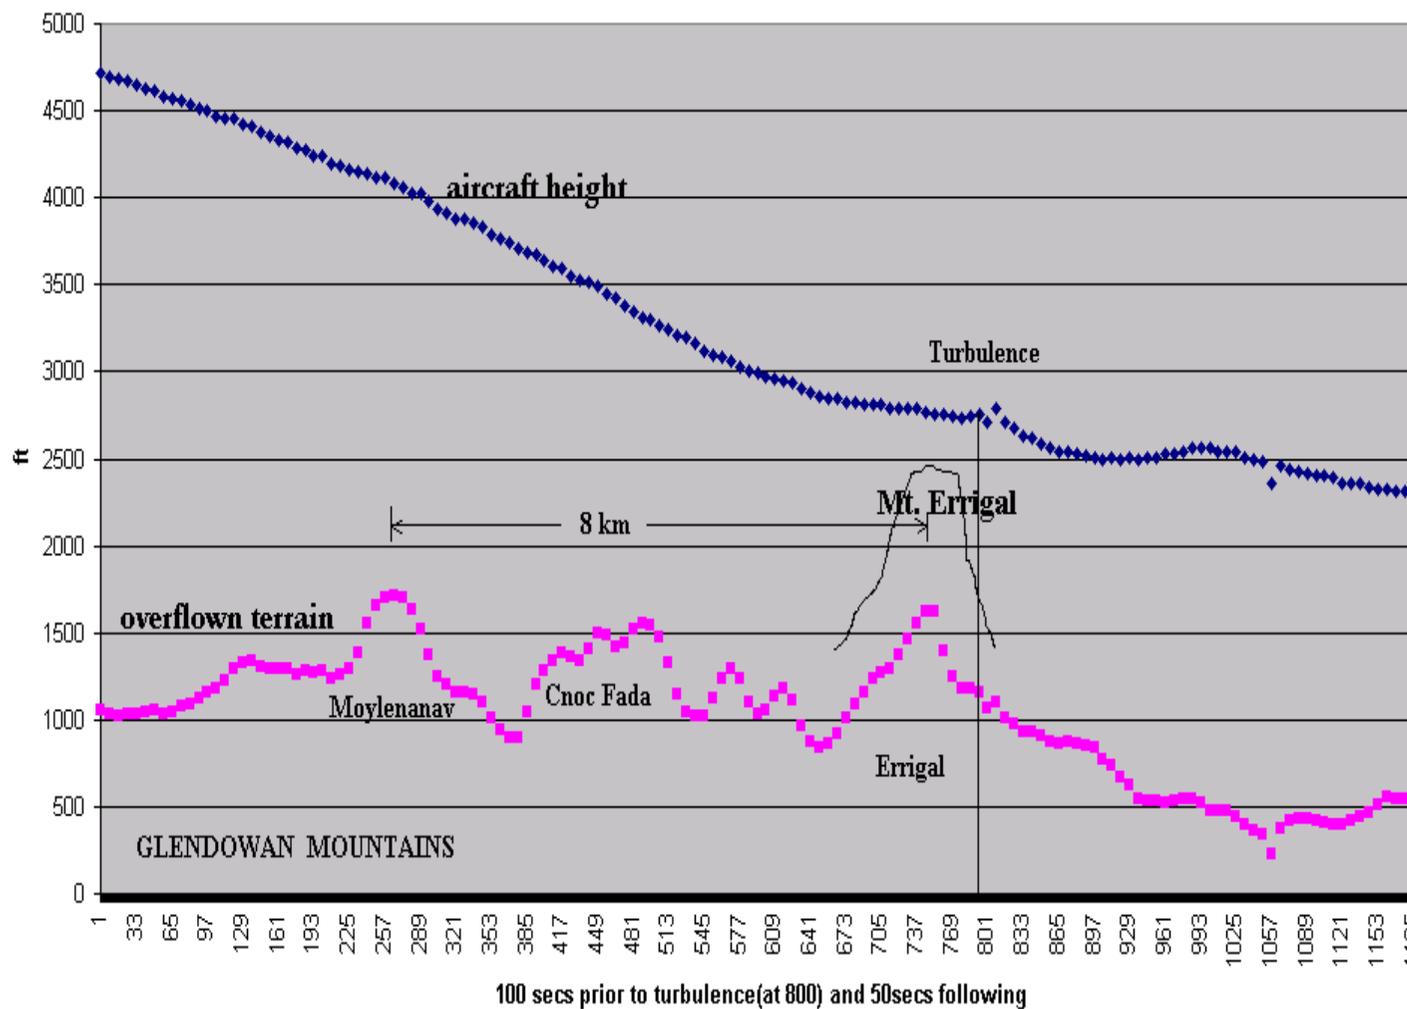
Aircraft Altitude versus overflown Terrain

At 12.50 hrs, the aircraft was at a pressure altitude of 3200 ft on a heading of 342° M and the RA recorded 2160 ft. The heading then decreased to 328° M as the aircraft approached Mt. Errigal and increased again slightly to 330° M as it passed east of the mountain. The pressure altitude remained more or less constant at 2770 ft. but just 4 secs prior to the onset of major turbulence the RA height had decreased to 1135 ft as the aircraft flew over high ground.
