Runway overrun by Celtic Airways Fokker F.27, G-ECAT, at Sligo Airport, Ireland, November 2, 2002

FINAL REPORT

AAIU Formal Report No: 2005-015

Operator:	Celtic Airways
Manufacturer:	Fokker
Model:	F 27 – 500
Nationality:	UK (Callsign ECY 4065)
Registration:	G-ECAT
Location:	Sligo Airport (EISG), Ireland N541648 W0083557
Date/Time (UTC):	2 November 2002 @ 17.02 hrs

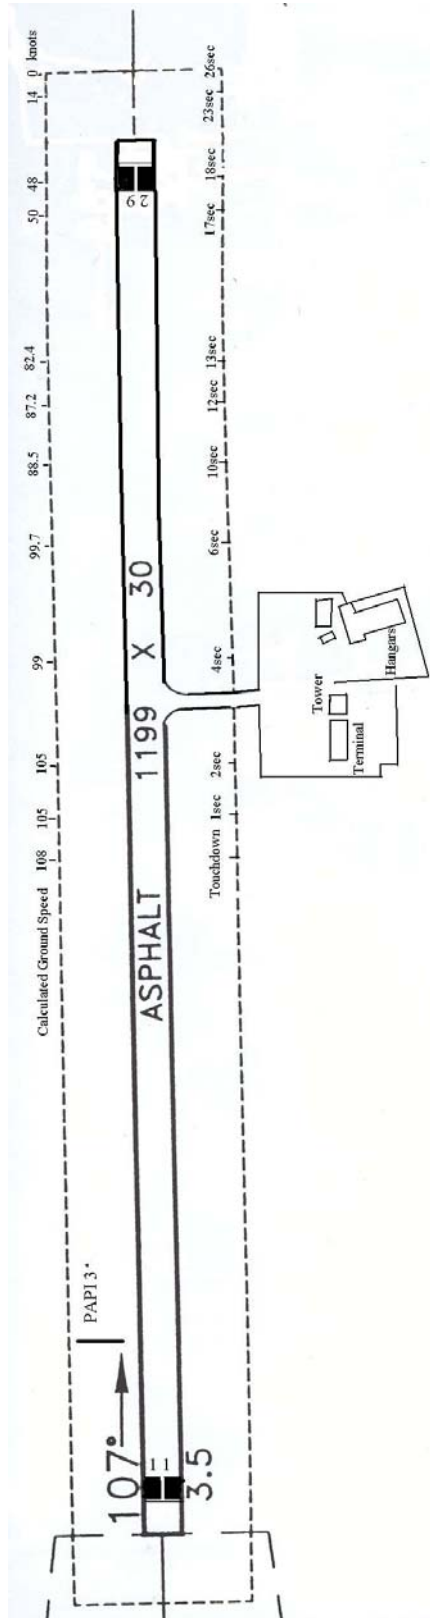
APPENDIX C

The point at which these forces return to normal were found to coincide with the point at which the heading ceased turning and this was taken as the point where the aircraft came to rest. The final deceleration was in the region of 8 ft/sec/sec and existed for 294 metres (967 ft). The total landing roll therefore, was 753 metres (2470 ft). The position at which the aircraft came to rest was measured as 50.5 metres from the runway pavement. This would indicate that the aircraft touched down about 460 metres from the threshold of RWY 11 (**Appendix C**).

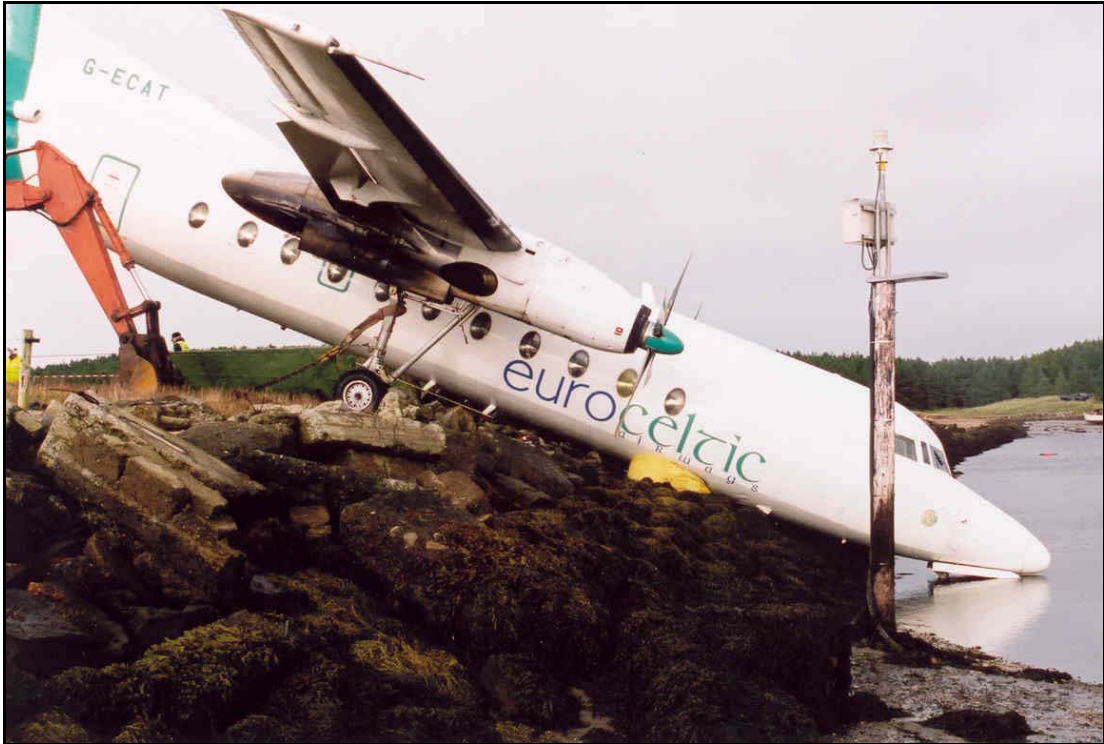
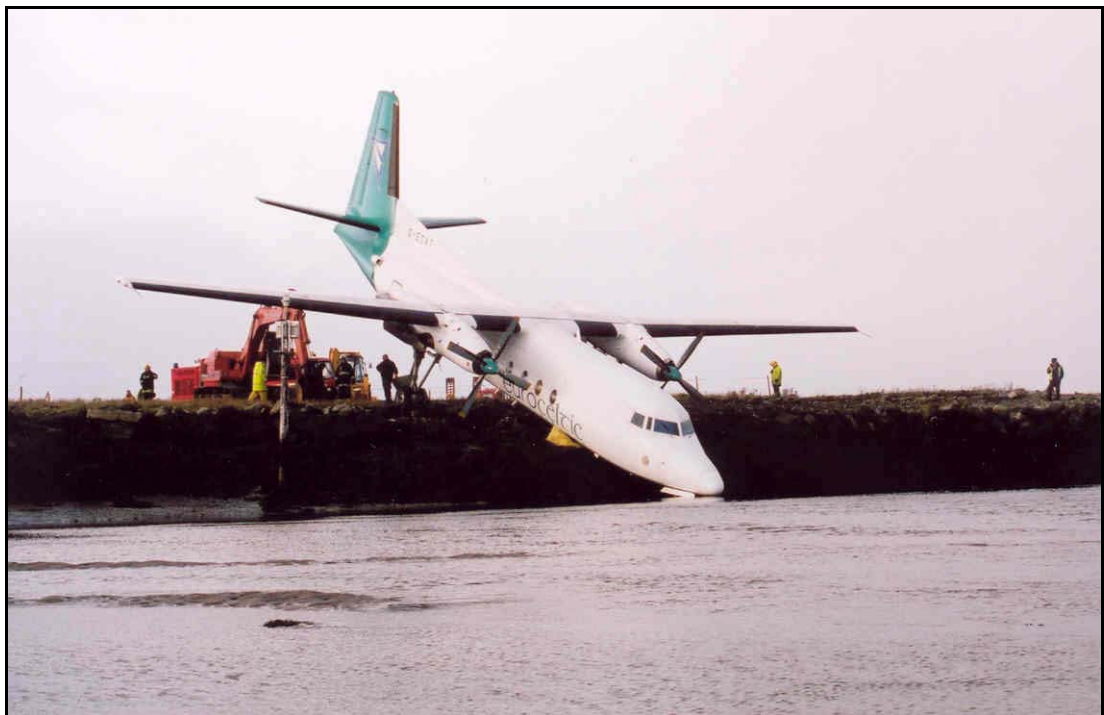
APPENDIX D

The aircraft continued on through a prepared run-off area at the end of the runway, for a further 50 metres, before coming to rest (17.02:30 hrs) with the main wheels embedded in boulders that formed part of an embankment leading down to the sea. The main wheels were approximately one metre short of where the boulders fall away into the sea.

The nose wheel, cockpit and forward section of the fuselage cleared the top of the boulder embankment and the aircraft tilted approximately 15-20 degrees nose down onto the outgoing tide. Full tide was due at 04.00 hrs the following day at a depth of 3.9 meters.

The aircraft came to rest at the seawall embankment off the end of RWY 11. Large boulders, which formed part of the embankment, arrested the further travel of the aircraft. However, the nose section of the aircraft came to rest on the out-going tidewater. On initial inspection the aircraft sustained extensive braking damage to the four main wheels and impact damage to the nose wheel. Some damage was caused to the forward underside of the fuselage due to resting contact with the boulders. During the night of the accident the rise and fall of the tide immersed the cockpit and forward section of the cabin. This salt water caused immediate visible corrosion in the cockpit and rendered the airframe a total economic write off.

Final resting position of G-ECAT at half-tide mark.

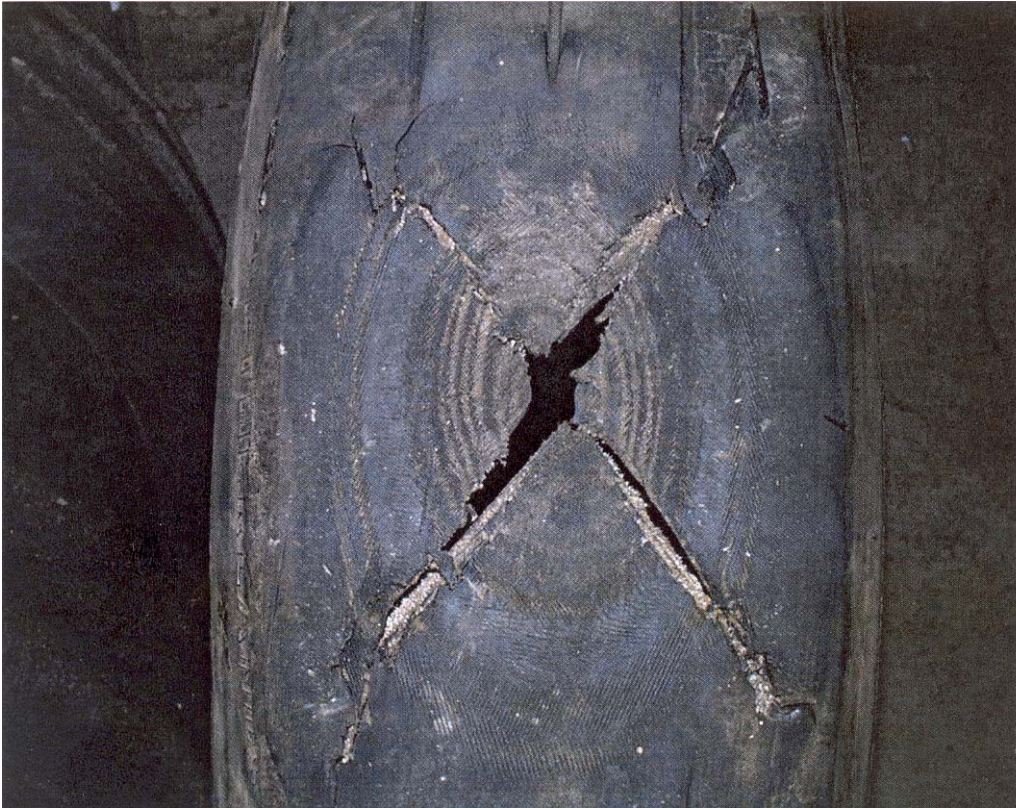
APPENDIX E

Three main wheel tyres were found to have deflated and showed signs of rotating on their wheel rims after deflation. These were both tyres on the port side and the starboard inner tyre. The starboard outer remained inflated. All four tyres were removed for further examination. The results of this examination showed that the starboard outer type was worn down to almost its limits, and did not show any indication of skidding or aquaplaning. All the other three tyres showed a distinct skid mark, where the tyre material had been worn significantly, to such an extent that the tyre pressure caused the remaining material to suffer the classical X type of burst failure (**Appendix E**), thereby deflating the tyre. None of these three tyres showed any indication of aquaplaning.

The failure of three burst tyres is consistent with the aircraft landing with the wheels not rotating. The probable scenario is that the brakes were heavily applied either when the aircraft was airborne during a bounce, or when it had touched on with only the nose wheel in ground contact.

When the main wheels subsequently came into contact with the runway, the locked tyres were worn away quickly. As noted in 1.6.3 above, the anti-skid would not have released the brakes in such circumstances

When sufficient material was eroded, the tyres material was insufficient to resist the internal inflation pressure, and, the tyre burst at this point. This failure mode was noted on all three failed tyres. Once each tyre had burst and deflated, it rotated on its rim, thereby negating any braking affect.

The tread shows a skid mark, 90° counter-clockwise from the serial number. In the skid mark all individual tread and carcass plies show up as oval rings. In the centre of these ovals there is an 'X' break visible. Next to the skid damage there are oval wear marks visible
