## Taxiway excursion involving a Boeing 737-200 (EI-COA) at Charleroi, Belgium, November 29, 2002.

## FINAL REPORT

*AAIU Formal Report No: 2004-006*

**Operator:** Ryanair

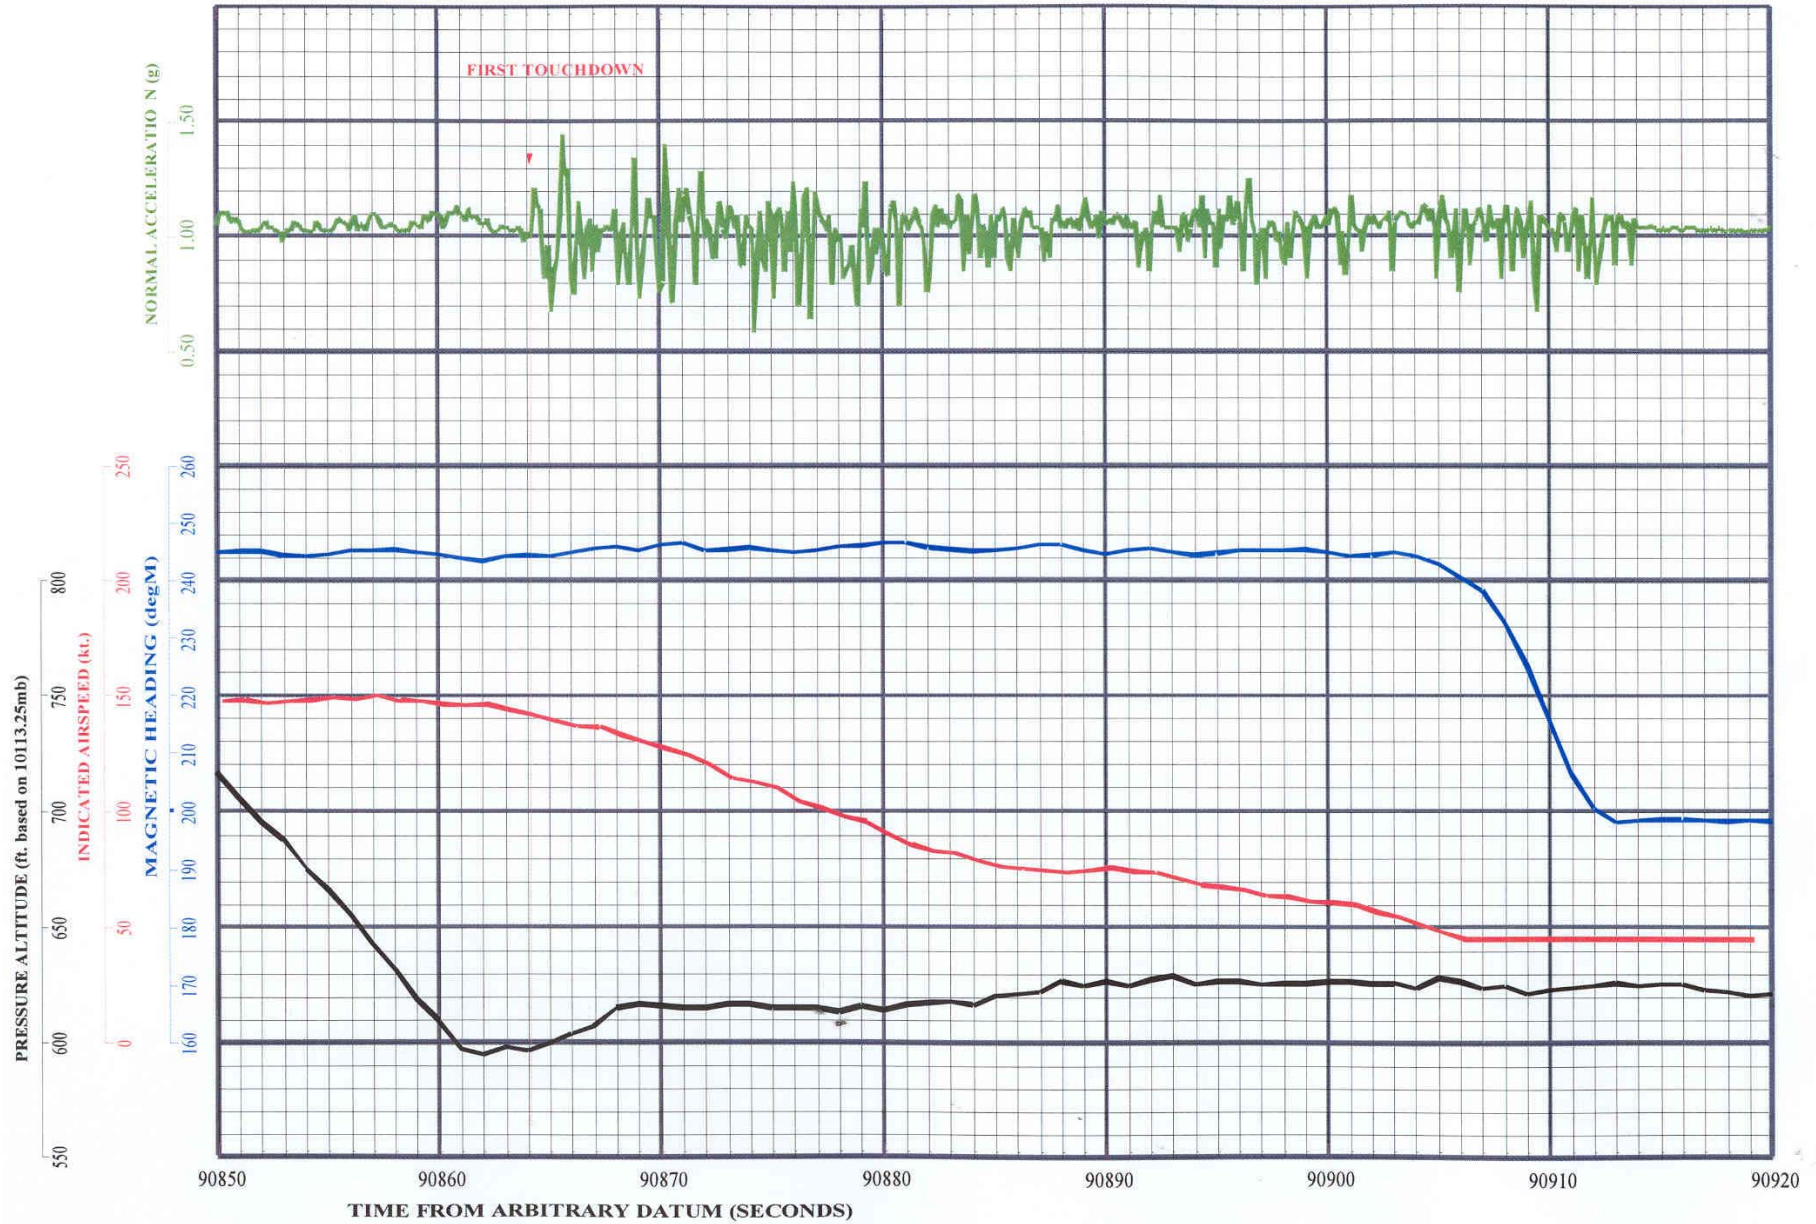
# APPENDIX A

The aircraft was fitted with a Cockpit Voice Recorder (CVR) and a Flight Data Recorder (FDR), as standard. Both recorders were retrieved by the Belgian Authorities and sent to the UK AAIB facility at Farnborough for downloading of data. The CVR recordings relevant to the incident had been overwritten and were of no benefit to the investigation. The FDR data was downloaded, and copied to AAIU. Relevant information obtained is produced, in part, at **(Appendix A)**.

B737-230, REGISTRATION EI-COA, OVERRUN AT BRUSSELS ON 29 NOV. 2002

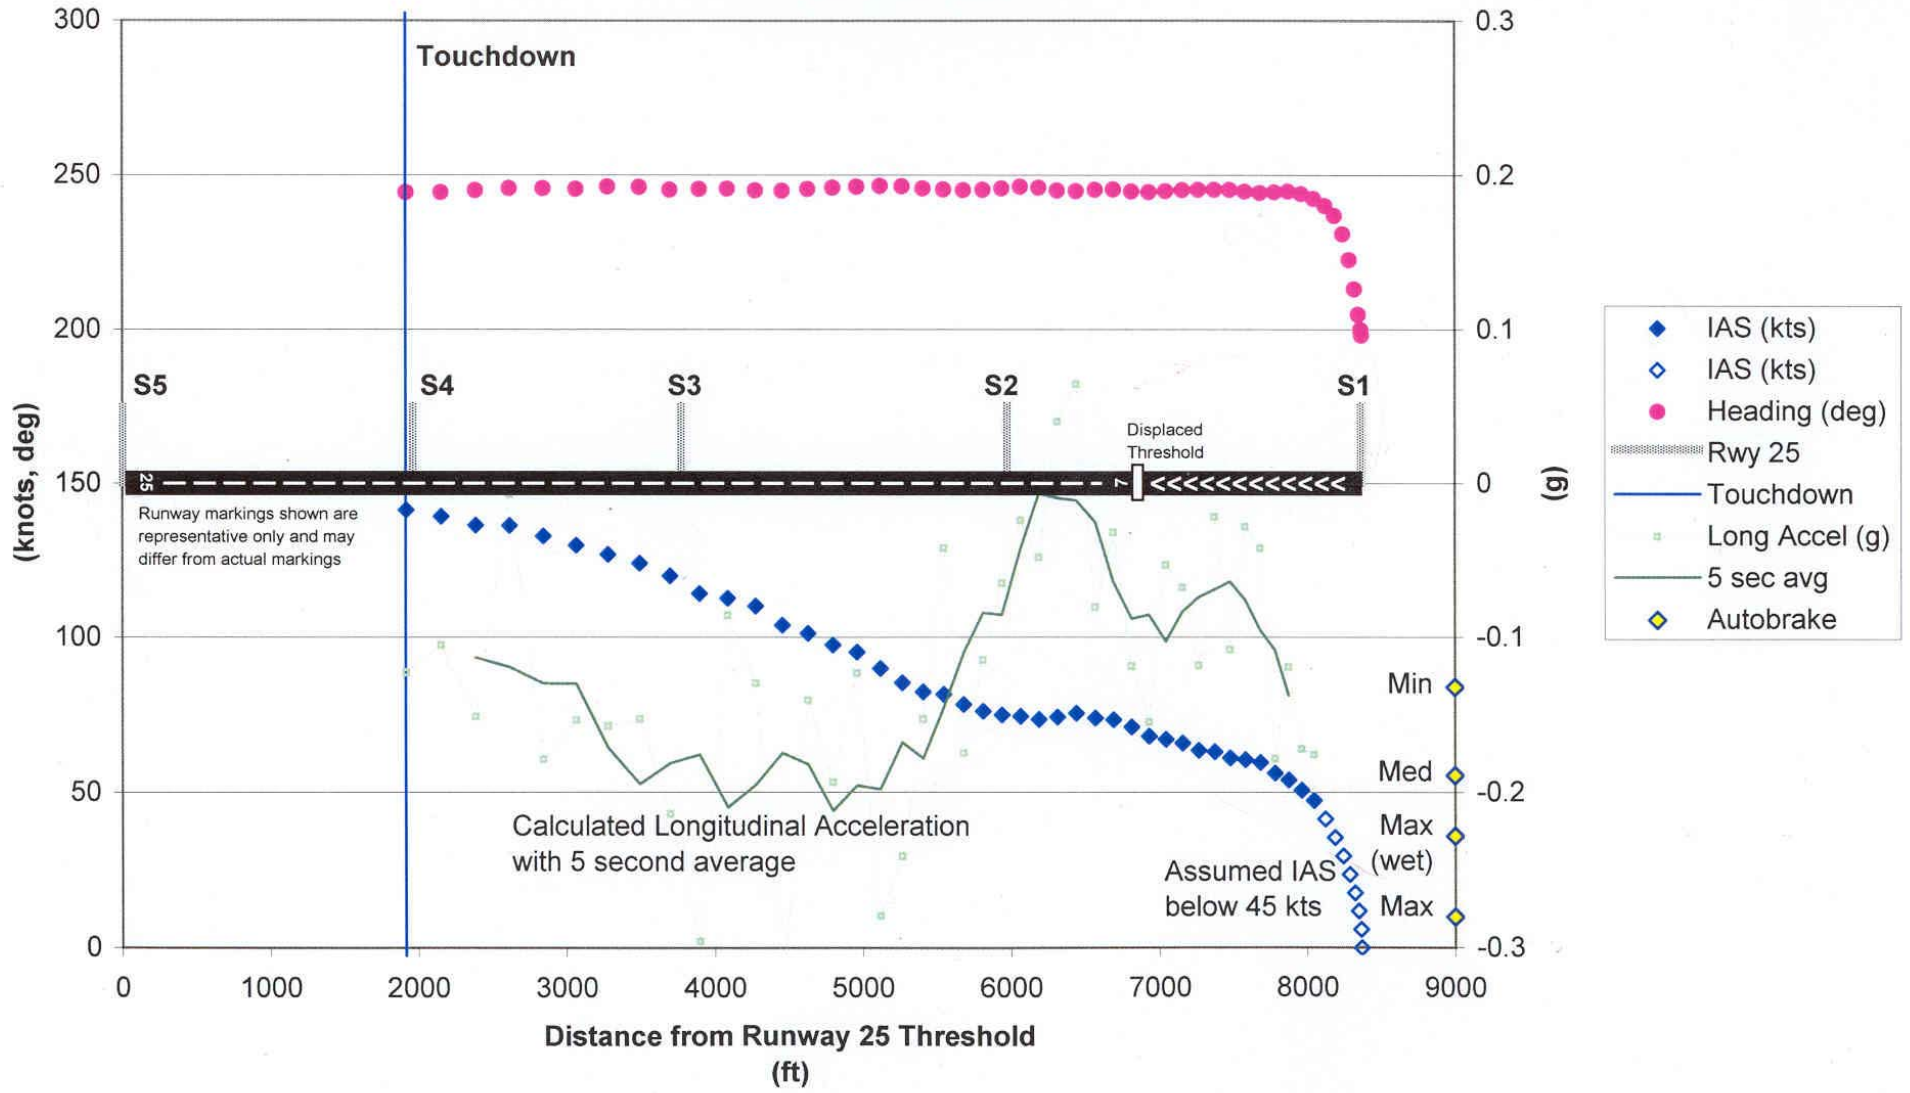
## APPENDIX B

The attached plot (**Appendix B**), derived from data downloaded from the FDR, shows the speed down the runway, position of the various taxiways and calculated deceleration levels. As airspeed is not recorded accurately on the FDR below 45 kt, a constant deceleration is assumed between the last valid value and the time the aircraft came to a rest. These points are depicted as hollow diamonds on the plot. The Captain recalled turning on to S1 at 60 kt or less and this correlates with the FDR data, which shows that the turn to S1 was initiated at an indicated airspeed of 50 kt. At about 70 kt and at an appropriate point as determined by the Captain, braking was commenced. However, the deceleration did not approach the previously achieved value. It was at this late phase of the landing that the stopping technique used by the Captain did not have the desired effect. Repeated brake application and finally continuous brake application failed to achieve a safe taxi speed, as the aircraft turned into exit S1 and, very quickly, the aircraft vacated the taxi-way, with its nosewheel and number 3 mainwheel in the grassy overrun area. The aircraft then stopped and the crew shutdown the engines.

### RYR 737-200 EI-COA Runway Overrun
