Precautionary diversion on an Airbus A330-301 (EI-JFK) following takeoff from Dublin, Ireland, June 4, 2004.

FINAL REPORT

1 **AAIU Synoptic Report No: 2006-006**

Aircraft Type and Registration:	Airbus A330-301, EI-JFK
No. and Type of Engines:	2 x GE CF6-80E1A2
Aircraft Serial Number:	086
Year of Manufacture:	1994
Date and Time (UTC):	4 June 2004 @ 10.07 hrs
Location:	On take off from RWY 28, Dublin Airport
Type of Flight:	Scheduled Public Transport
Persons on Board:	Crew - 12 Passengers - 303
Injuries:	Crew - Nil Passengers - Nil
Nature of Damage:	No damage to aircraft
Commander's Licence:	ATPL
Commander's Details:	Male, aged 44 years
Commander's Flying Experience:	15,000 hours of which 110 were on type
Information Source:	Operator informed AAIU

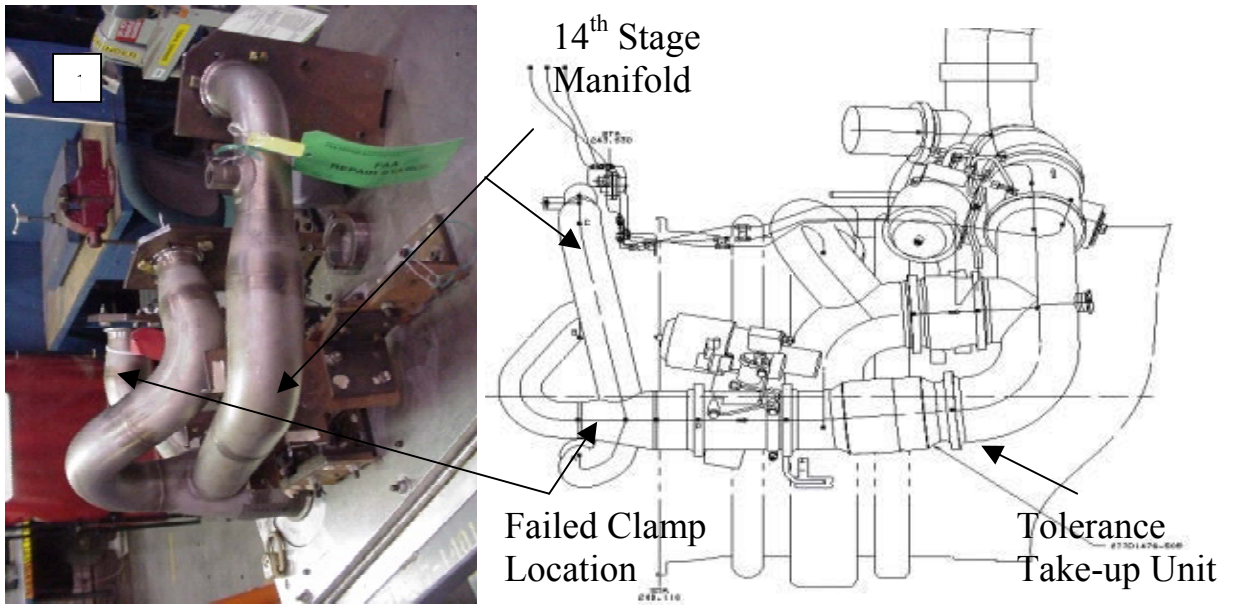
The manifold was returned to the manufacturer for examination. It was placed in the production tooling for a conformity check. The following observations were made:

- Upper tube flange out by $17/32$ inches.
- Lower tube flange out by $5/8$ inches.
- PRSOV (Pressure Relief Valve) tube out by $7/32$ inches.

1 *The 14th stage manifold-to-port mismatch observed on the engine, and the deviation to the*
2 *alignment features when installed in the tool, was attributed to manifold distortion resulting*
3 *from pressure application with the manifold unrestrained at the port.*

Photo 1: The 14th Stage Manifold on a tool rig
Photo 2: The failed manifold coupling position
Photo 3: The fractured clamp

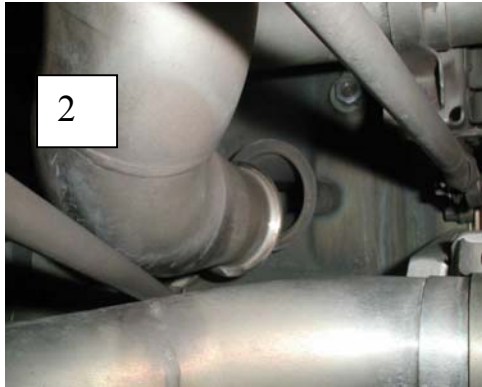
Engineers inspected the engine and confirmed they located a pneumatic duct leak. A full post event inspection revealed that a V-band clamp at the 14th Stage Manifold lower engine port had detached, allowing hot air (greater than 600°C) to bleed into the engine core compartment. There was a circumferential split along one of the V-band clamp segments. Localised heat distress was noted over an area of 12 square inches particularly to the electrical harness outer jackets. It was also noted that there was misalignment of the manifold at one of its ports. The tolerance take up (TTU) adjustment sleeves had separated and its inner duct suffered distortion (see **Appendix A**).

Three V-band couplings attach the manifold to the engine ports. The coupling at the lower port had failed. A portion of this coupling was recovered and sent to the manifold manufacturer. The remainder of the coupling was discovered during the subsequent engine shop visit.

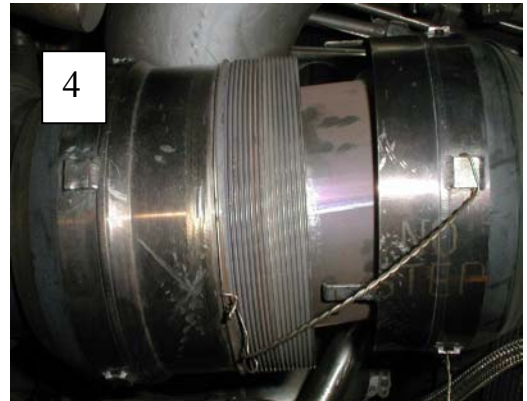
It was confirmed that the coupling was manufactured from A286 alloy. Scanning electron microscopic (SEM) examination revealed that the coupling failed due to fatigue fracture morphology. It was determined that no corrosion or embrittlement mechanism was involved in the coupling failure.

It was concluded that “the coupling was subjected to prolonged cyclic tension loading, which initiated and propagated the fracture to the point of coupling failure”.

The tension loading introduced into the 14th stage manifold lower coupling installation by the unrestrained TTU inner duct, exacerbated by a HPV cyclic loading component due to the loss of TTU support, initiated a fatigue fracture in the coupling. Fracture propagation continued to the point of coupling failure.
