Loss of steering on a slippery taxiway on the Easyjet Boeing B737-700, registration G-EZJM, at Amsterdam Airport Schiphol on 22 December 2003

**Loss of steering on a
slippery taxiway**
of the Easyjet Boeing B737-700,
registration G-EZJM,
at Amsterdam Airport Schiphol
on 22 December 2003

The Hague, (investigation number 2003133)

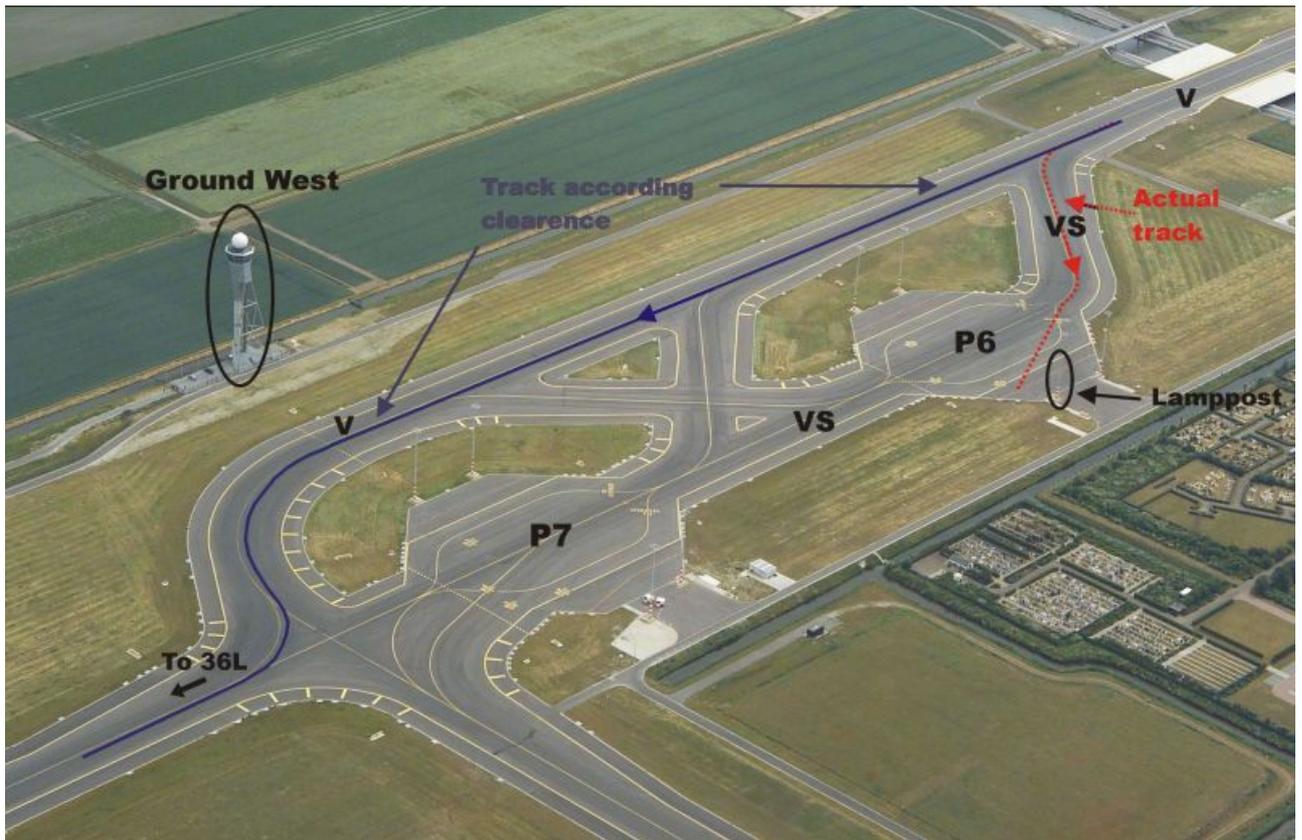
Figure 1: aerial photo of the route and the place of the accident (photo KLPD)

When the aircraft had made the turn towards taxiway VS, it appeared that the aircraft no longer responded to the steering and skidded towards the left side of the taxiway. There the aircraft collided with its left wing against a lamppost. Taxiway VS and the de-icing area P6 located there both turned out to be completely covered with ice. Both the aircraft and the lamppost were seriously damaged.

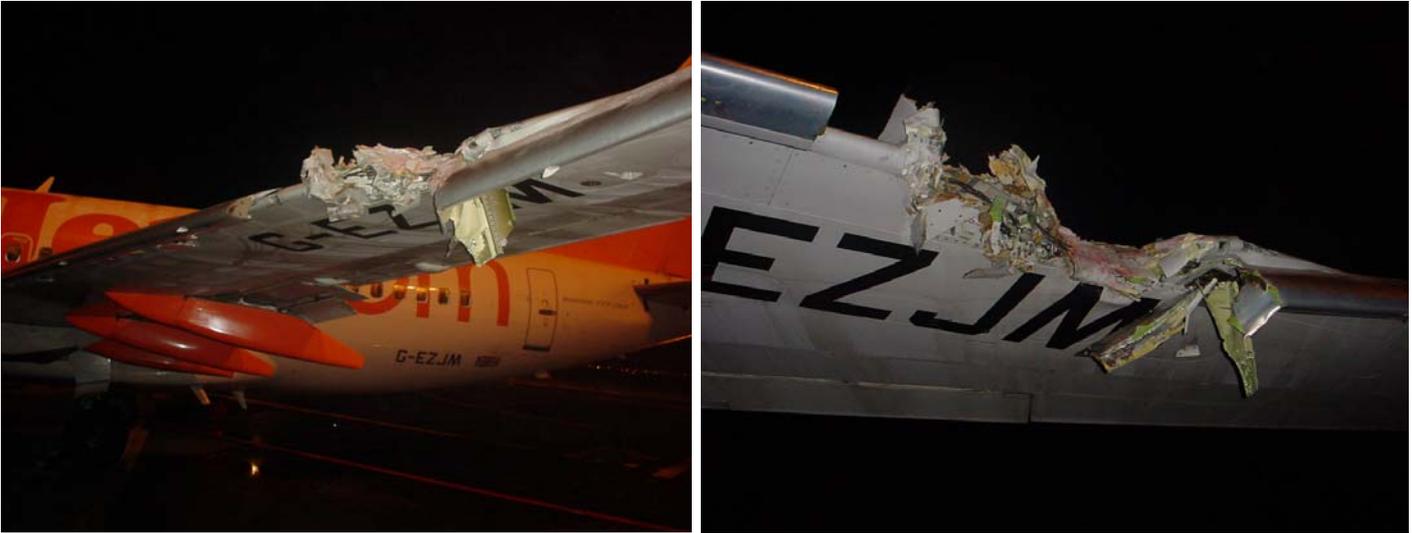
Figure 3: Photos of the damage to the left wing

A large part of the sheeting on the bottom and top of the left wing was damaged and had to be renewed. Furthermore a part of the left wing's leading edge with the pipelines lying behind it and the leading edge valves were destroyed. There was no fuel leak. The damage was repaired by Boeing personnel. After inspection in March 2004, the aircraft was declared airworthy after which Easyjet put it back into regular service.

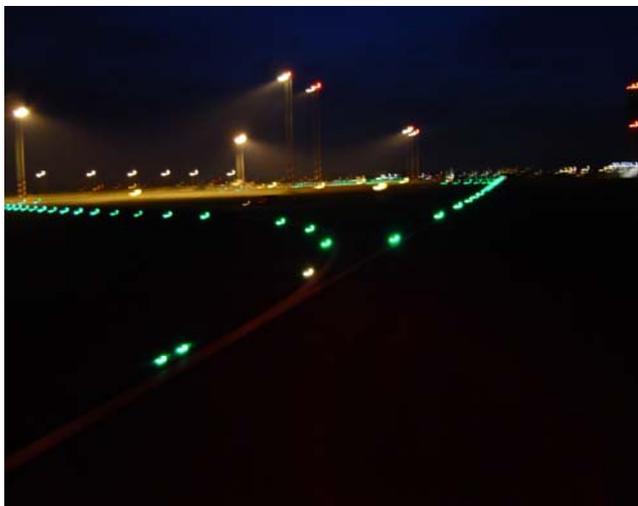
Figure 4: Fork of V and VS with P6 (left)

AAS has divided the airport into 13 service areas. The lighting is operated per service area. Taxiways V and VS are situated in service area T. It appears from the information of AAS that all the taxiway lighting in service area T was illuminated at the time of the accident and was burning with strength of 10%. According to the information of an employee of the airport that was a normal strength considering the prevailing visibility conditions.

Also the apron lighting of the de-icing aprons P6 and P7 were illuminated. No rules have been drafted with regard to the use of apron lighting.

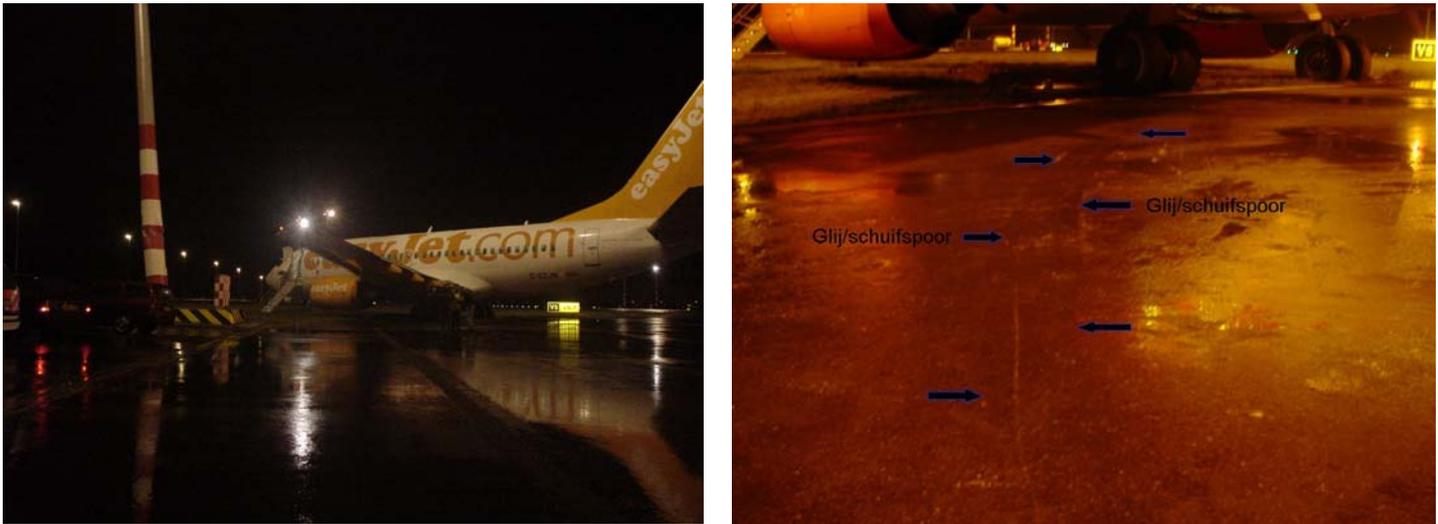
Figure 5: Photos of the aircraft after the accident and the tracks on the apron

The aircraft stood with its nose in an alignment of about 270° to apron P6. On the apron a tire track was visible on the ice running from the left side of the apron diagonally to the right up to the edge of the apron where the wheels of the main landing gear stood against the electricity wells. The nose wheel stood in the grass and had made a straight track from the edge of the apron. The tip of the left wing was situated in front of the lamppost, looking in the direction of the front of the aircraft. The damage on the left wing was located at a short distance from the wing tip, towards the body. This damaged part of the wing was located a few meters to the right in relation to the lamppost.

In connection with drainage, apron P6 slopes down slightly to the left side.
