REPORT

REP: 41/2000

-type & reg.: Ilyushin Il-76TD, RA 76750

Type of occurrence: Serious aircraft incident, the aircraft made a low final approach and collided with ILS localizer (LLZ) antenna at the approach end of the runway (localizer for approach RWY 09)

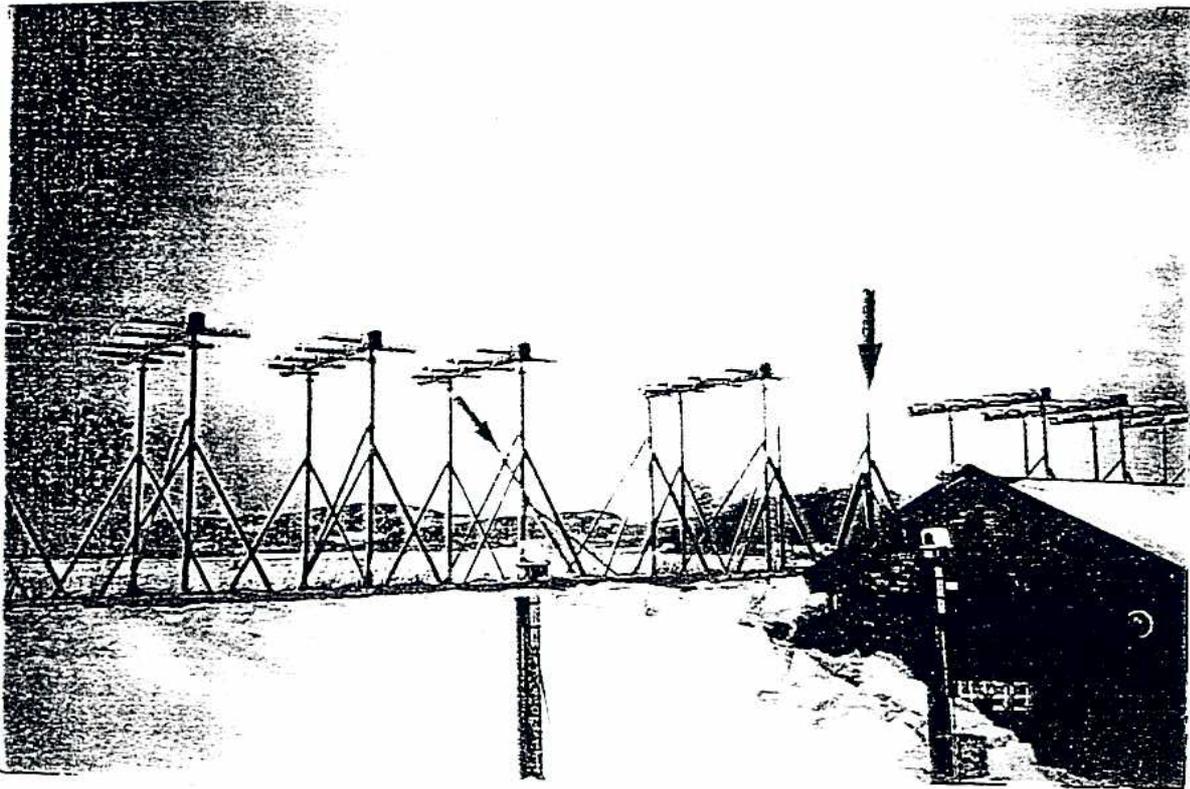
LLZ-09 ANTENNA ARRAY AND THE EQUIPMENT BUILDING

Other damage: 8 of the 12 elements of the ILS LLZ-09 antenna array were more or less damaged, 3 of them totally. Profiles belonging to the array damaged and out of position. Antenna masts were broken and cables and cable-connectors damaged as well. The antenna situated on top of the communication equipment building, of 1.40 m height over the roof, were put down. Some minor damages made on the top of the roof of the same building, and the obstruction light on the north side of the antenna array was moved out of alignment. The estimated cost of the repair is NOK 744.000,-.

RA76750 landed at time 03:55:00Z. When passing over the runway end, the aircraft's landing gear collided with the localizer antenna installation. At the same time the alarm for LLZ RWY 09 operation failure was heard and seen in the tower. After parking, the crew was requested to report in the control tower.
