AIRPROX incident between a Cessna 650, LN-NLD, and Airbus A320, HS-IPZ, approximately 20 NM north of Oslo.

Investigative Body: Accident Investigation Board Norway (AIB), Norway

REP: 4/2001
Date: 18 January 2001

-type & reg.:	Cessna C 650, LN-NLD and Airbus A 320, HS-IPZ
Radio call sign:	NOO 03, SWR 417
Date and time:	02 June 2000, 1525 UTC
Location:	Approximately 20 NM south of ENGM
Type of occurrence:	Air traffic incident, AIRPROX
Type of flight:	Ambulance flight / commercial airline operation
Light cond.:	Daylight
Flight cond.:	IMC, both aircraft
Flight plan:	IFR, both aircraft
Information sources:	Report from ATC, Commanders reports and AAIB/Ns own investigations.

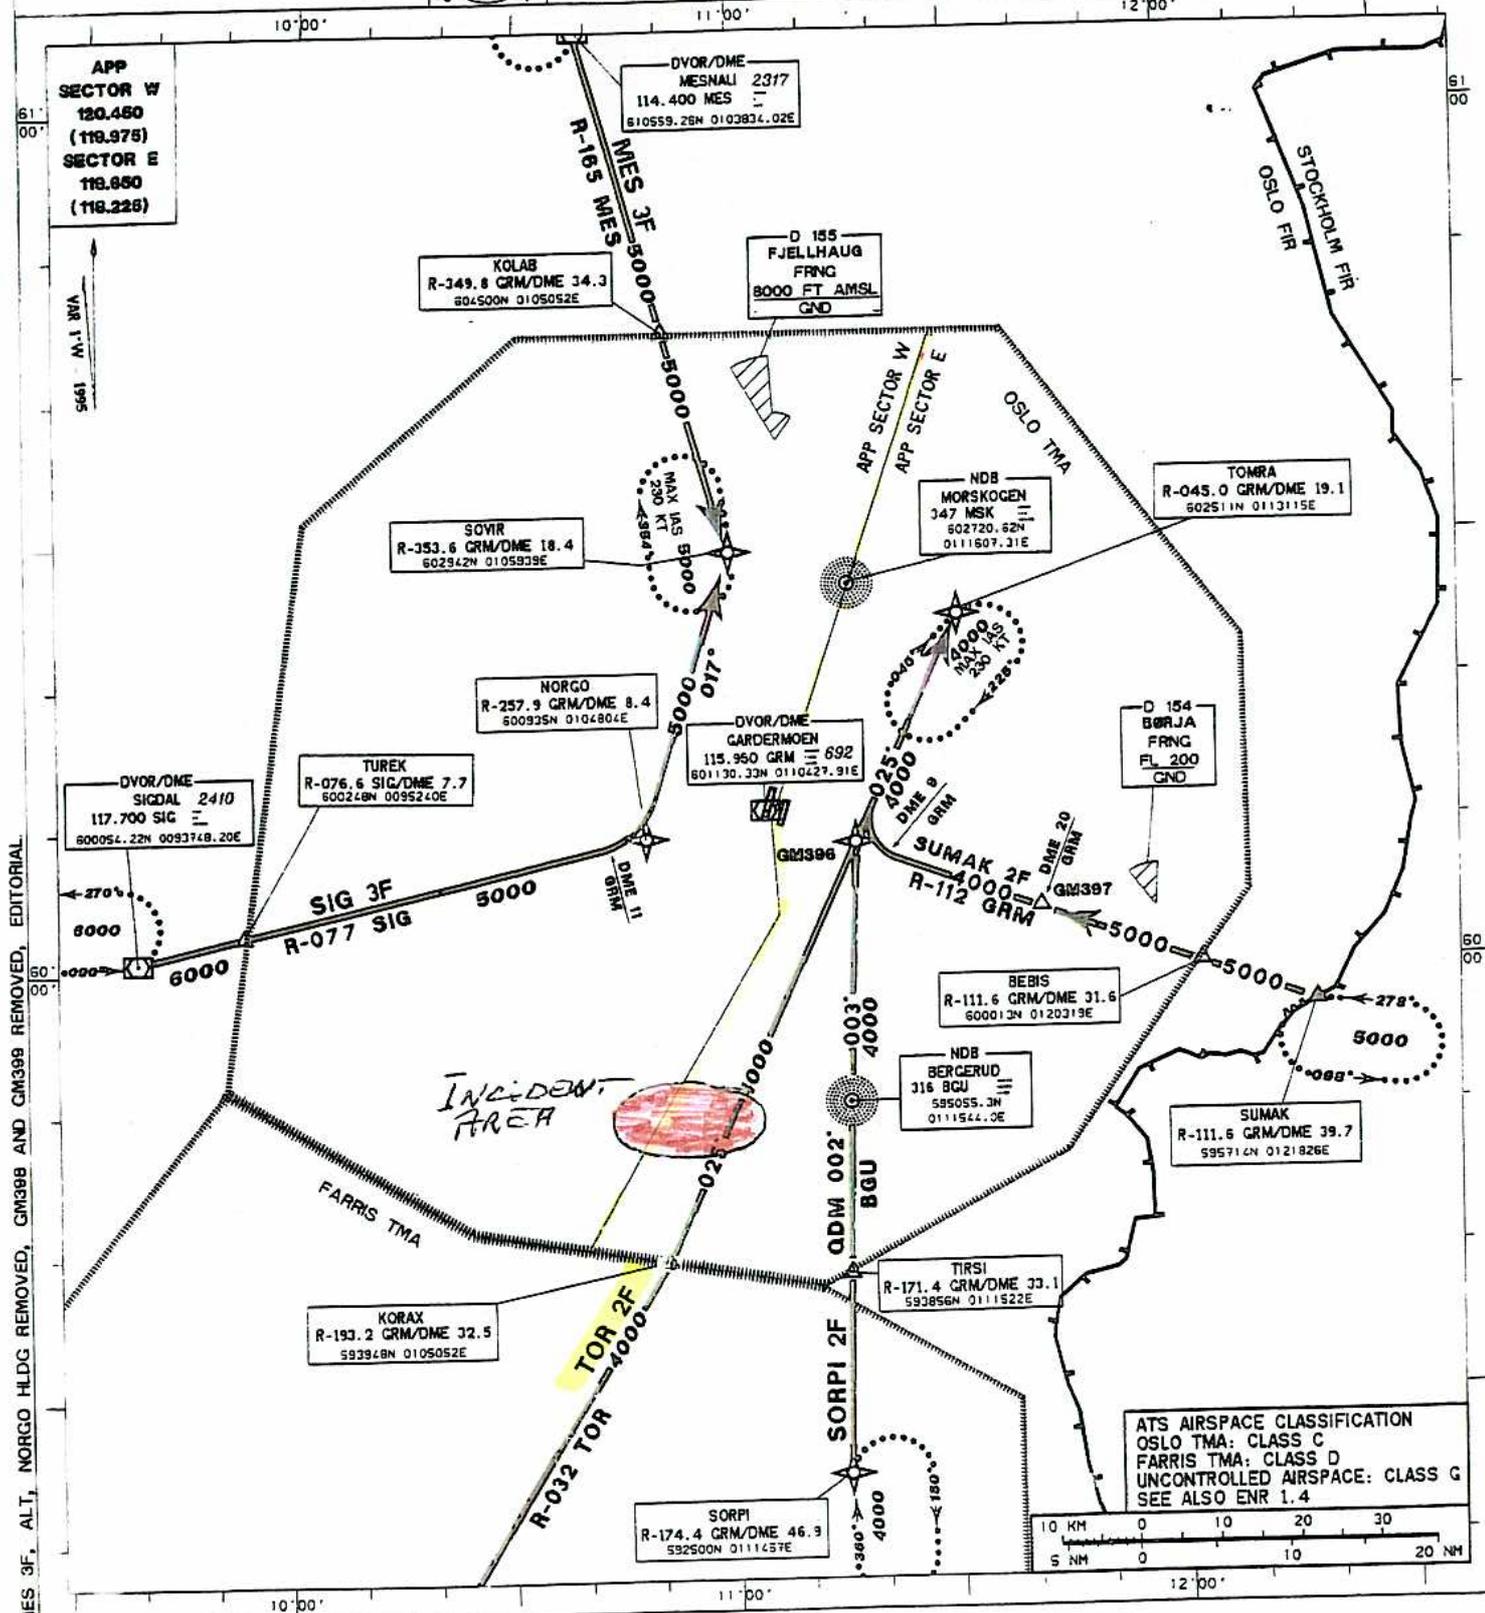
STANDARD ARRIVAL CHART
INSTRUMENT (STAR) - ICAO

The STAR TOR 2F and SID SKI 2C are located in different sectors of OSLO TMA. The STAR and the SID are located close to the common border between the two sectors.

SID SKI 2 C contains a noise abatement procedure involving a left turn after take off, bringing the tracks of SID SKI 2C and STAR TOR 2F closer than 5 NM from each other at a point approximately 8 NM south of the departure end of RWY 19L. The result is a situation that may cause insufficient lateral separation between aircraft operating on the STAR and SID respectively. Close co-ordination between the two controllers in order to ensure sufficient vertical separation is therefore a requirement when both procedures are in use simultaneously.

The AAIB/N recommends that the CAA/N consider a revision of all aspects concerning the STAR and SID procedures at Oslo Airport Gardermoen in order to ensure adequate separation between arriving and departing aircraft (Recommendation no. 4/2001).

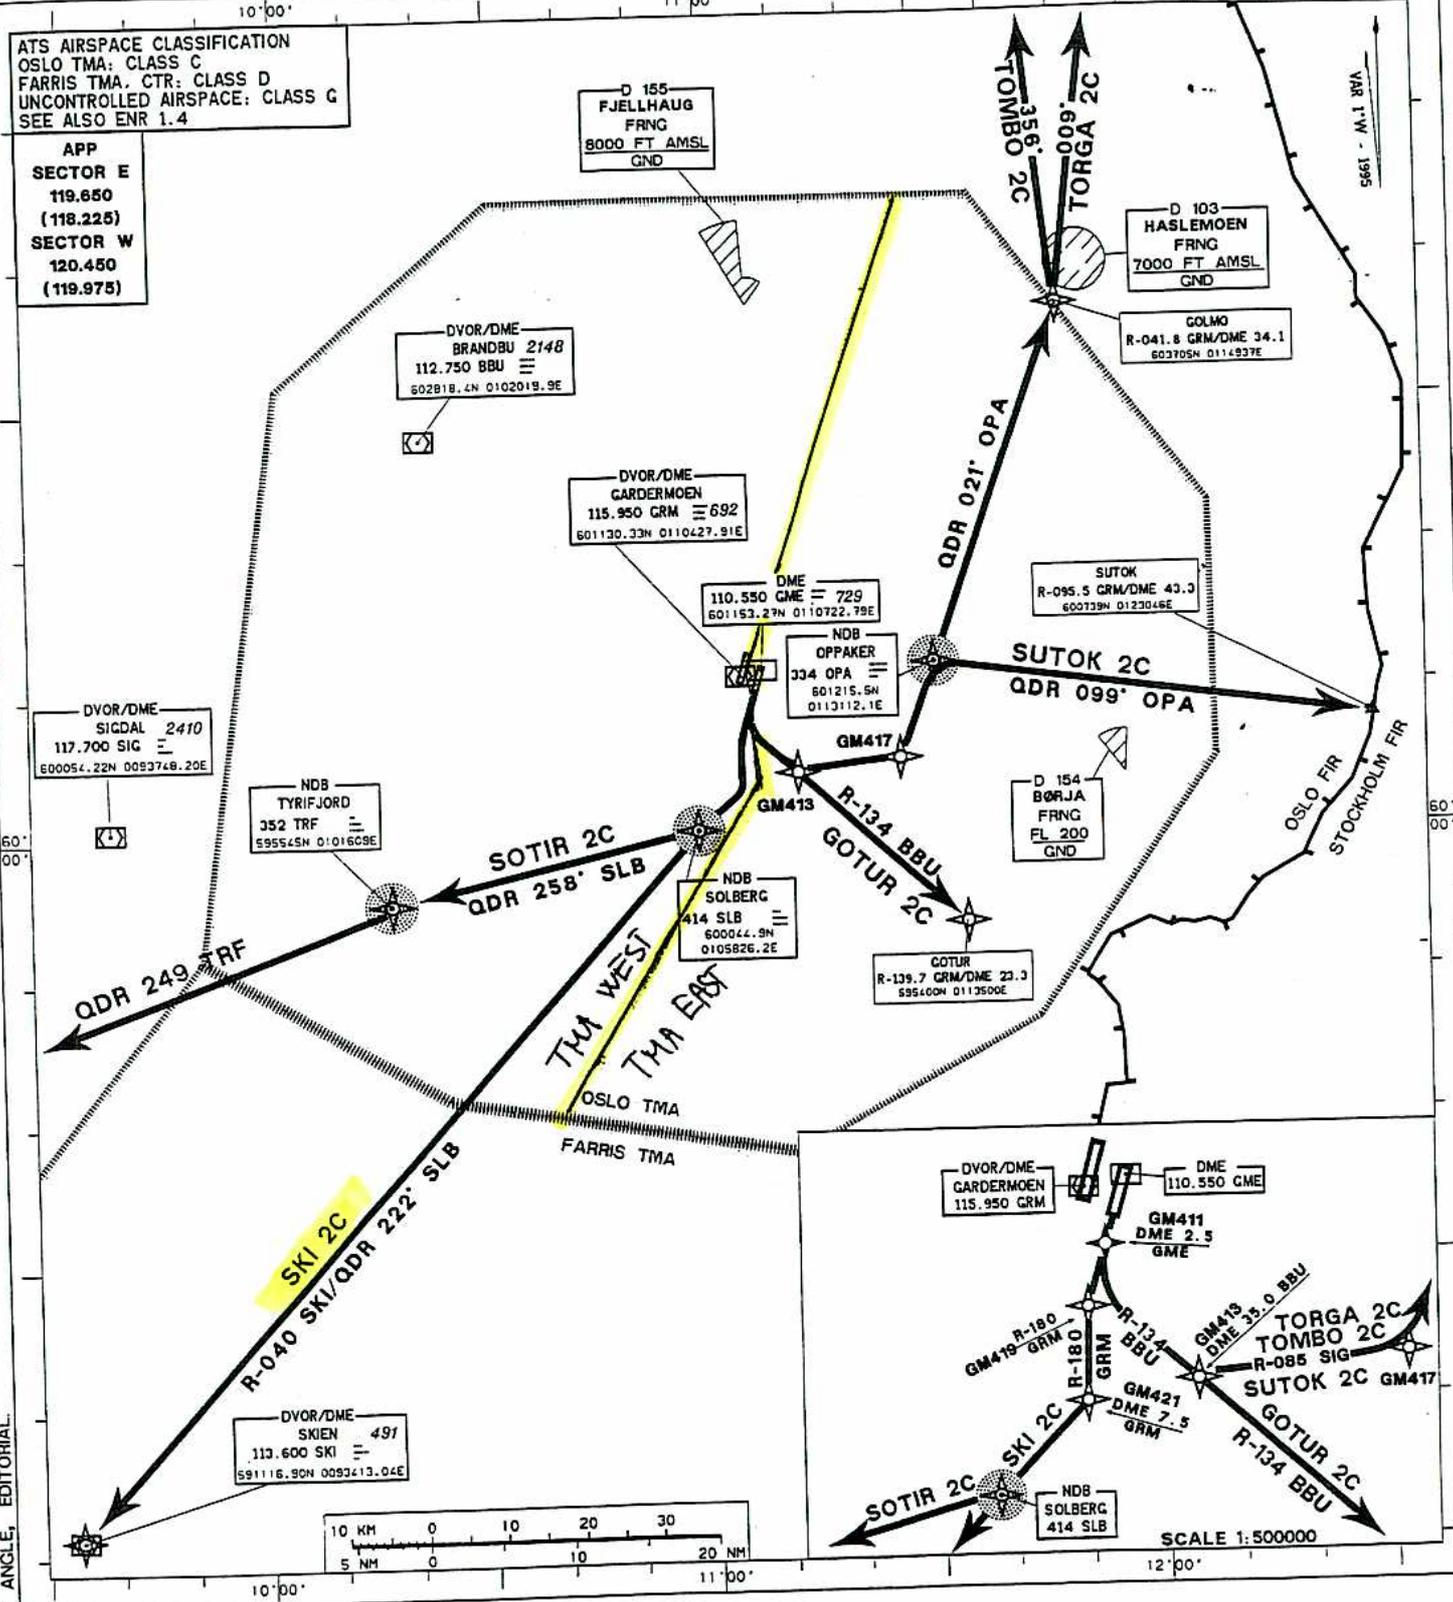
STANDARD DEPARTURE CHART
INSTRUMENT (SID) - ICAO

The incident does however indicate a weakness in the STAR - SID system at Oslo Airport Gardermoen.
