AVIATION OCCURRENCE REPORT

02-010

Boeing 747-419 ZK-NBS flight NZ 2, in flight flap separation
over Manukau Harbour by Auckland International Airport

30 August 2002

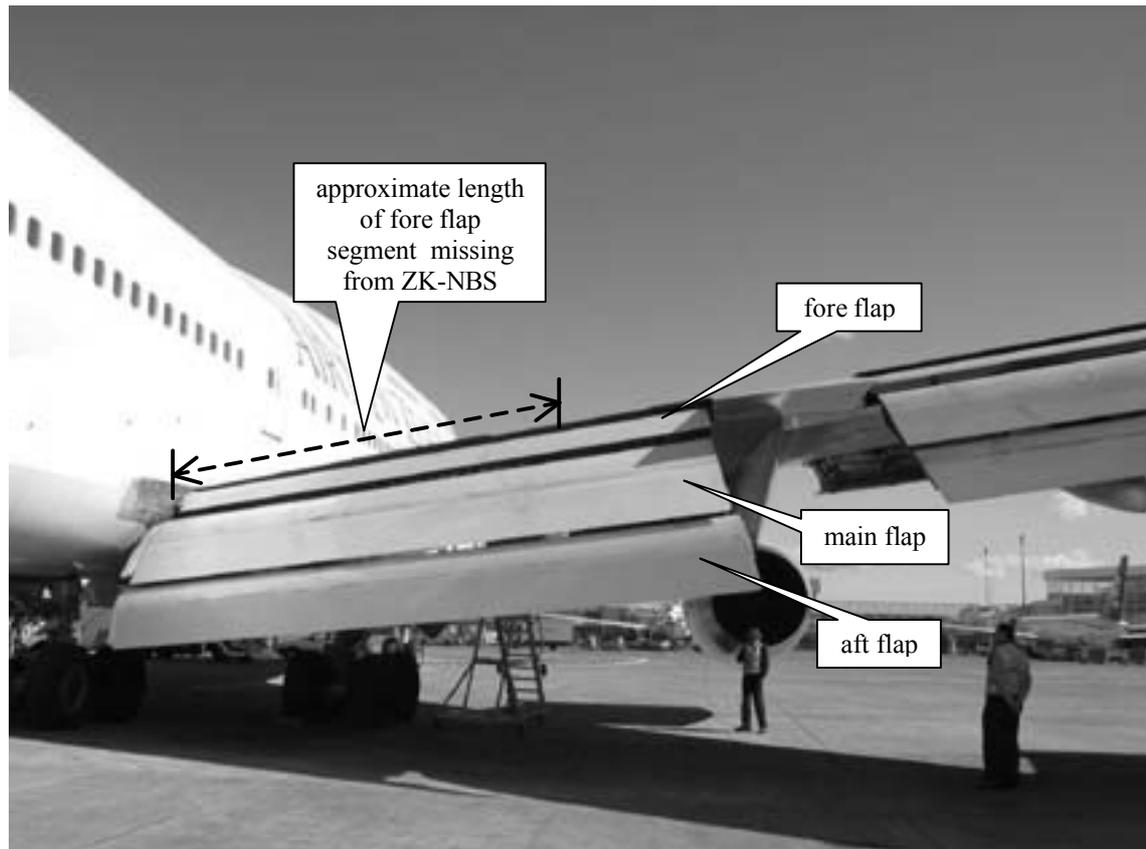
Figure 1
Boeing 747-400 right inboard trailing edge flaps

1.10.1 About 70% of the innermost segment of the right inboard trailing edge fore flap separated from ZK-NBS during the departure from Auckland (see Figure 1). The outermost flap segment was found skewed about 20° and remained attached to the aircraft, being bolted to the outer fore flap carriage by way of its fitting. The inner fore flap link attachment bolt and bearing remained attached to the flap carriage. A fractured end segment of the fore flap link (see Figure 6) was found inside the inner flap track fairing (canoe).

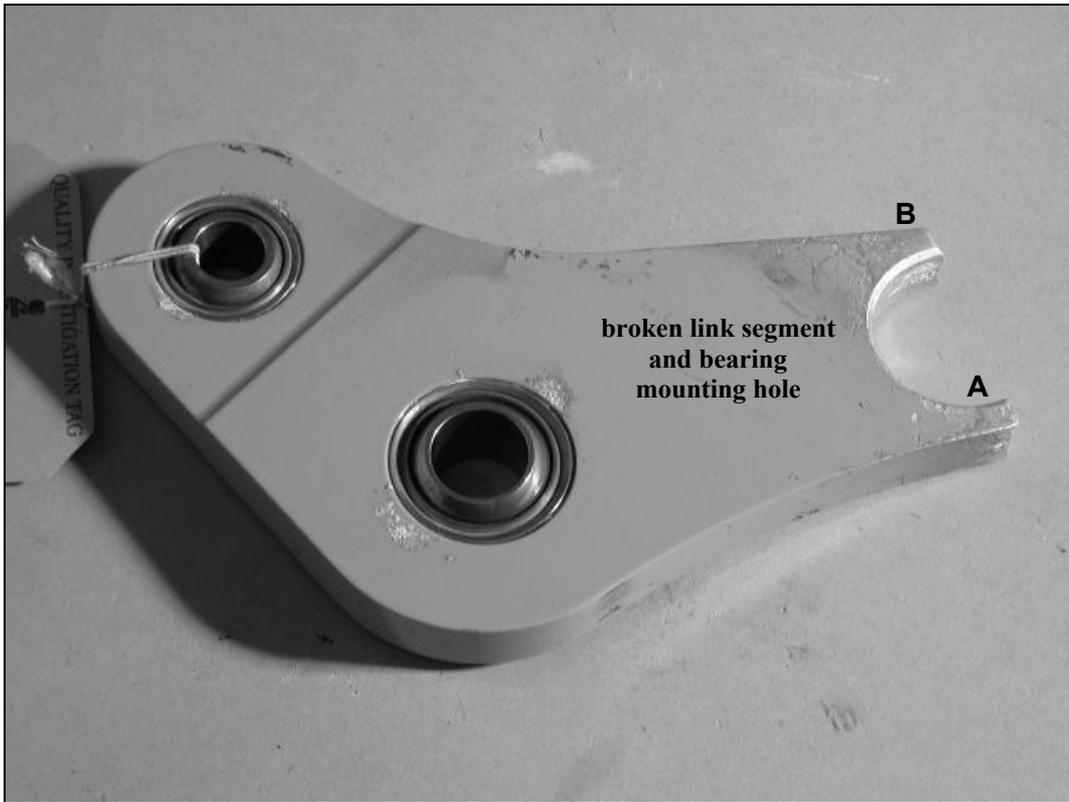
Figure 4
Failed fore flap link from ZK-NBS

1.13.2 The link failed at either side of the bearing-mounting hole (see Figure 4) where the bearing attached the link and fore flap to the inner fore flap carriage assembly. Significant features were that whereas one side had failed in overload, the area of overload on the other side was less than 25% of the fracture surface, and that a pre-existing stress corrosion crack covered over 75% of the surface (see Figures 6 and 7).

- 1.13.9 An initiation process similar to that of fracture “A” probably caused the cracking at the bore side of fracture surface “B” (see Figures 4 & 6). The cracks were predominately caused by fretting fatigue.

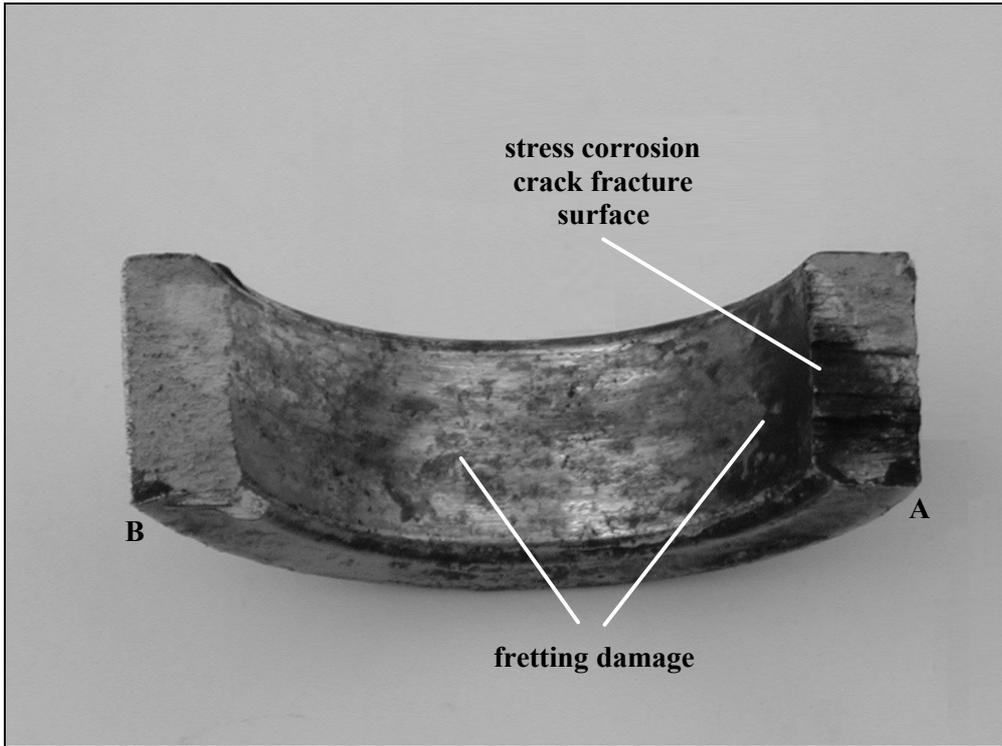
Figure 6
Failed fore flap link piece

- 2.6 The fore flap link failed because a large pre-existing crack had grown to a critical size. The crack covered about 75% of the cross section of the link in the area housing the self-aligning monoball end bearing.

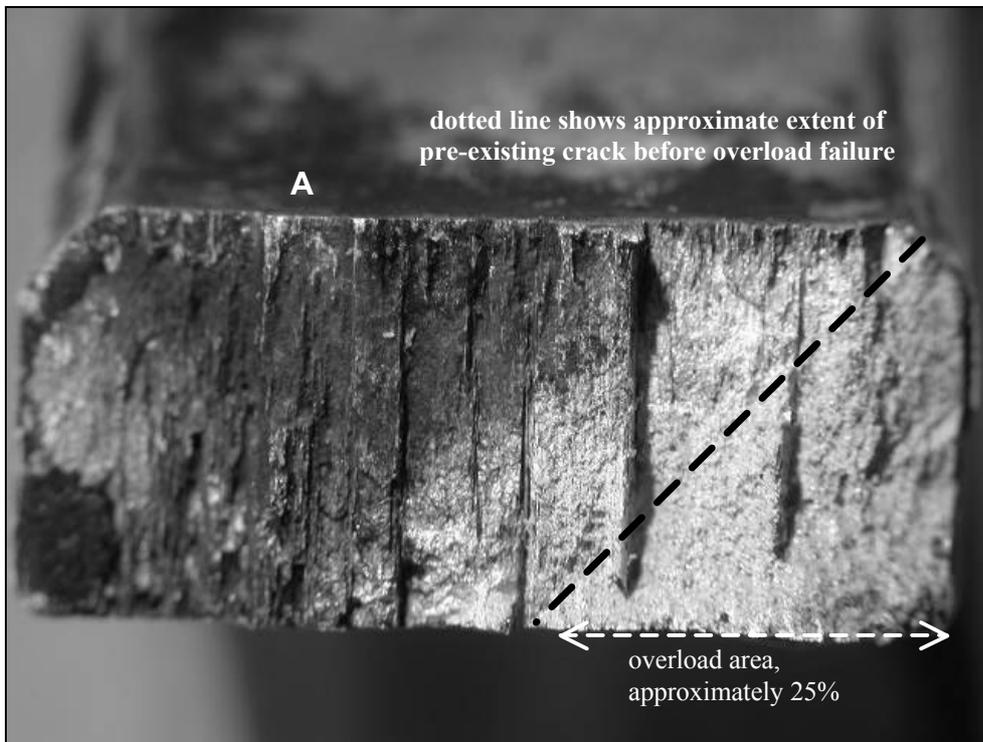
Figure 7
Failed link piece fracture surface A

1.13.6 The metallurgist said it was highly unlikely that the link failure occurred from incorrect installation or the incorrect use of the material. Fracture surface "A" (see Figures 4, 6 & 7) was the major failure and it had a number of initiation points along the width of the link, indicating that the loading on the component was even. The fracture sequence was stress corrosion cracking, followed by corrosion fatigue, followed by fatigue and then overload.

- 1.13.8 The stress corrosion cracking in fracture surface “A” spread across the entire section and the metallurgist said it was highly probable the cracking started as fretting corrosion fatigue cracks. A significant amount of fretting debris was present in the area indicating that fretting had occurred and that fretting damage was present in the area.

- 2.8 The majority of the cracking occurred because of stress corrosion cracking followed by corrosion fatigue. The rate of cracking was unknown, but stress corrosion cracking can increase rapidly. The crack faces were not heavily polished, suggesting that the crack had propagated in a relatively short period of time, weeks rather than months or years.
