Tail strike during take-off, Boeing 747-412 9V-SMT, flight SQ286, Auckland International Airport 12 March 2003

AVIATION OCCURRENCE REPORT

03-003

Boeing 747-412 9V-SMT, flight SQ286, tail strike during take-off,
Auckland International Airport

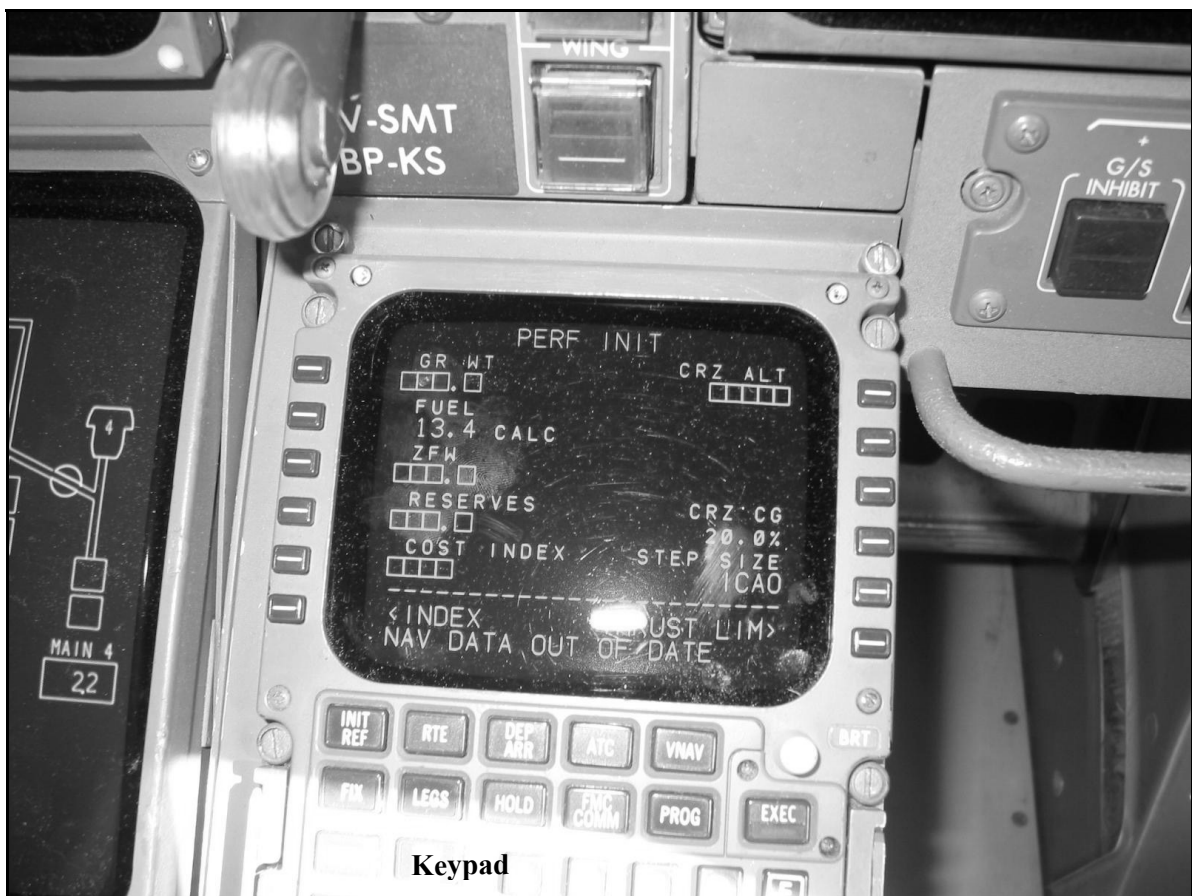
Figure 2
9V-SMT FMC display

- 1.1.13 The captain checked the FMC computation of the aeroplane on-board fuel against the required fuel weight. Seeing these weights were similar he entered the ZFW from the load sheet into the FMC's ZFW field (see Figure 2). The FMC automatically added the ZFW to its own computed aeroplane on-board fuel weight and displayed gross weight (GR WT) in the GR WT field on its display unit. The captain verified that the GR WT field on the display unit corresponded to the take-off weight recorded on the load sheet.

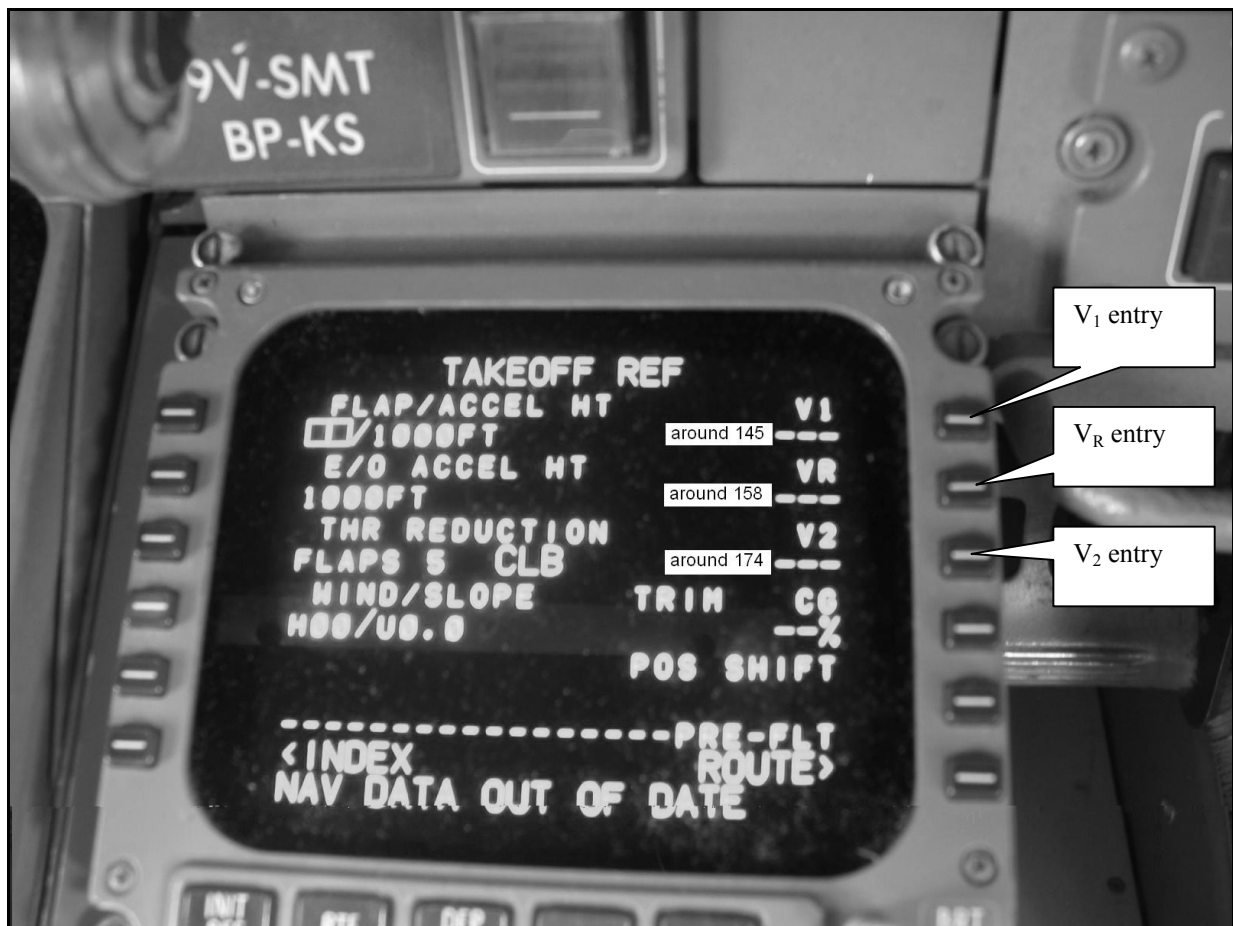
Figure 3
9V-SMT FMC display of V speeds

- 1.1.14 The captain entered the manually calculated V speeds directly into the FMC's V_1 , V_R and V_2 fields, replacing the V speeds the FMC had itself computed and was displaying on its display unit (see Figure 3). Despite significant differences the FMC accepted the input V speeds, showing them on its display and storing them in the flight management system (FMS), which highlighted them on the captain's and first officer's primary flight displays (PFD) air speed tapes. The PFD highlighted V speeds were normally hidden from view until the aeroplane speed increased during take-off, at which time they appeared on the speed tapes so the pilots could refer to them. The before take-off procedure called for the pilots to check the EPR thrust setting on the engine indication and crew alert system display (EICAS), and to check that the correct V speeds were set and appeared on the PFD airspeed indicators.

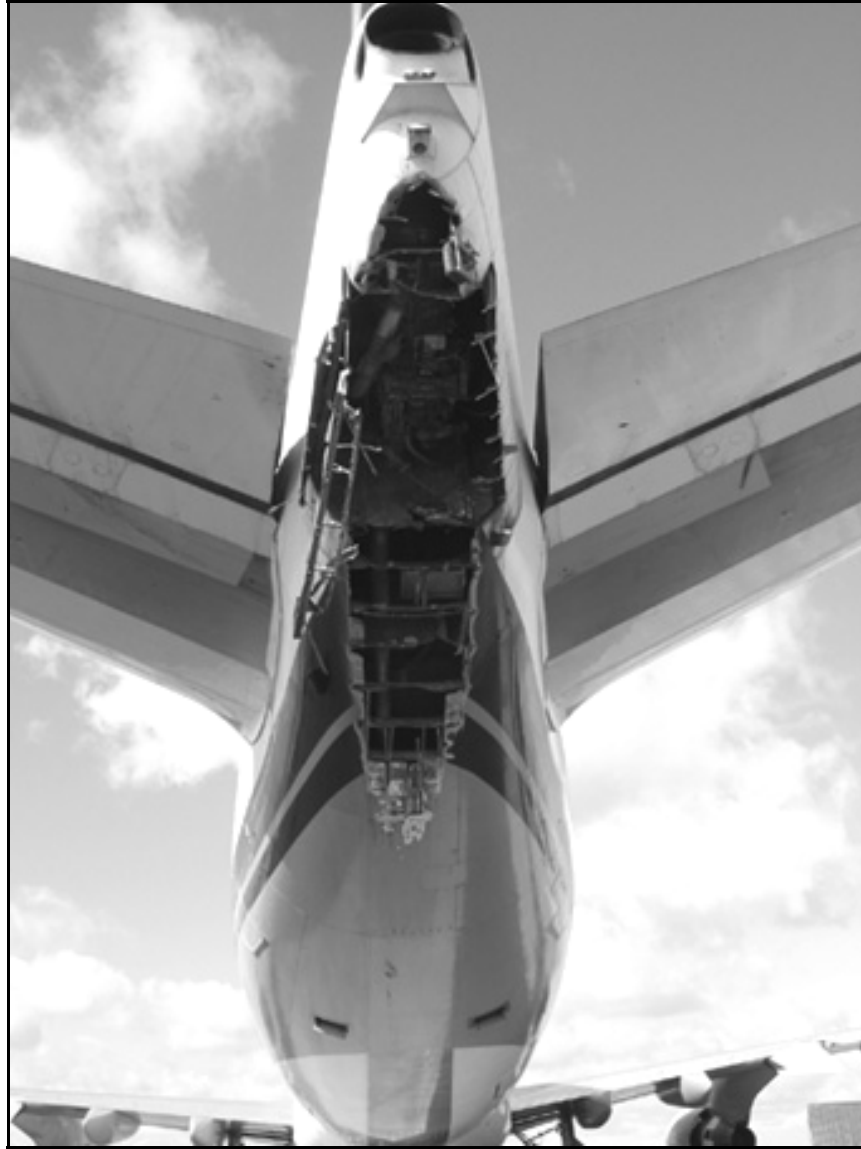
Figure 4
9V-SMT damaged tail section

1.3.1 During the tail strike, 9V-SMT incurred major lower fuselage skin panel abrasion damage, including multiple nicks, scratches, scrapes and gouges, which extended from just behind its aft pressure bulkhead to the clamshell door assembly under the APU (see Figure 4). There was some further skin abrasion forward of the aft pressure bulkhead including a small skin puncture. The aft pressure bulkhead was not damaged. There were small skin punctures in each horizontal stabiliser.

1.3.2 A number of stringers and frames were heavily abraded and much of the lower fuselage skin behind the aft pressure bulkhead was missing. The APU clamshell doors were also heavily abraded and hung open, exposing the APU assembly. The clamshell doors contained part of a fire wire loop that surrounded the APU, which was used to signal any APU fire warning to pilots.

- 1.12.1 See 1.3 Damage to aircraft, and Figure 4.

1.3.4 The operator sent its own engineers to Auckland to carry out an initial damage assessment. The aeroplane manufacturer then carried out its own detailed damage assessment and sent its rapid response team to carry out the repairs. The major repair work took several weeks to complete.

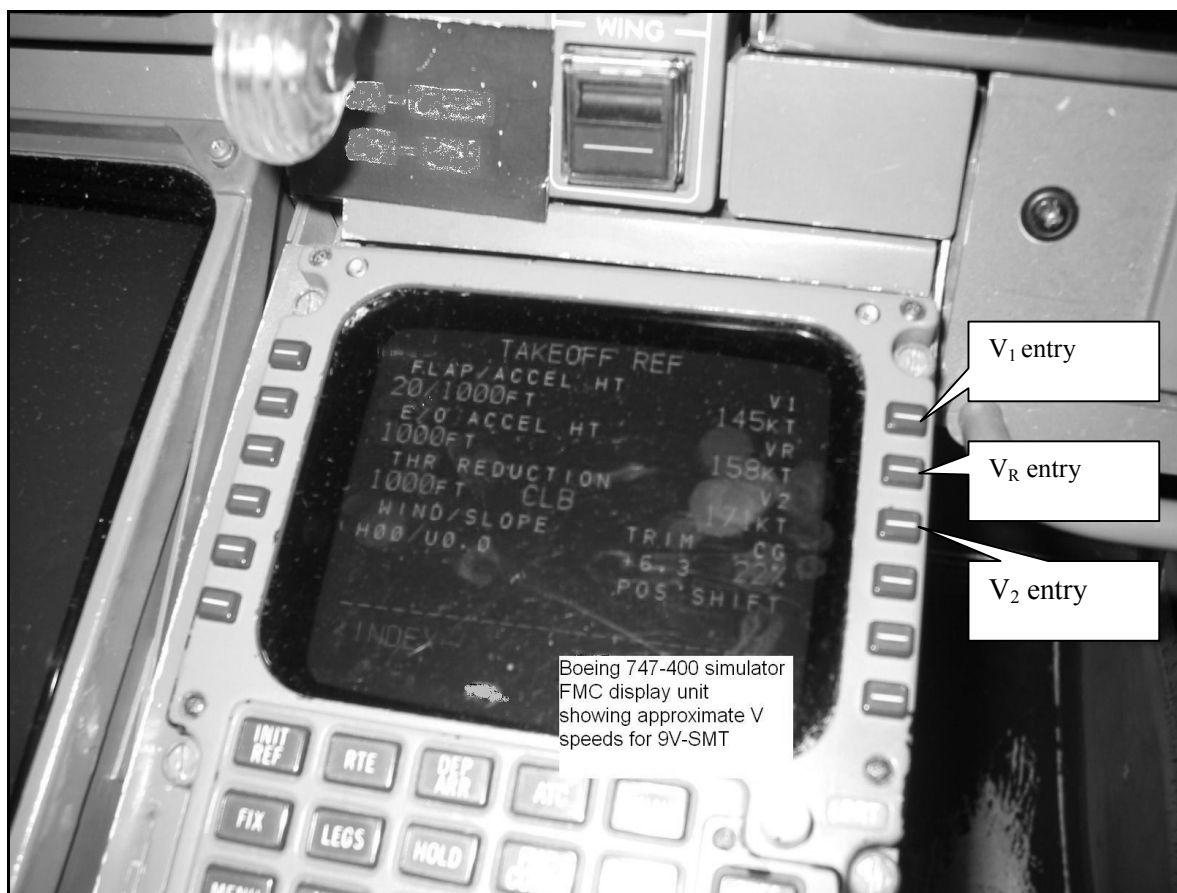
Figure 5
Boeing 747-400 simulator FMC display

1.16.2 Another operator's Boeing 747-400 flight simulator with a FMS setup similar to that of 9V-SMT was used to examine the FMS. Using the same weights and settings as those for the accident flight, the FMC displayed V_1 as 145 kt, V_R as 158 kt and V_2 as 174 kt on its display unit (see Figure 5). The erroneous V speeds used with 9V-SMT were then entered into the simulator's FMS by overwriting the FMC displayed V speeds. The FMC accepted these entries without challenging them and stored them in the FMS.

1.16.3 The flight simulator FMC also accepted an erroneous ZFW entry into its GR WT field, but only when that weight minus the aeroplane fuel weight was greater than the aeroplane empty weight.

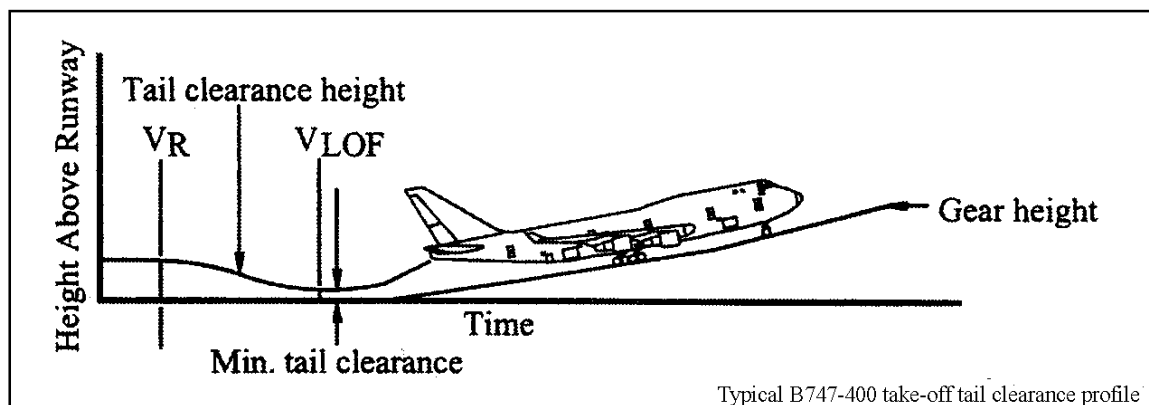
Figure 6
Typical take-off tail clearance height depiction

- 1.17.13 The aeroplane manufacturer had determined and published the geometry-limited tail strike aeroplane body angles necessary to achieve a tail strike on its various aircraft during take-off and landing. For the Boeing 747-400 this was 11° with the main undercarriage oleos fully compressed and 12.5° with the oleos extended. Any time the body angle approaches these geometric limits the possibility of a tail strike increases dramatically. The point of minimum tail clearance during a normal take-off occurs immediately after the aeroplane has lifted off (see Figure 6). This is a consequence of the aeroplane geometry and the dynamic forces that are acting after take-off rotation has been initiated. If the rotation is started too early, or is performed at too high a rate, the minimum tail clearance decreases and may result in ground contact. A rotation rate in excess of 3° per second could bring about a tail strike. For a normal take-off, lift-off would occur at 8.5° to 10° body angle.
