Jammed aileron, Incident involving aircraft SE-DRG, 13 January 1997, in controlled airspace west of Stockholm, AB county, Sweden

Micro-summary: A loose plate caused a jammed aileron and difficulties in controlling this BAe 146-200 .

Report C 1997:49
Incident involving aircraft SE-DRG,
13 January 1997,
in controlled airspace west of
Stockholm, AB county, Sweden

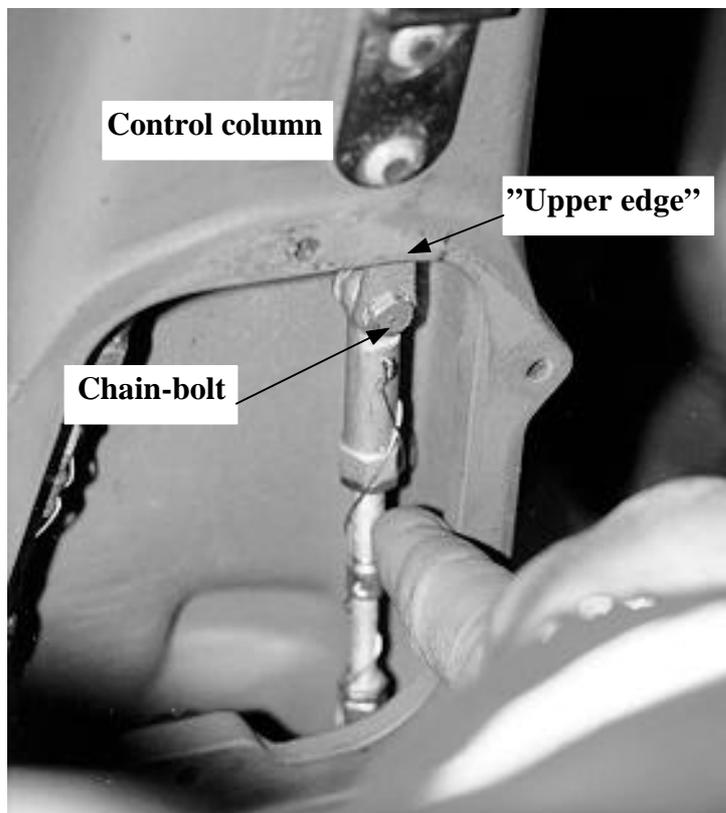
During the technical investigation of the aircraft after the incident performed at Norrköping/Kungsängen airport in co-operation with representatives of the manufacturer, British Aerospace (BAe), it was found that the chain in the right control column (Chain assy, P/N AS7877-24P) assembly which transfers the wheel movement to the right aileron control system was slack. With the column pulled fully back the chain could "fall back" allowing a bolt head on the chain (Bolt, P/N DHS 1426-2-5DD) to catch against the upper edge of the inspection hole in the column. Scratches in the paint on the upper edge of the hole indicated that there had been mechanical contact during a wheel movement to the right. "The feeling" in the control-wheel during a simulated locking was verified by the captain.

The left control column as well as all other control columns of the airline's other aircraft proved when checked also to have chains that were more or less slack.

The type of fault was new for BAe. In the manufacturer's Aircraft Maintenance Manual (AMM) the control column was defined as a "component" requiring no specified or periodical maintenance as long as it was mounted in the aircraft ("On condition").

Following the incident control columns and cover plates of all aircraft operated by the airline were checked and action taken. The task was completed within 24 hours of the defects being discovered.

- a) supplemented the AMM with a requirement to check the chain tension periodically and
- b) modified the cover plates in such a way that they will no longer cause jammed ailerons. In a Mandatory Modification Service Bulletin BAe will order replacement of all existing plates by the new ones, when manufactured.

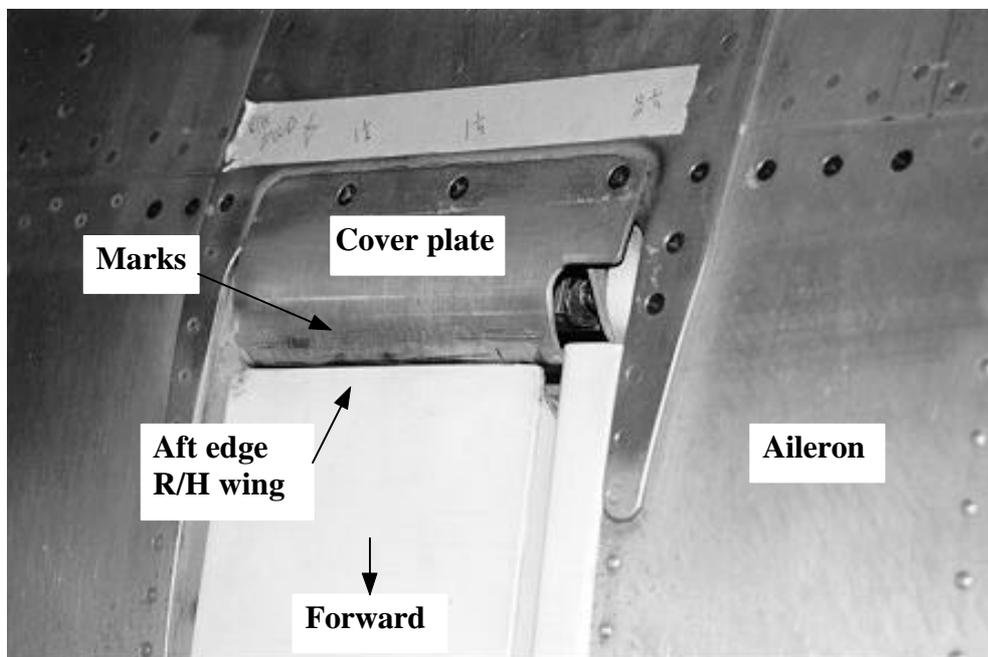
During the technical trouble-shooting at Gothenburg/Landvetter airport it was found that the top cover plate (Cover plate, P/N HC576H0032-001) over the centre hinge of the right aileron was loose. The three fixing screws (Bolt, P/N NAS4403-7) in the aft edge of the plate holding it fast to the aileron were not fully tightened. With the aileron in neutral position, the play between the forward edge of the plate and the aft edge of the wing at the level of the hinge was approximately 1.1 mm. In flight, however, the aerodynamic forces lifted the forward edge of the plate so that it could catch against the trailing edge of the wing skin thereby jamming the upward movement of the aileron (right wheel throw) at around neutral position.

Marks on the forward edge of the cover plate indicated that the aileron had been jammed on one or more than one occasion in connection with upward manoeuvring of the aileron.

Also, this type of fault was new to the manufacturer. The AMM contained no special mounting instructions for the cover plates or any special regulations regarding a check on the play between cover plates and wing trailing edges.

The probable cause of the incident was a loose cover plate on the right aileron which, under the influence of aerodynamic forces during flight could catch against the trailing edge of the wing skin thereby jamming the upward movement of the aileron.
