## Runway overrun, Incident involving aircraft UK76824, 27 December 1998, at the Stockholm/Skavsta Airport, D county, Sweden

**Report RL 2000:05 e**

**Incident involving aircraft UK76824,  
27 December 1998,  
at the Stockholm/Skavsta Airport,  
D county, Sweden**

**L-125/98**

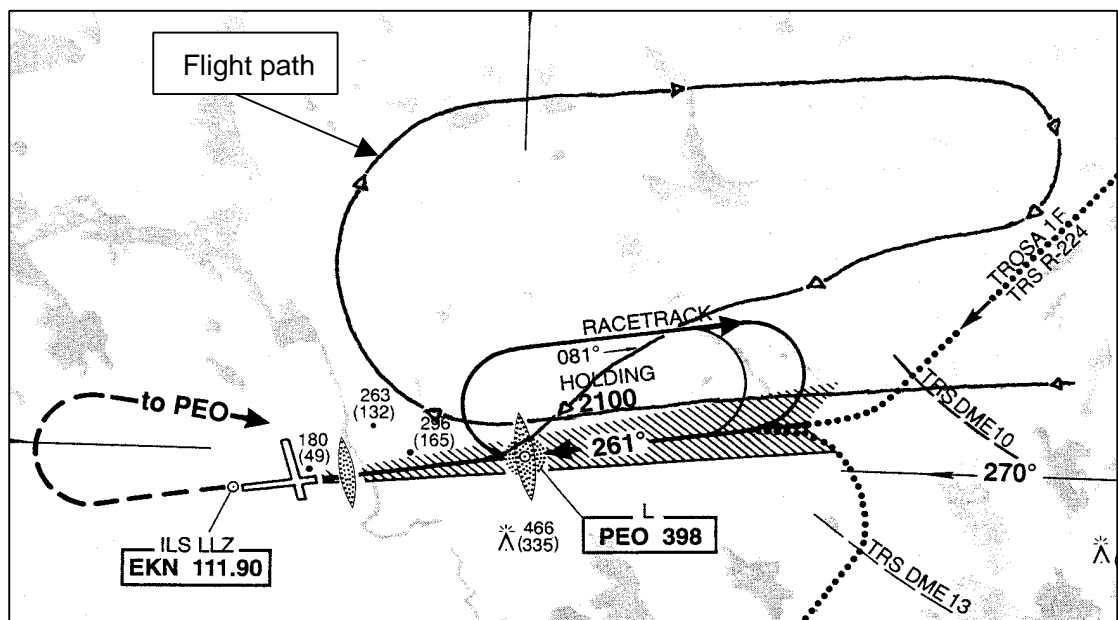
#### 1.16.1 Radar plot

The aircraft's track in relation to the PEO NDB and the airport during the last 12 minutes of flight has been determined with the aid of a radar plot from MUST and is contained in *appendix 5*. All height information is the aircraft's altitude above sea level (QNH). The same radar plot has been transposed onto an approach and landing chart (appendix 2) in the diagram below.

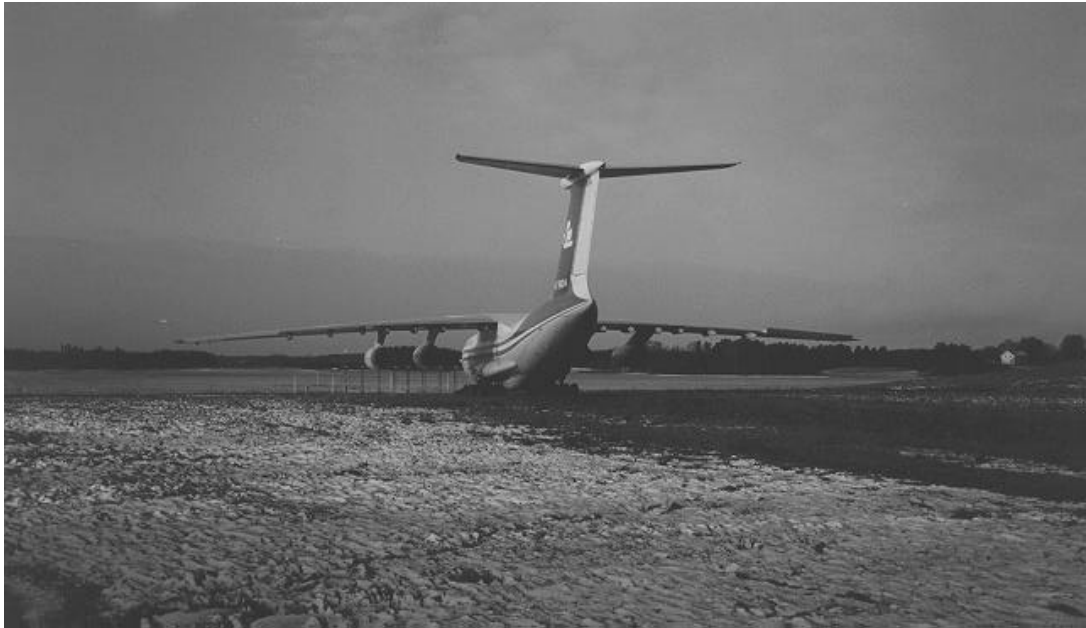
#### 1.16.2 Point of touch down

The commander has stated that the touch down occurred about 300 m. down the runway. Witnesses have stated that the touch down occurred after about half the

runway length. The runway was inspected after the incident by airport personnel accompanied by the commander. The airport personnel were able to determine that the aircraft's wheelmarks began approximately level with a road that crosses the runway at midpoint, that being 1,270 m. from the threshold.
