Proximity incident, Incident between aircraft LN-RON and TF-FIP in the airspace above Stockholm/Arlanda airport, AB County, Sweden, on 25 January 2002

Report RL 2003:01e

***Incident between aircraft LN-RON
and TF-FIP in the airspace above
Stockholm/Arlanda airport, AB County,
Sweden, on 25 January 2002***

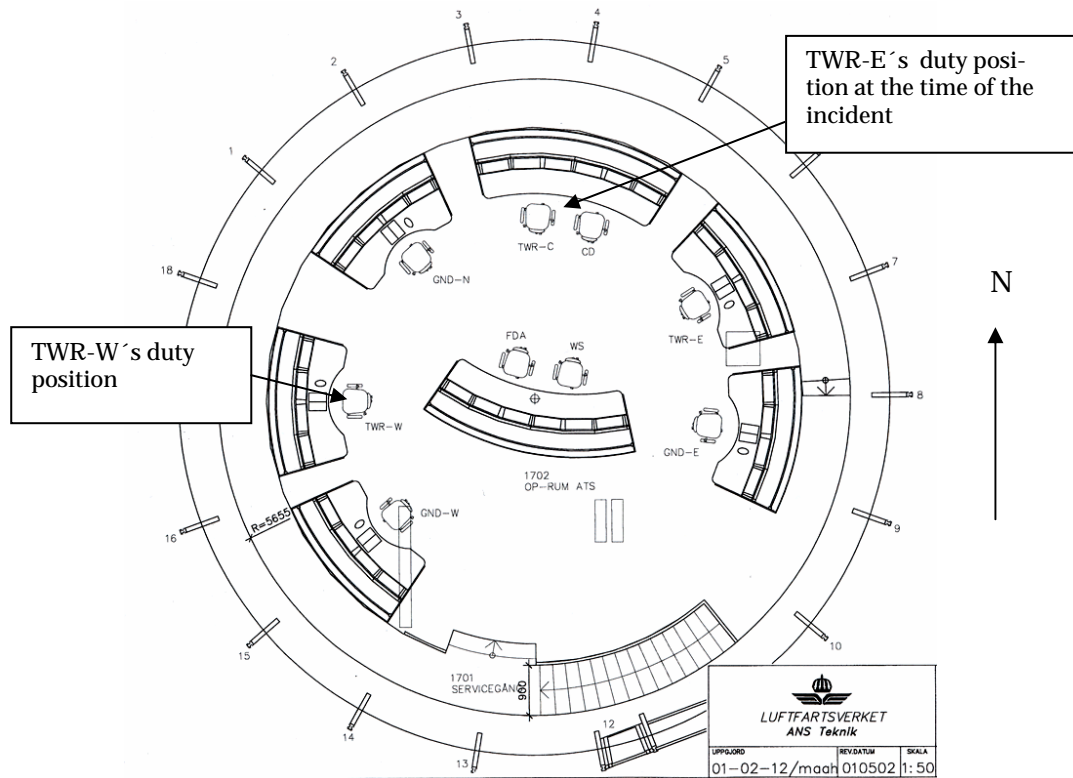
TWR-W was to visually determine when landing was accomplished on runway 26 in order to be able to issue takeoff clearance for departures from runway 01L. TWR-W did not have the possibility to monitor the radio communication between landing aircraft and TWR-E. To attract attention when an aircraft discontinues a landing, there is warning signal, audible within the tower, which the controller is to activate. The tower controller in position TWR-E activated the alarm at the same time that the controller in position TWR-W instructed SAS 1551 to reject the takeoff.

Image: Depicts duty position placement when runway three is in use. At the time of the actual occurrence TWR-E was working from TWR-C's duty position, see arrow. (Source: LFV 2002-1843-002)
