Dual electrical failure, Incident involving aircraft SE-LGZ in the air space over Mariehamn, Sweden on 31 January 2003

Report RL 2004:26e

Incident involving aircraft SE-LGZ in the air space over Mariehamn, Sweden on 31 January 2003

Case L-03/03

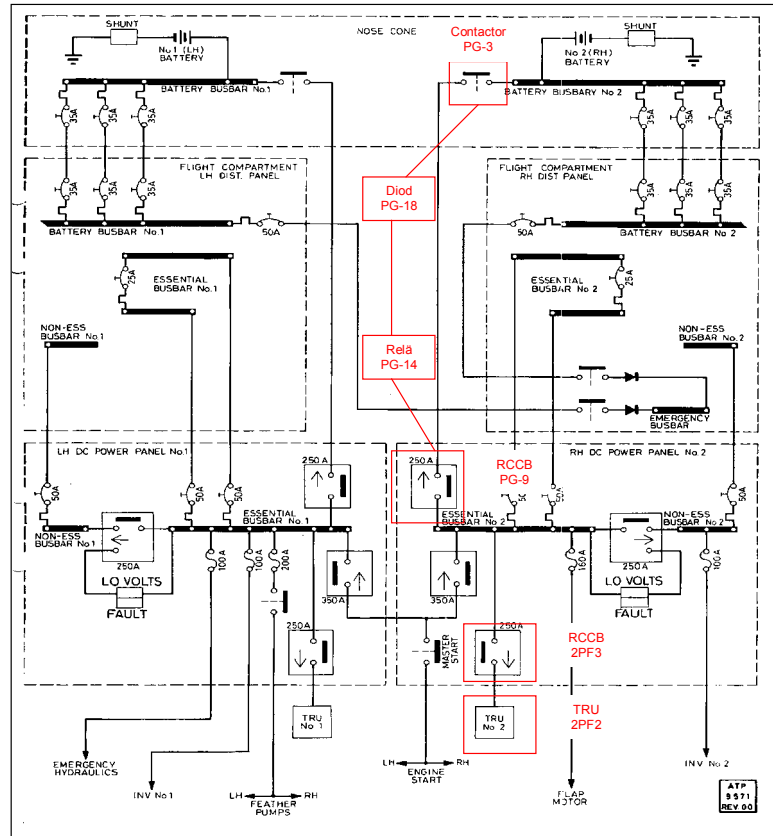
Portion of wiring diagram

Current is supplied to the 28V DC- system, both from the TRUs and from the batteries, via a special type of relay, the Reverse Current Circuit Breaker (RCCB) which, apart from breaking and making the connection, also acts as a diode. The RCCBs are controlled in their turn by switches, contactors, relays and diodes included in the aircraft's electrical system. One of these contactors is the battery main switch.

SHK was informed by the aircraft company of the incident on the same day that it occurred, since the SHK was already investigating a similar incident with the same aircraft type that had afflicted the company just under three months previously. Further investigation of the aircraft was conducted by technicians from the aircraft company in consultation with SHK. During the fault-finding and putting in order of the aircraft selected components were replaced and checked separately. At functional tests of these components the RCCB (2PF3) was found to be unserviceable.

For the 28 V DC-system to become ‘dead’, it is necessary that the current supply from both generators/TRUs and batteries is interrupted. The technical fault detected in the RCCB explains the power cut from the TRU side. Regarding the power cut from the battery circuit, several explanations are possible. It has however been impossible to produce any definite conclusion.

- replacing all RCCB “Mod A” with RCCB “Mod B”,
- introducing operating time limitations for RCCBs
- shortening the operating time interval for batteries.

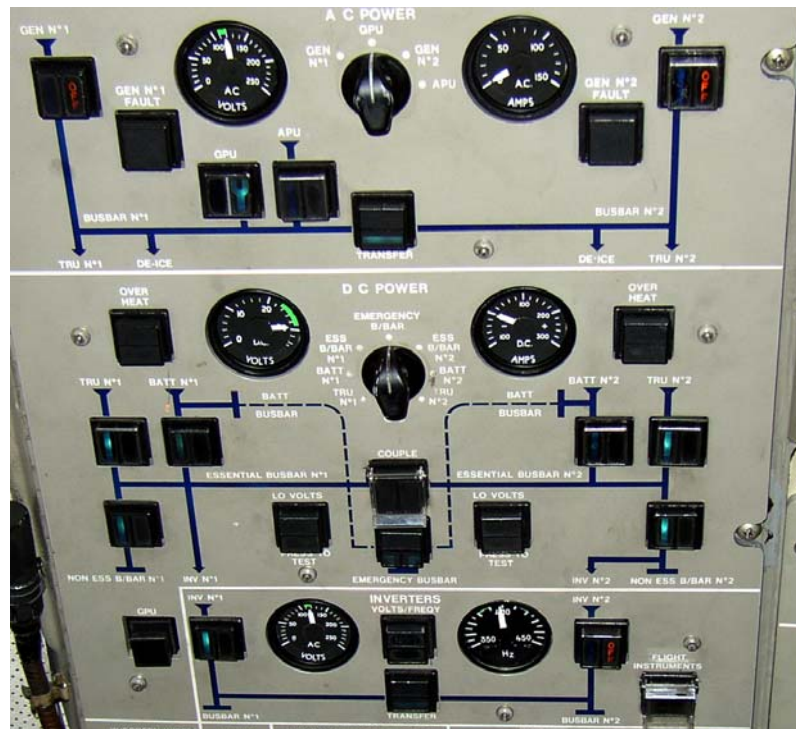
Control panel

In the ceiling above the left pilot’s seat there is a control panel for controlling and checking the status of the aircraft’s electrical system. Switching on and off is effected on the panel with press-buttons that light up with a blue line if they are ‘on’ and show a lighted OFF symbol if they are ‘off’, see photograph below.

Interruption of the power supply from the battery does not normally trigger any warning but is shown only by the blue line on the switch for battery contactors to extinguish. Thus the power supply from the battery may have been interrupted for some time before the incident without the pilots noticing it.

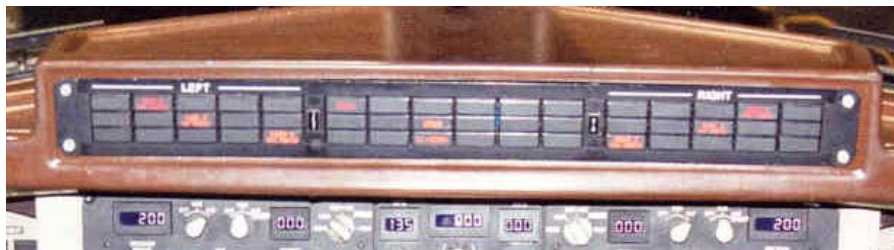
Emergency panel

In connection with the power loss the main warning lamp started to blink, the blue mimic line in the R/H GEN switch went out, and the warning R/H INVERTER and EXIT lit up on the emergency panel. On the instruments the pilots saw that the right 28 V DC⁴-system was without voltage and the right battery was no longer connected. The instruments for the right engine did not work.

At the top of the instrument panel there is an emergency panel with warning texts that light up in the event of failures or abnormal situations. In connection with such warnings a blinking main emergency lamp and an acoustic warning signal (Master Caution) are activated. An interruption in the power supply from a battery does not trigger a warning.

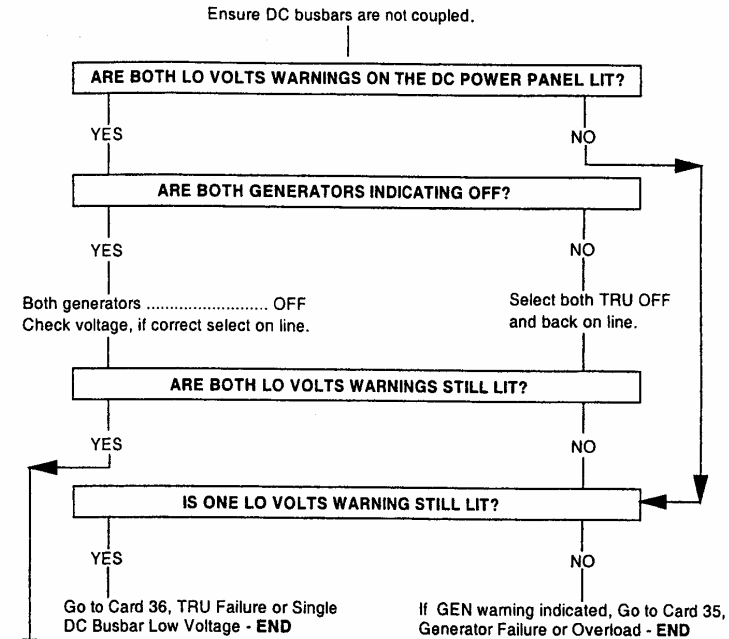
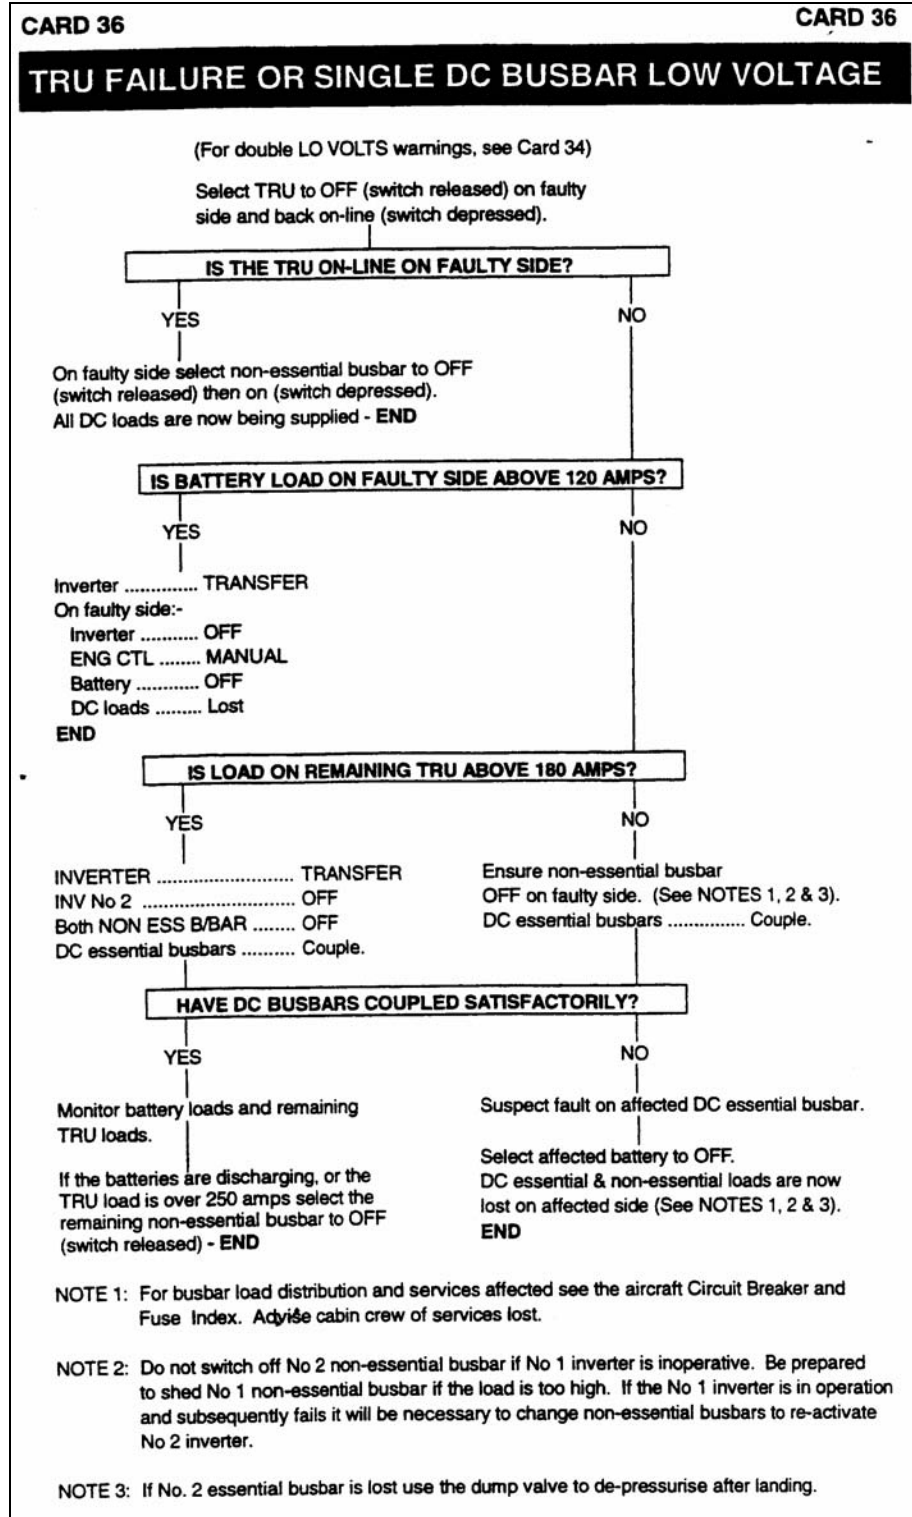
DOUBLE GEN/TRU FAILURE OR DC BUSBAR LOW VOLTAGE

As mentioned above, the emergency checklist should be the natural aid to pilots to identify a possible fault and take the most suitable action from the point of view of flight safety. It should be easy to understand and very user-friendly. In SHK’s opinion the present emergency checklist does not meet these demands. It is complicated, the logic is not self-evident, the typeface is small, the text on the emergency panel is not given as headlines for steps to be taken, etc.

Since the left electrical system was functioning without remark, there are strong indications that it would have been possible to supply the right DC system from the left via “COUPLE”, thus regaining full function in all systems connected to the right side DC- and AC-systems. In fact, this emerges to some extent from the emergency checklist (Card 36) under the heading “TRU FAILURE OR SINGLE DC BUSBAR LOW VOLTAGE”.
