Runway Overrun During Landing On Taipei Sungshan Airport, Transasia Airways Flight 536, A320-232, B-22310, October 18, 2004

GE 536 Occurrence Investigation Report

Runway Overrun During Landing On Taipei Sungshan Airport

A320-232, B-22310

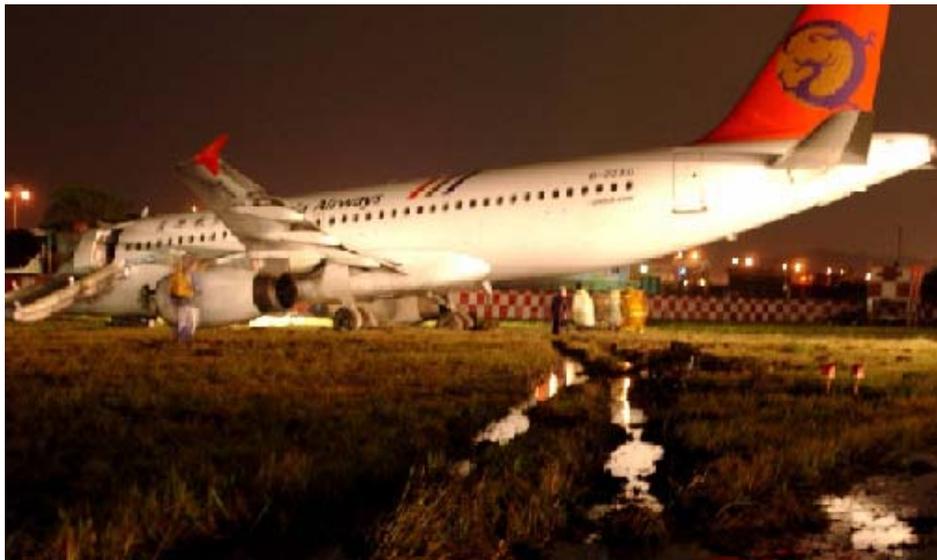
The aircraft rolled off Runway 10 and came to rest in a muddy area. Aircraft longitude axis 90 degrees to the runway heading (Figure 1.3-1) . The NLG entered a drainage ditch (approx 1m deep) (Figure 1.3-2) and sliding tube of the nose gear was broken(Figure 1.3-3), number two engine nacelle bottom came in contact with the ground(Figure 1.3-4), damage the RH pylon structure and some engine fan blades were evident.

Figure 1.3-1 The aircraft rolled off runway and came to rest in a muddy area 90 degrees to the runway heading

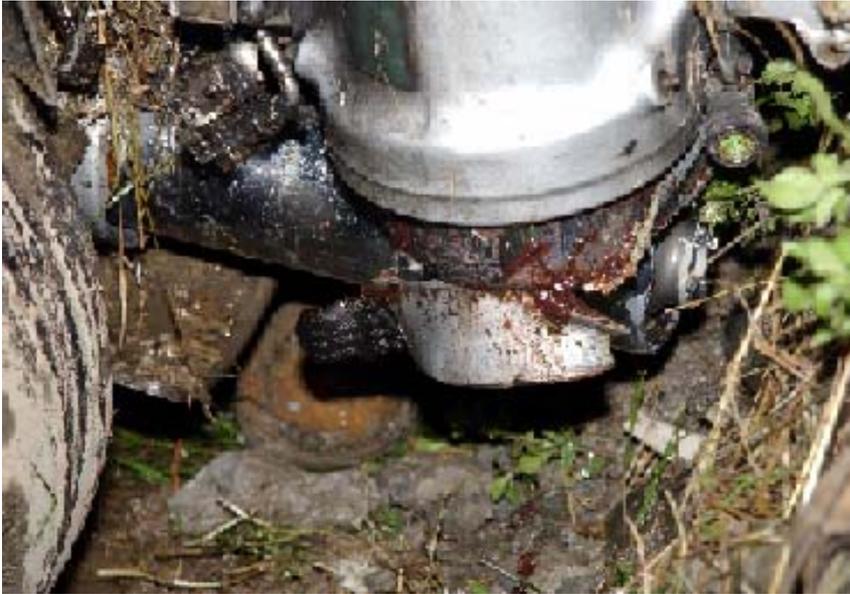
Figure 1.3-3 Sliding tube of the nose gear was broken

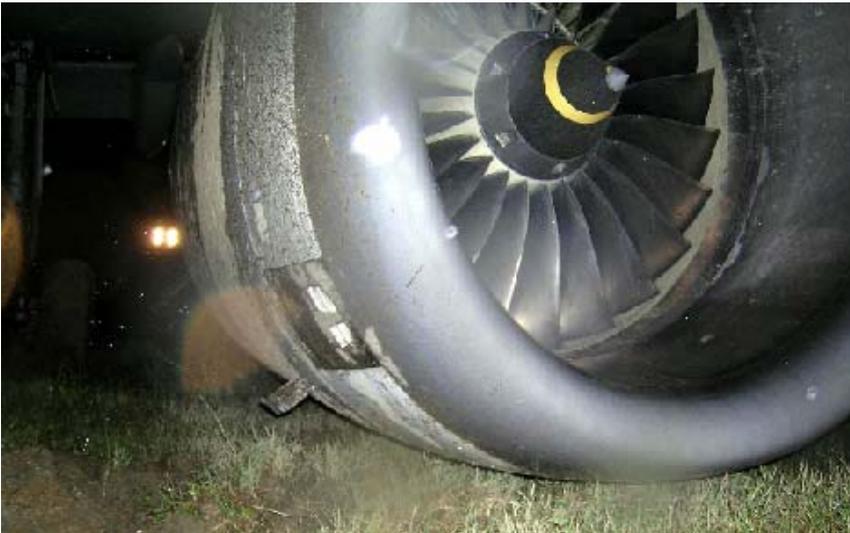
Figure 1.3-4 Both engine nacelles came in contact with the ground

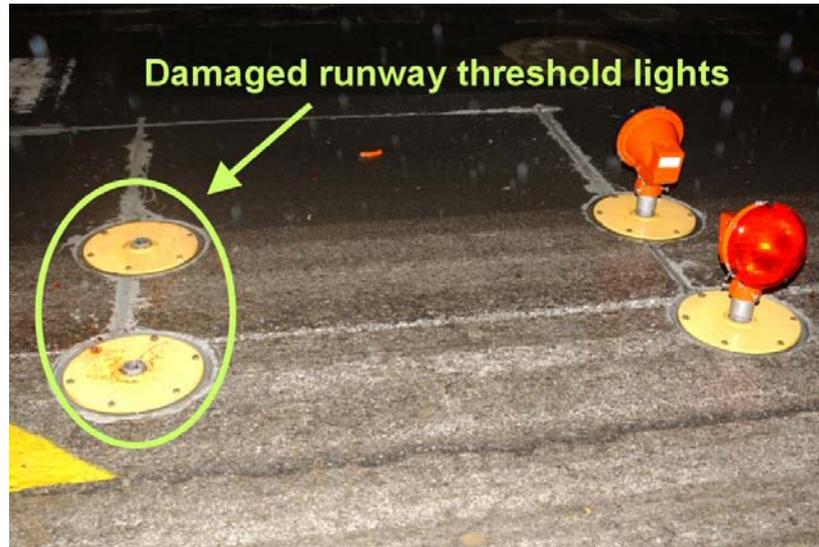
From the observation of the tire marks, the nose gear passed through two runway threshold lights (Figure 1.4-1) . The right main landing gear passed through two electrical handholds. Wreckages of the damaged electrical handholds were shown in Figure 1.4-2.

Figure 1.4-1 Damaged runway threshold lights

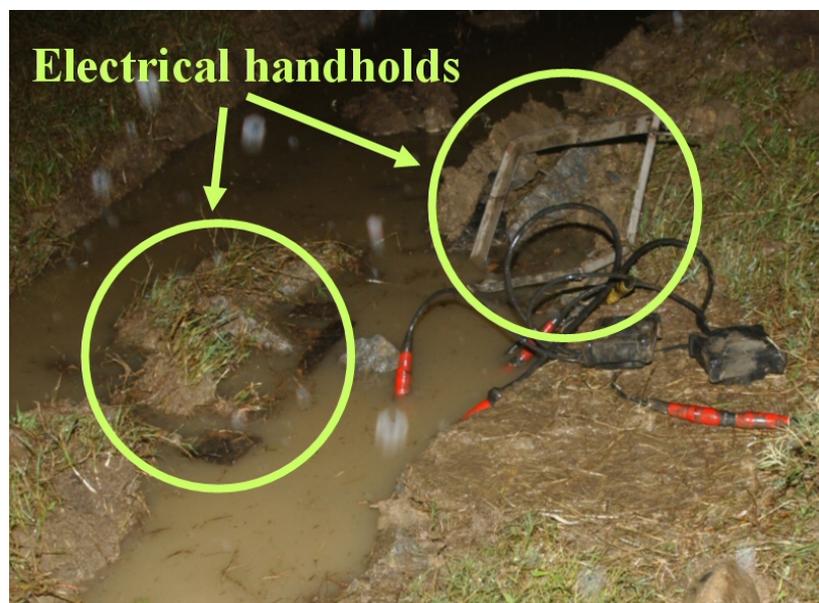
Figure 1.4-2 Damaged electrical handholds

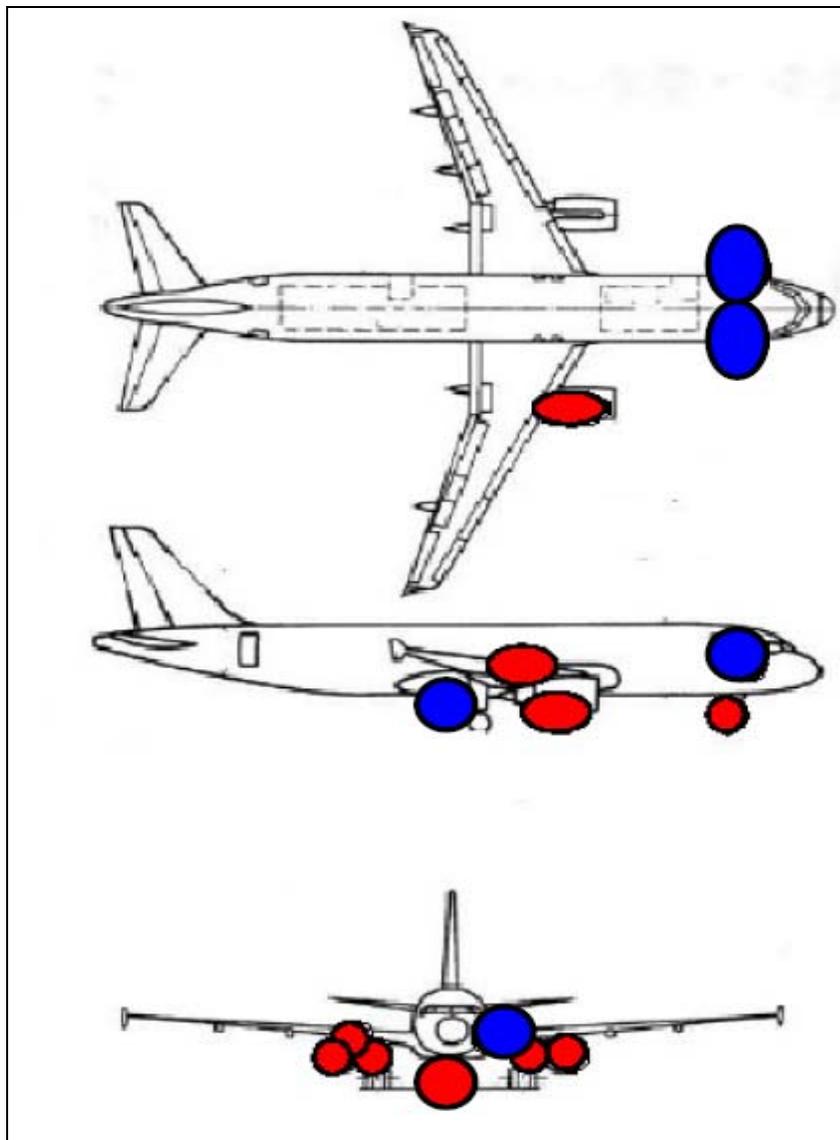
The damaged (red point) and contaminated area (blue point) of the aircraft are shown in Figure 1.12-1.

Figure 1.12-1 The damaged and contaminated area of the aircraft

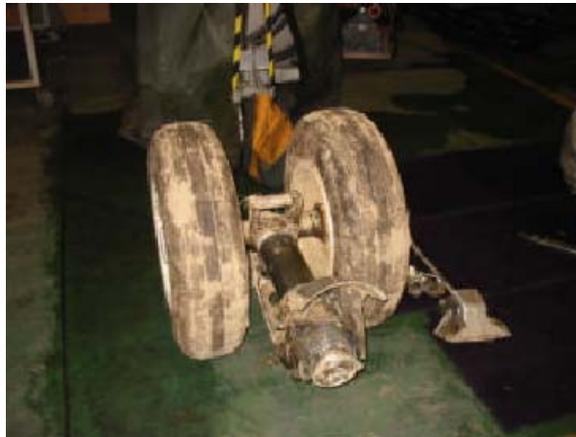
- No visual damage noted at the NLG attachment or to the bay structure.
- Sliding tube broken and associated harnesses destroyed (Figure 1.12-2,3) .
- NLG Aft door (LH and RH) damaged during recovery (Figure 1.12-4) .

Figure 1.12-2NLG Sliding tube broken and associated harnesses destroyed

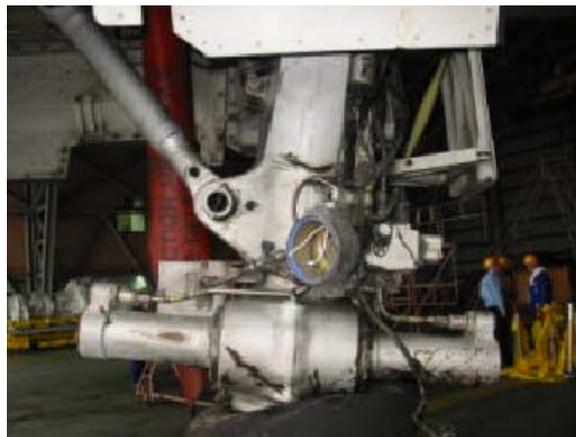
Figure 1.12-3NLG without broken sliding tube

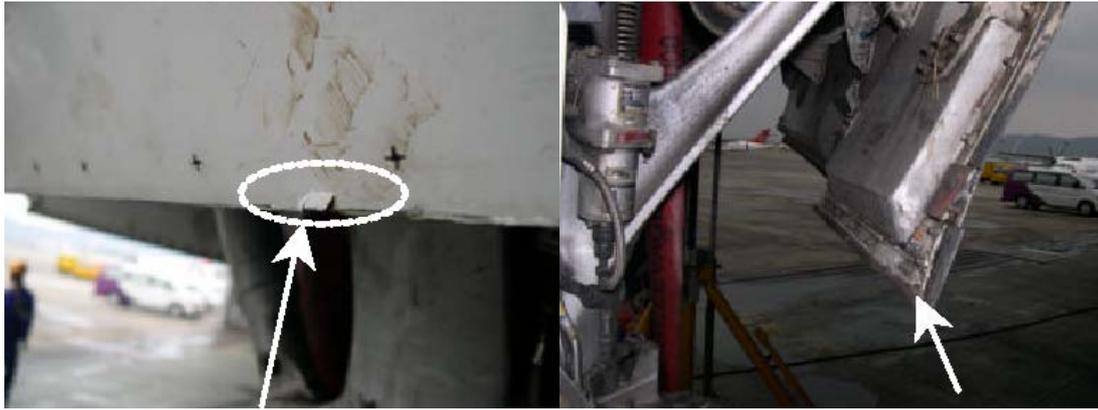
Figure 1.12-4 Deformation and dent to NLG Aft doors

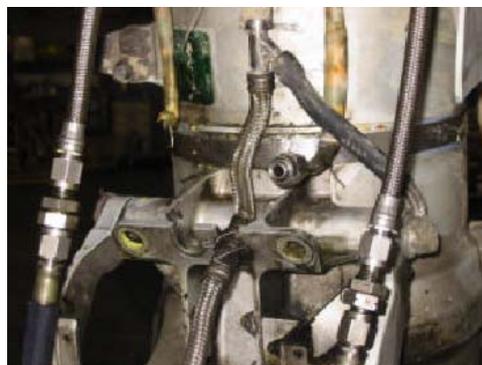
- No visual damage noted at the MLG attachments or to the bay structure.
- Damage noted to LH tire due to contact with runway object.
- LH and RH MLG experienced damage to the electrical and hydraulic systems on the casing during recovery. Compression of the systems against casing has scratches to the surface of both assemblies (Figure 1.12-5, 6)
- LH MLG door minor seal detachment noted. Not considered occurrence related.

Figure 1.12-5 LH MLG electrical and hydraulic systems damage

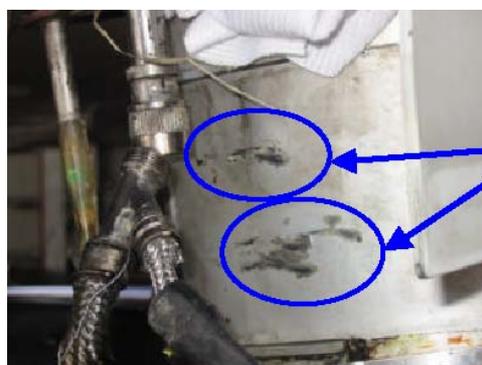
Figure 1.12-6 LH MLG Scratches – max depth 0.5mm

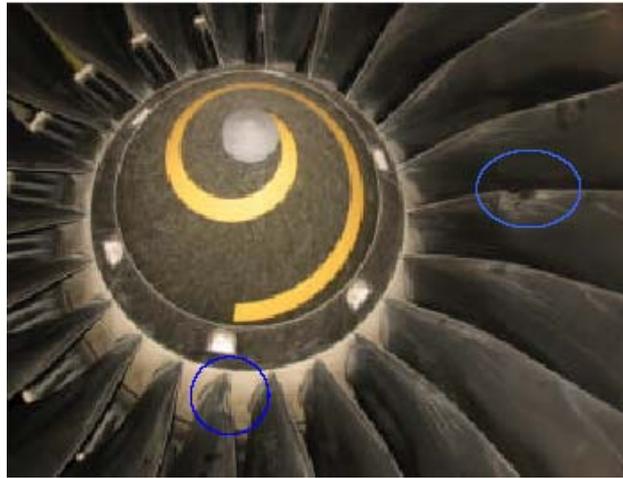
- Three fan blades and cone damage (Figure 1.12-7, 8) ;
- 5 damage locations noted on the LH Nose cowl (four on the inner surface and one external) (Figure 1.12-9, 10) .

Figure 1.12-7 Fan damage

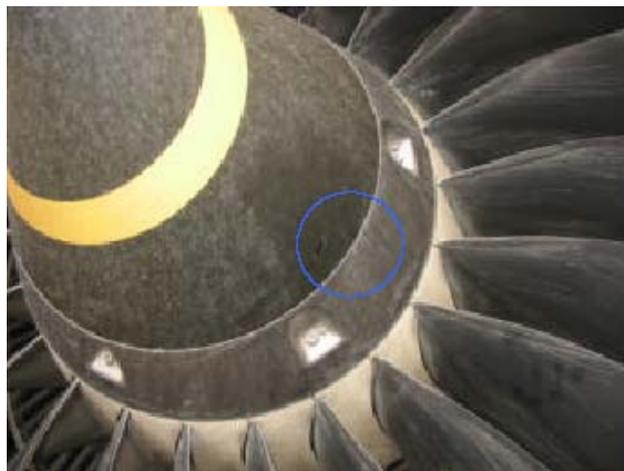
Figure 1.12-8 Cone scratch

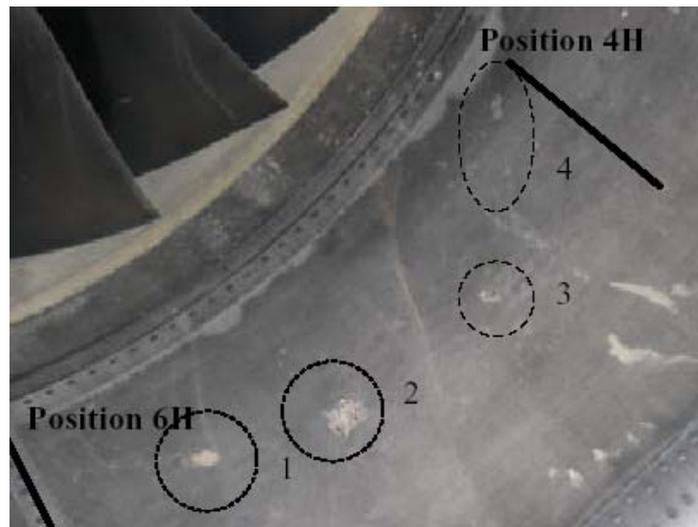
Figure 1.12-9 Inner Surface damage

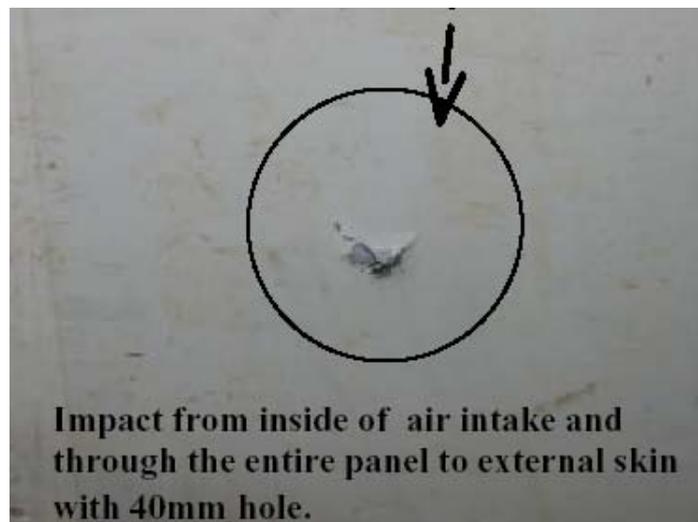
Figure 1.12-10 External Damage

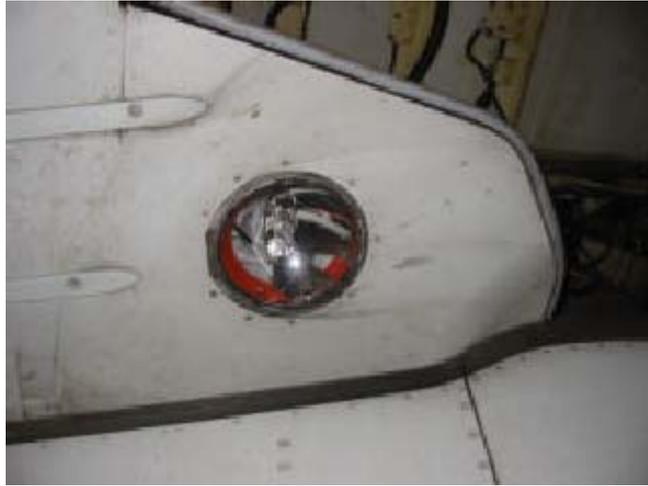
- Landing light damaged (Figure 1.12-11)

Figure 1.12-11 Landing light damaged

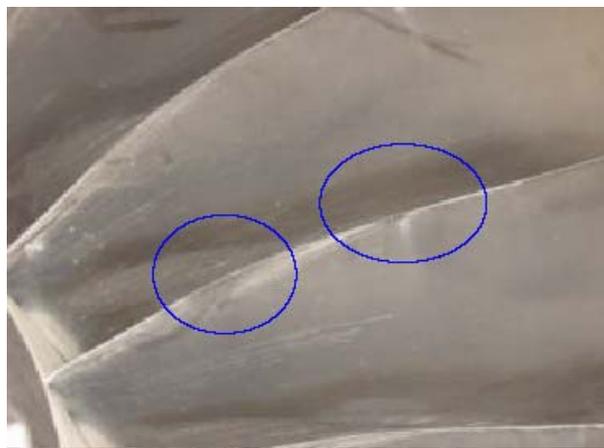
- Two fan blades noted damaged (Figure 1.12-12) .
- Piping bent, lower drain missing (Figure 1.12-13) .
- Lateral cooler damaged (Figure 1.12-14) .
- Extensive damage noted on the nose cowl, fan cowl and thrust reverser (Figure 1.12-15) .

Figure 1.12-12 Fan damage

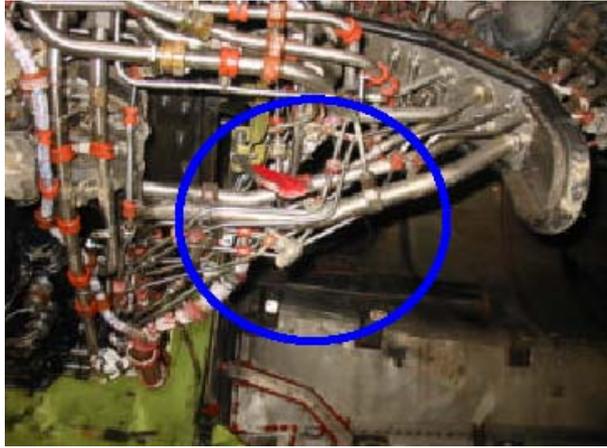
Figure 1.12-13 Bent Pipes, lower drain missing

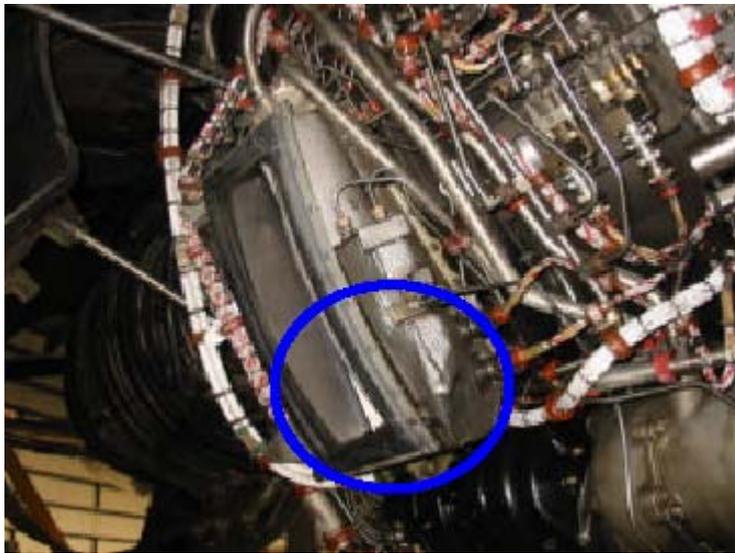
Figure 1.12-14 Lateral cooler damaged

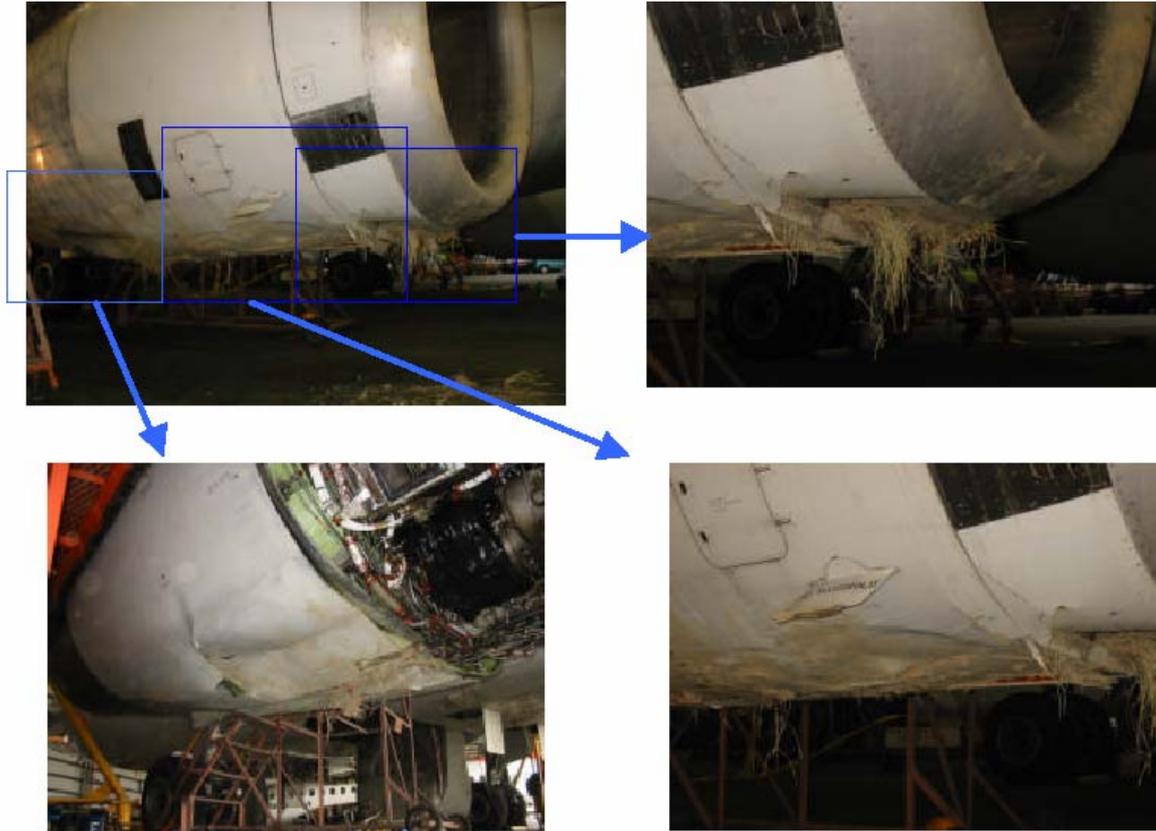
Figure 1.12-15 Nacelle Overview

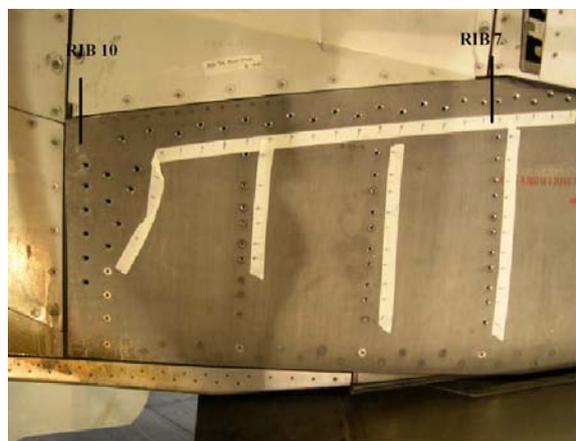
- No visible damage to the attachment points.
- Lateral panel deformation and fastener pulling (Figure 1.12-16) .
- Upper panel deformation/ fastener pulling (Figure 1.12-17~20)
- Closing panel and fairing damage (Figure 1.12-21) .
- Cantilever deformation (Figure 1.12-22)

Figure 1.12-16 Lateral Panel Pulled fasteners

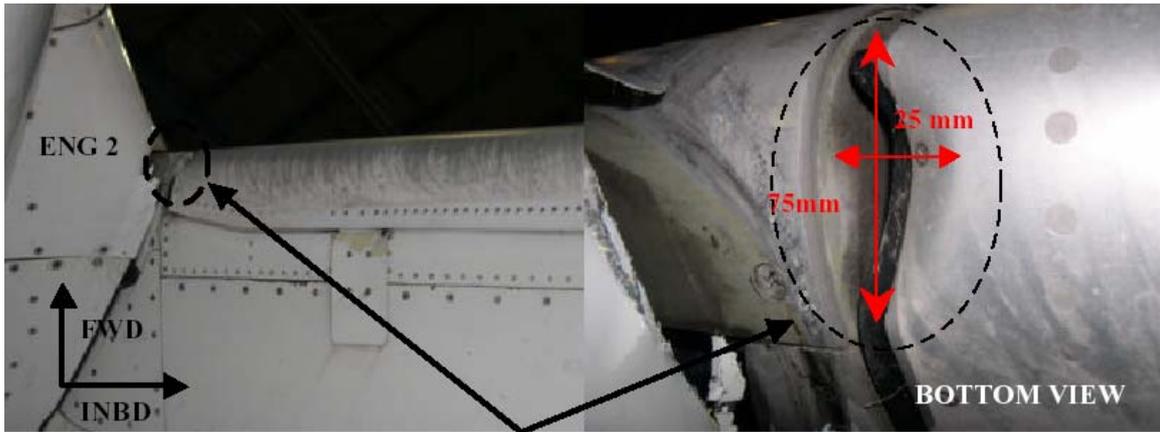
- Damage noted to No. 1 Slat near pylon, leading edge lower skin exhibited a 25mm x75mm dent(Figure 1.12-23), leading edge upper skin exhibited a 25mm x90mm dent (Figure 1.12-24) .

Figure 1.12-23 leading edge lower skin exhibited a 25mm x75mm dent

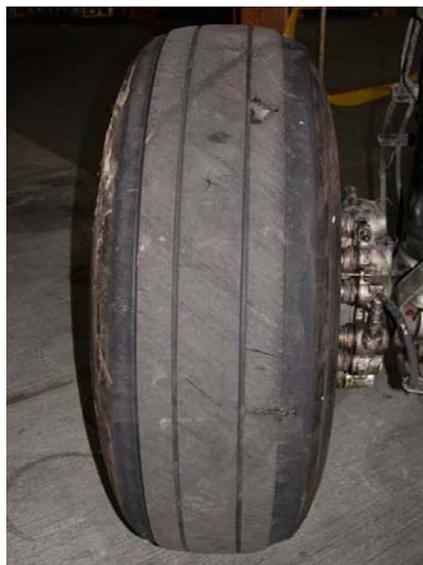
All four tires had deep cut damage (depth up to tread reinforcing ply) and diagonal scratch marks, as shown in Figure 1.16-1. There is no tread rubber reversion present.

Figure 1.16-1 Deep cut damage and diagonal scratch marks
