Runway overrun, Trans World Airlines, Inc., B-707, N742TW, The Greater Cincinnati Airport, Erlanger, Kentucky, November 6, 1967

AIRCRAFT ACCIDENT REPORT

B-707, N742TW

THE GREATER CINCINNATI AIRPORT

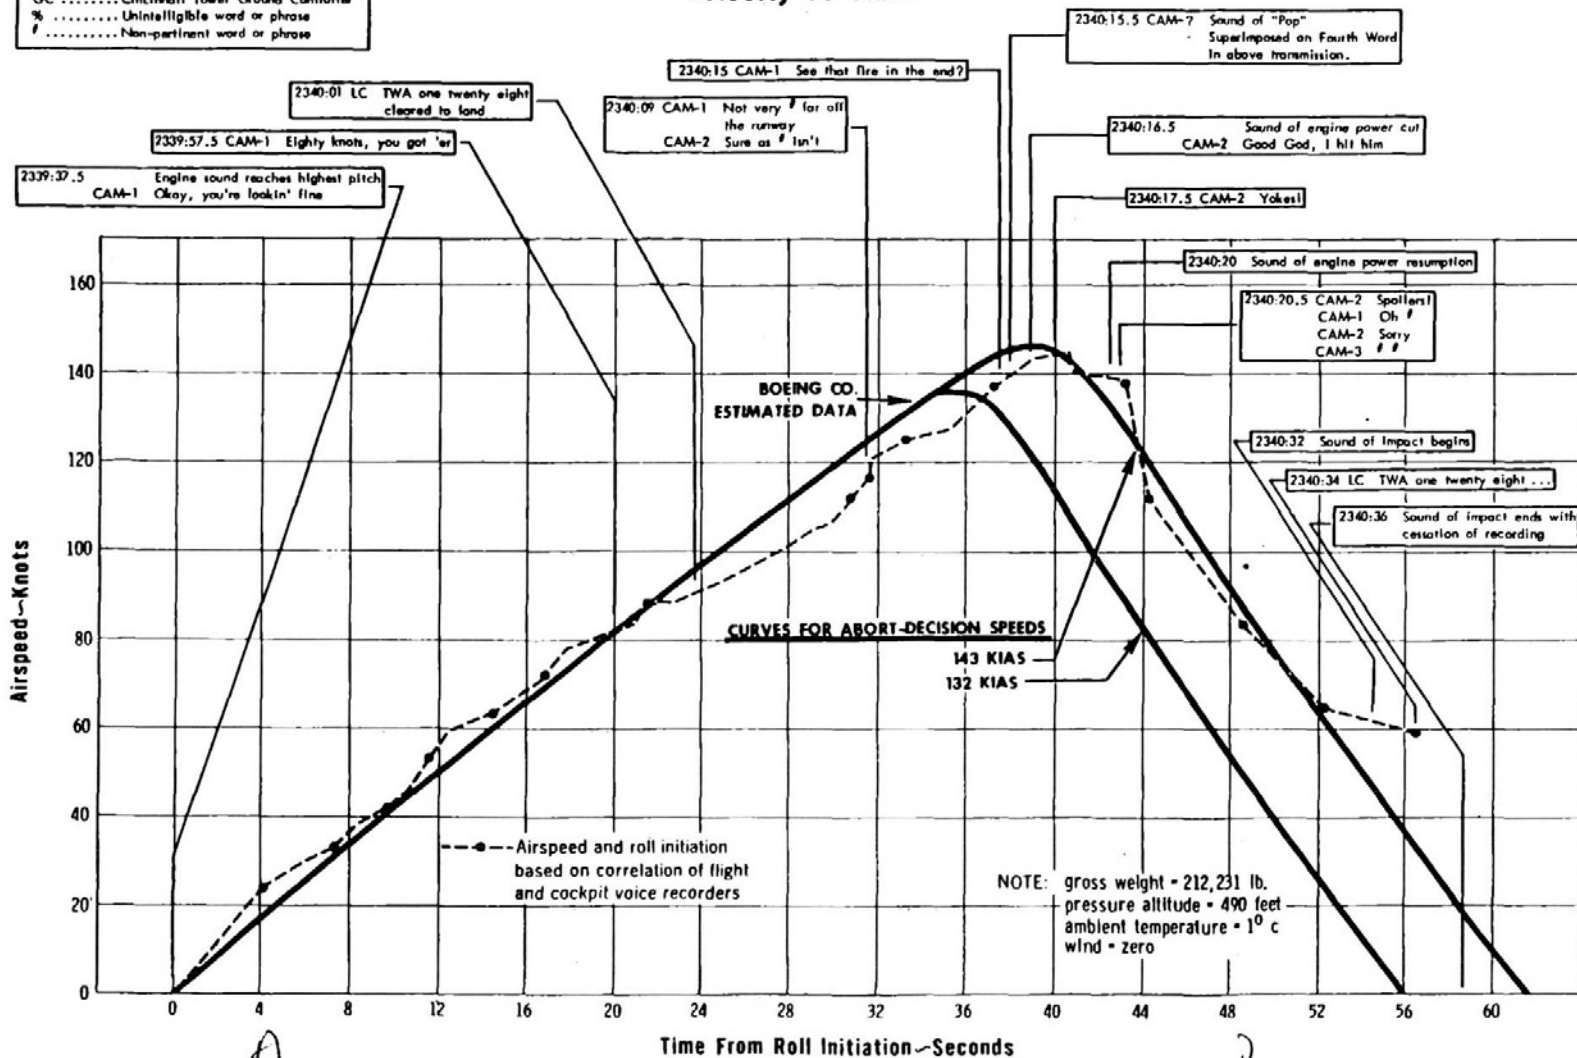
Velocity vs Time

Since the flight recorder medium does not reflect the takeoff roll initiation point, the record was presented on a graph with a time scale of 70 seconds which included a period of time preceding the takeoff through that point where the traces became aberrant. The airspeed trace began increasing at a relatively uniform rate from approximately 10 to 15 knots at 21 seconds, to a maximum of 145 knots at 61 seconds. At this point, the airspeed decayed to 140 knots in 1 second, to 111 knots in the next 2 seconds, and finally decreased to 59 knots where it became aberrant at 70 seconds. The heading of approximately 270° was relatively constant until 61 seconds at which point it shifted momentarily to 265° and then returned to 270° at 64 seconds. The vertical acceleration trace also remained fairly constant until 66 seconds at which point accelerative forces were recorded ranging between ± 0.3 g and ± 2.2 g. The altitude trace varied between a low of 790 feet just prior to the maximum airspeed and a high of 930 feet which was recorded during the period of peak vertical acceleration forces.
