**Runway excursion, United Air Lines, Inc., Boeing 727 QC, N7425U,
Chicago O'Hare International Airport, Illinois, March 21, 1968**

AIRCRAFT ACCIDENT REPORT

UNITED AIR LINES, INC.
BOEING 727 QC, N7425U
CHICAGO O'HARE INTERNATIONAL
AIRPORT, ILLINOIS
MARCH 21, 1968

NATIONAL TRANSPORTATION SAFETY BOARD
DEPARTMENT OF TRANSPORTATION
WASHINGTON D.C. 20591

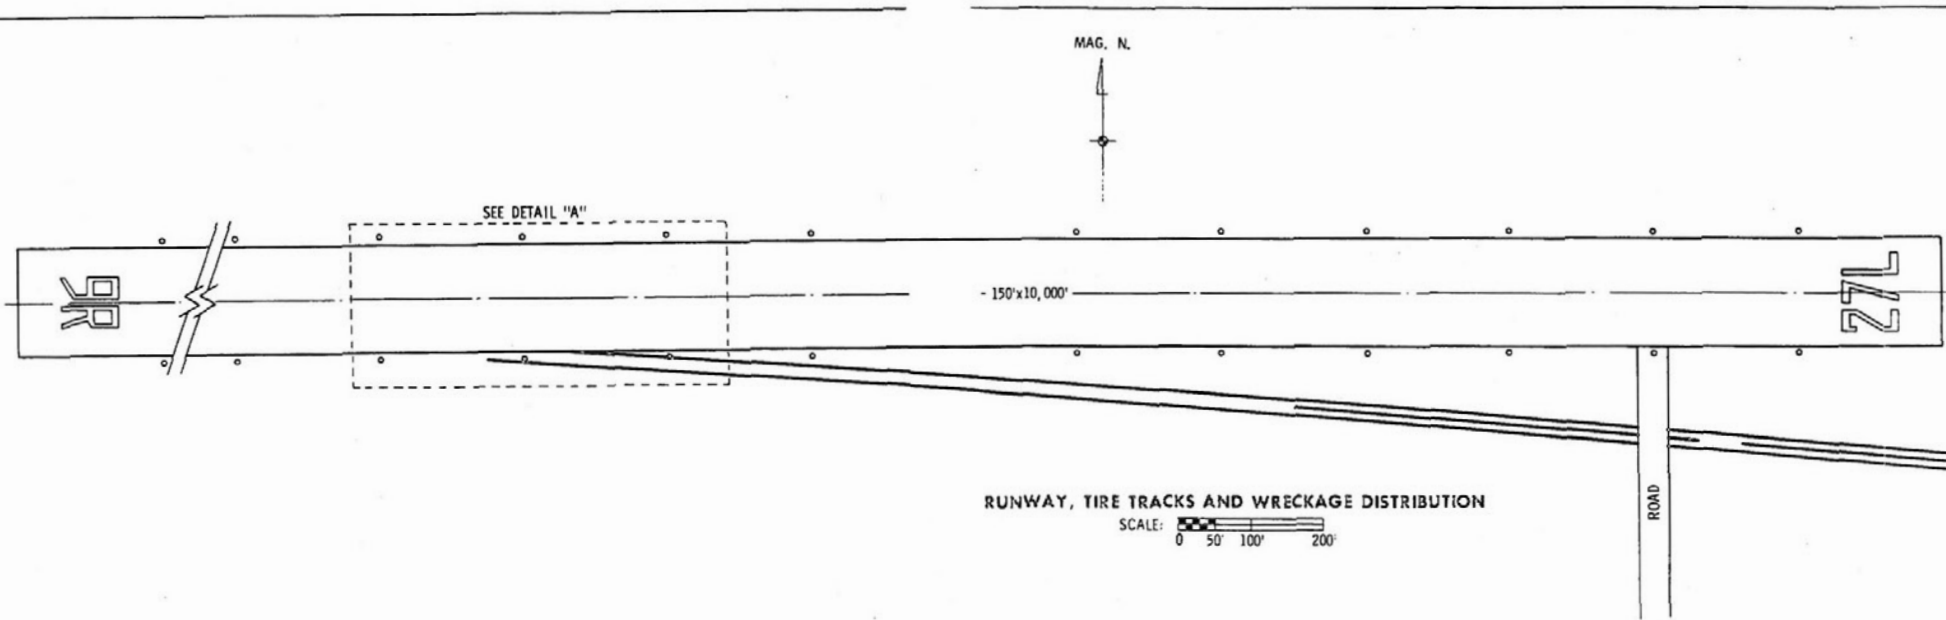
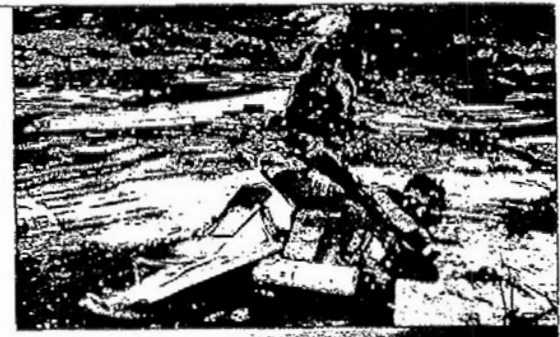
RUNWAY, TIRE TRACKS AND WRECKAGE DISTRIBUTION
SCALE: 0 50' 100' 200'

During an examination of Runway 9R, an impression was found in the flexible (macadam) pavement of the right runway shoulder. The start of this impression was approximately 2,200 feet short of the east or far end of the runway. The impression was approximately 100 feet long and was angled approximately 4° to the right of the runway centerline. The measured width of the impression was approximately 5-7/8 inches, which closely corresponds to the measured width (5-3/4 inches) of a worndown area found on the drag link lower tip of the tail skid assembly. The lower skid was fractured on the left side, approximately 5 inches from the skid end, and the drag link lower tip had sustained a heavy, continuous scraping.

A second mark was found along side of the above described impression. This mark, best described as a scrape, started on the cement portion of the runway at a point just short of the 5-7/8-inch impression and continued off onto the flexible pavement. The No. 2 (center) engine thrust reverser fairing, which is located at the 6 o'clock position, was found scraped through. Material which was similar to the runway cement and the flexible pavement was found embedded within the scraped portion of the fairing.

The impact with the ditch, which is approximately 6 feet deep, sheared the landing gears and damaged the left wing and underside of the fuselage. After contacting the ditch, the aircraft skidded, shedding portions of the lower fuselage structure and belly cargo, the ventral stair, and portions of the right wing. Just before the
