Uncontained engine failure, American Airlines, Inc., Boeing 747-121, N743PA, San Francisco, California, September 18, 1970

AIRCRAFT INCIDENT REPORT

**AMERICAN AIRLINES, INC.,
BOEING 747-121, N743PA
SAN FRANCISCO, CALIFORNIA
SEPTEMBER 18, 1970**

REPORT NUMBER: NTSB-AAR-71-7

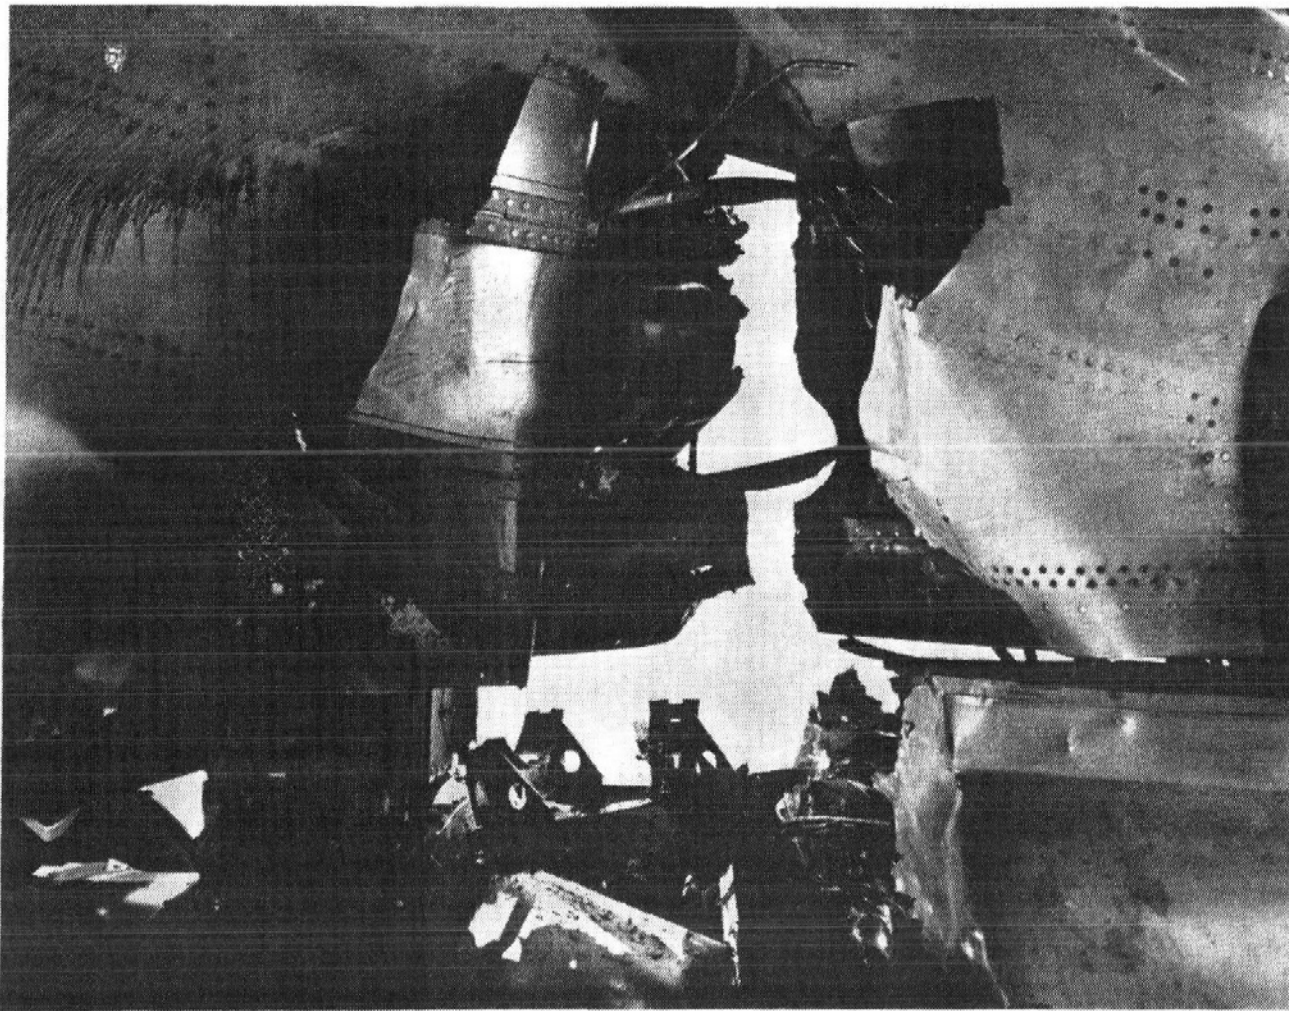
The most severe structural damage in the pylon was sustained between nacelle stations 197 and 208, (Photographs Nos. 1 and 2) which was directly in the plane of rotation of the second-stage turbine wheel. The lower spar (firewall), mid-spar outboard cap and web, and inboard stiffeners were severed. The pylon outboard skin was cut from nacelle water

line 136 to 186, while the inboard side skin was cut from nacelle water line 136 to 164. In this same area, the front spar chord lower flange was bent and the lower flange of the inboard stiffener was broken.

Photograph No. 1 Inboard side of No. 1 pylon - N743PA showing penetration damage between nacelle stations 196 and 208. (Note: Deflection of pneumatic duct and massive deformation of adjacent structure).

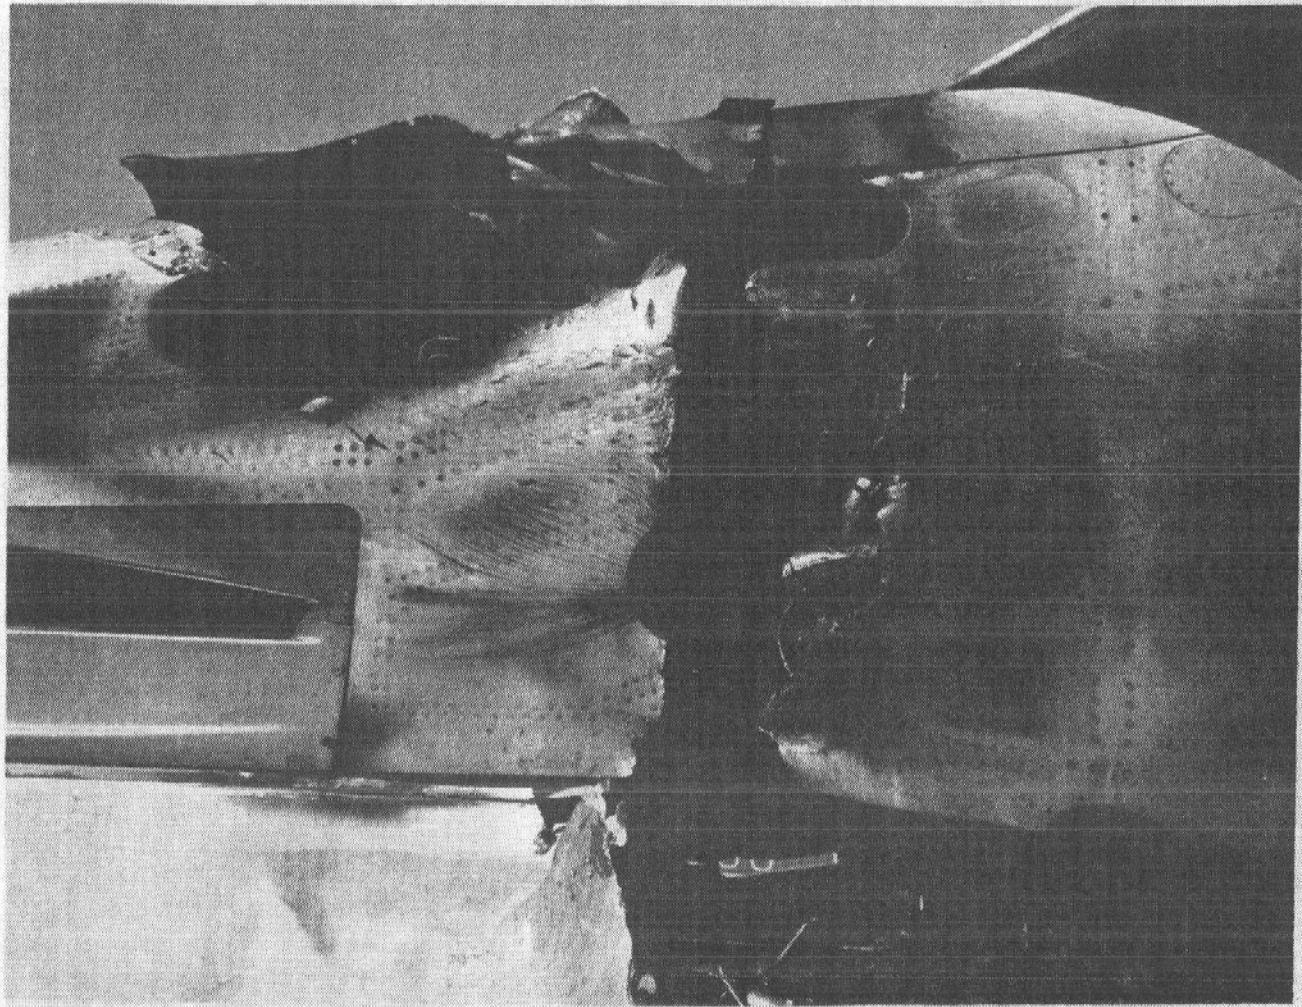
Photograph No. 2 Outboard side of No. 1 pylon, N743FA, showing penetration and fire damage between nacelle stations 196 and 208.

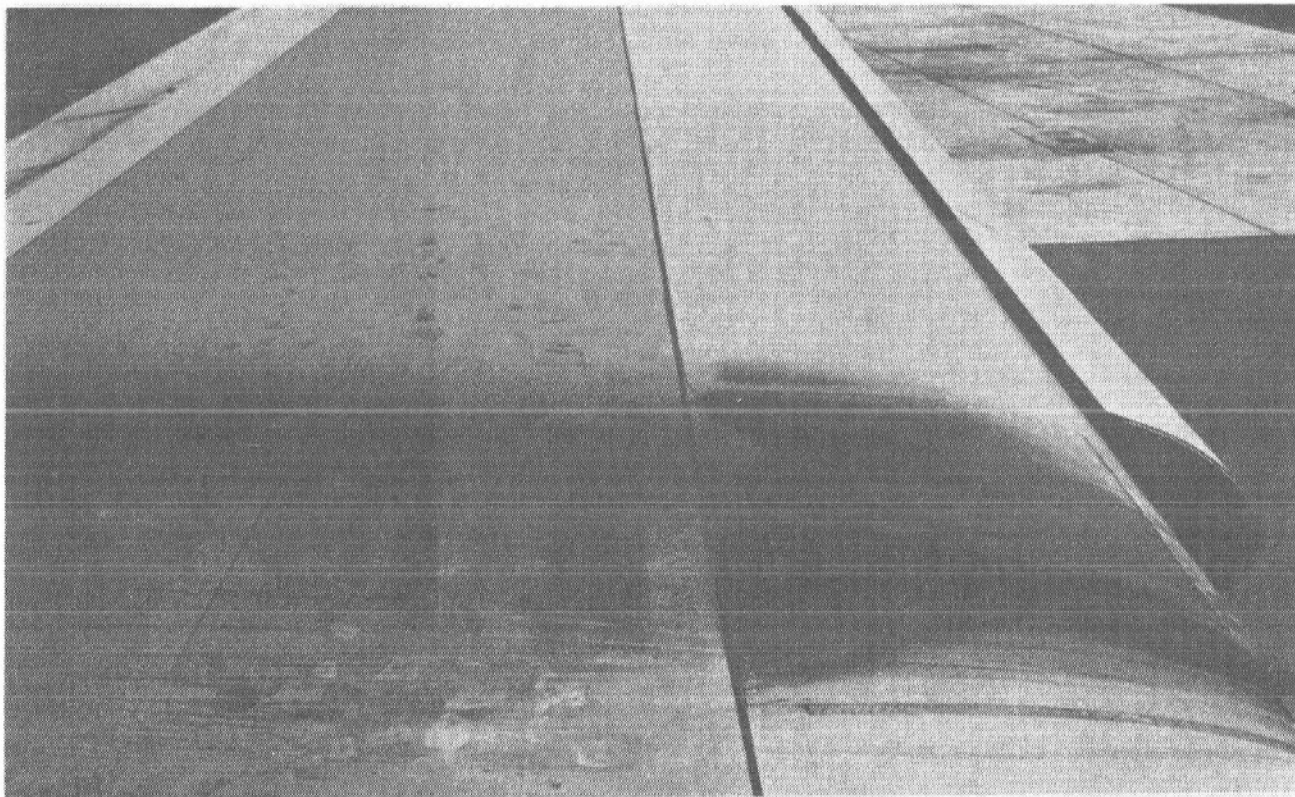
Varying degrees of fire (Photograph No. 3) and/or shrapnel damage were sustained by the left outboard flap, outboard aileron, No. 1 spoiler, flap track fairings, leading edge panels/fairings, wing leading edge support structure, and trailing edge panels.

Photograph No. 3 Forward area of top of left wing. Aft of No. 1 engine and pylon showing fire damage. (Note: Wrinkling of leading edge panel).

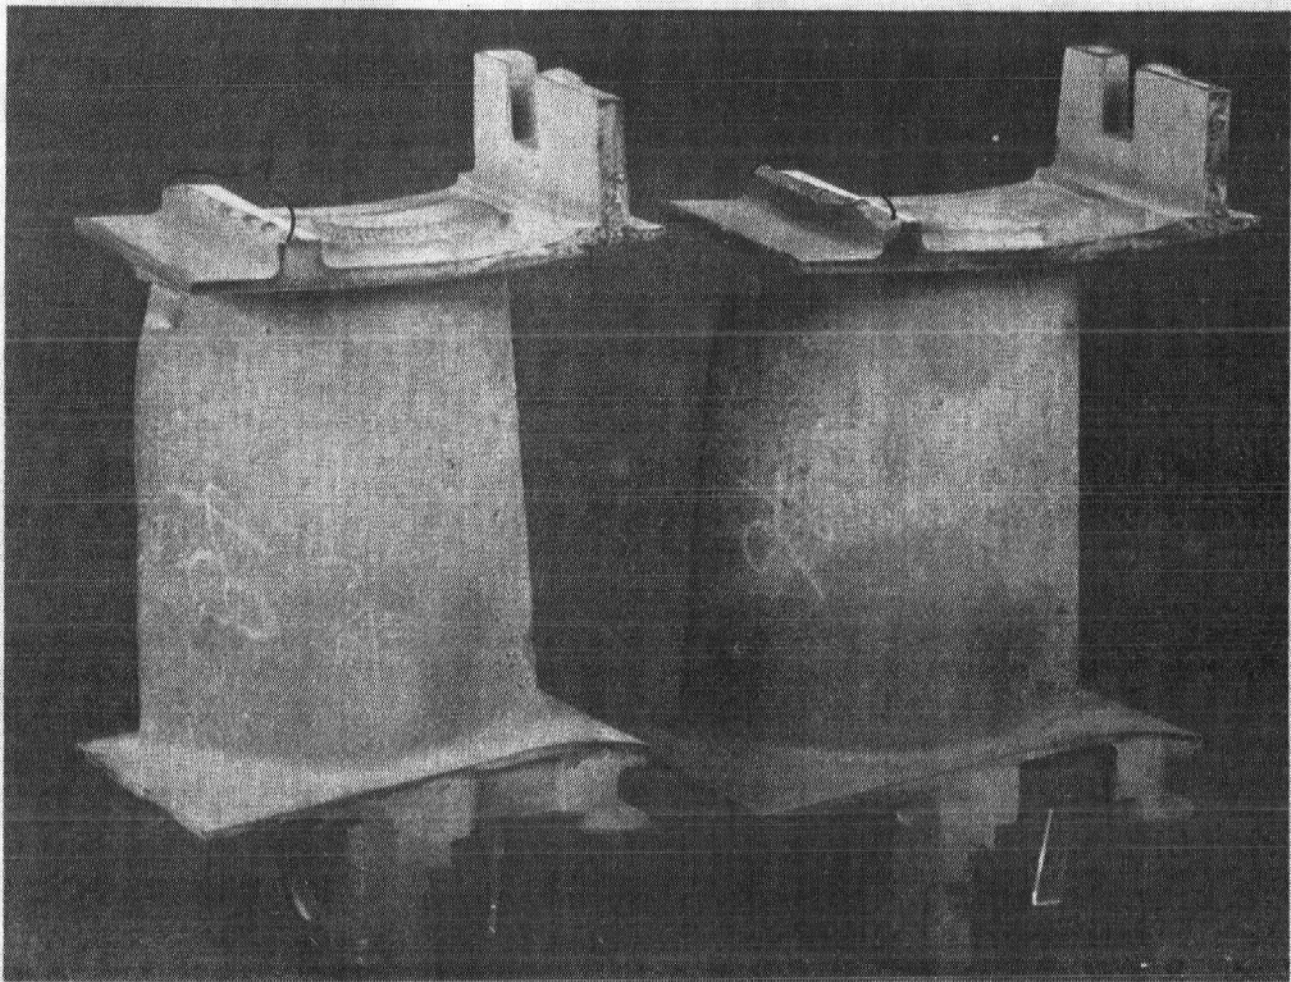
Thirty-two P/N 654352 second-stage turbine vanes had transverse fatigue fractures through the vane feet. The fractures, as well as cracks in other additional vanes, originated from the base of the front face of the vane feet near the convex side. Laboratory analyses disclosed that the mechanical and chemical properties of the vanes, as well as their dimensions, conformed to existing specifications.

Once the failure of one or more of the first-stage blades had taken place, severe and unusual vibratory loads were imposed upon the second-stage turbine vanes, inducing progressive fatigue failures of approximately 30 percent of the rear inner shroud feet of the vanes. The minimum thickness of the vane feet utilized in the No. 1 engine of N743PA was .083 inches. These were not designed to withstand the nearly 4.1 increase in vibratory loads which occurred when the initial failure of the first-stage blades occurred.

The fatigue failures of these inner shroud near vane feet allowed the second-stage turbine stator shroud assembly to shift rearward and rub against the front web surface of the second-stage turbine hub. This continued rubbing caused grooves to be worn into the disk portion of the front turbine hub. Finally, the front turbine hub fractured circumferentially in a rapid tensile manner at the grooved and weakened points, relating the entire rim portion of the disk.

Photograph No. 4 Second-stage turbine vane feet showing locations of vane foot fractures. (Note: Bracketed areas of vane feet at fracture surfaces).

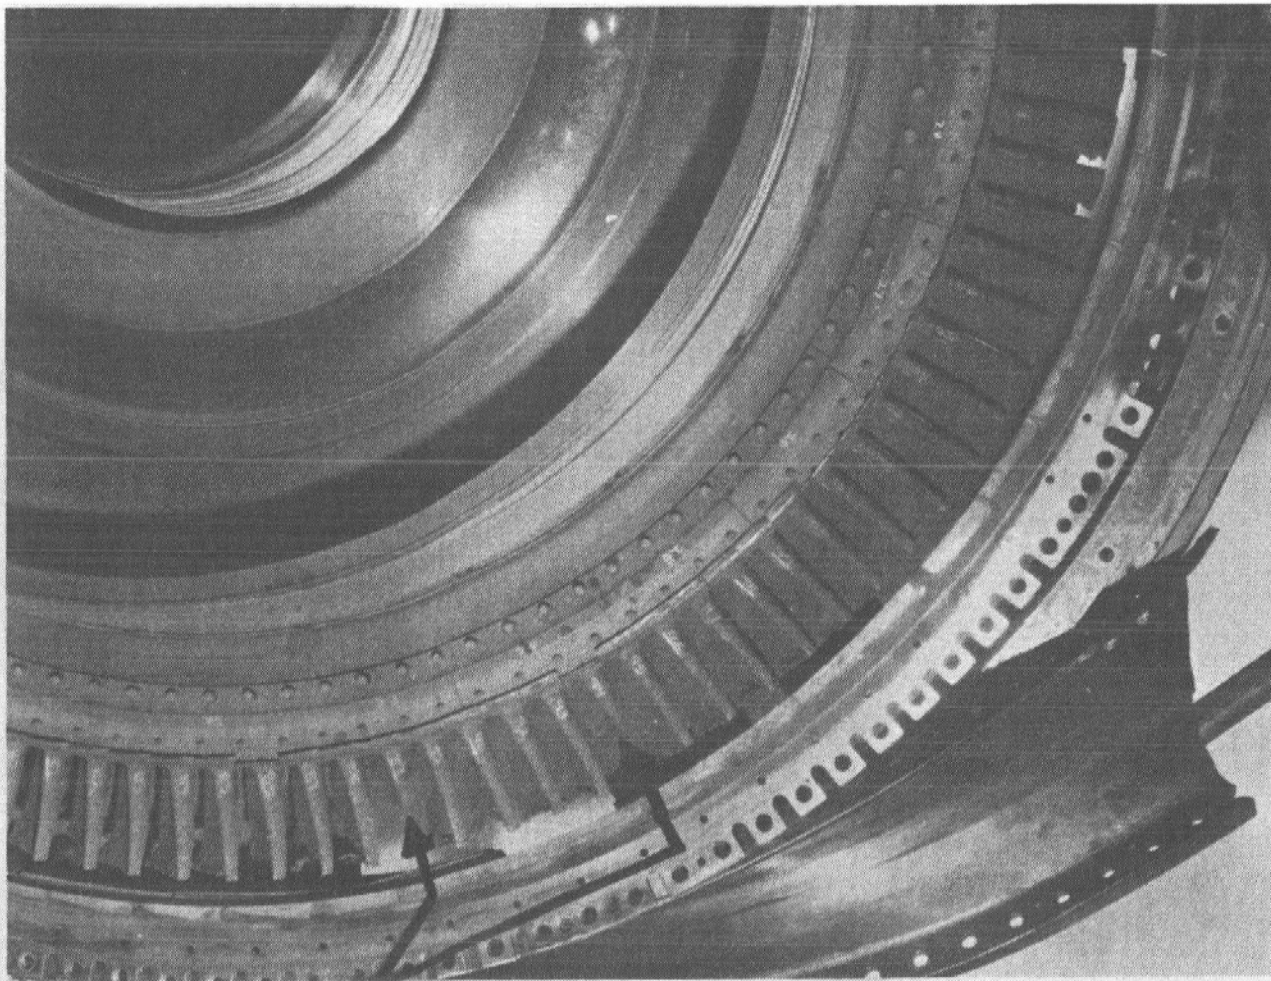
Detailed laboratory examination of seven P/N 674331 first-stage turbine blades disclosed transverse fractures through the airfoil sections approximately 1 inch above the blade root platforms. Thirty additional P/N 674331 first-stage blades exhibited cracks in the leading edges at locations similar to those found in the fractured blades (Photograph No. 5). The complete fractures, as well as the fractures seen through the cracks, exhibited oxide discolored dendritic surfaces. There was no evidence of fatigue. Spectrographic analysis of the turbine blade material disclosed that the material fully conformed to required specifications. None of the failed blades, nor 16 additional blades sectioned at random, showed any evidence of blocked cooling passages.

Metallographic examination of the fractured blades disclosed intergranular, oxidized fracture surfaces with associated alloy depletion. Evidence of sulfidation attack was also present along the fracture surfaces. This examination also provided evidence of metal temperatures of approximately 2,050° F. to 2,200° F. at the first-stage blade leading edges, and 2,000° F. to 2,050° F. at the blade trailing edges. Normal leading edge temperature of first-stage blades at takeoff thrust, operating on a standard 80° F. day, average 1,970° F. Under the same conditions, the maximum permissible temperatures at this point are between 2,025° F. and 2,050° F.

Photograph No. 5 Quadrant of first-stage turbine wheel No. 1 engine N743PA showing two of the fractured turbine blades. (See arrows at top of photo).

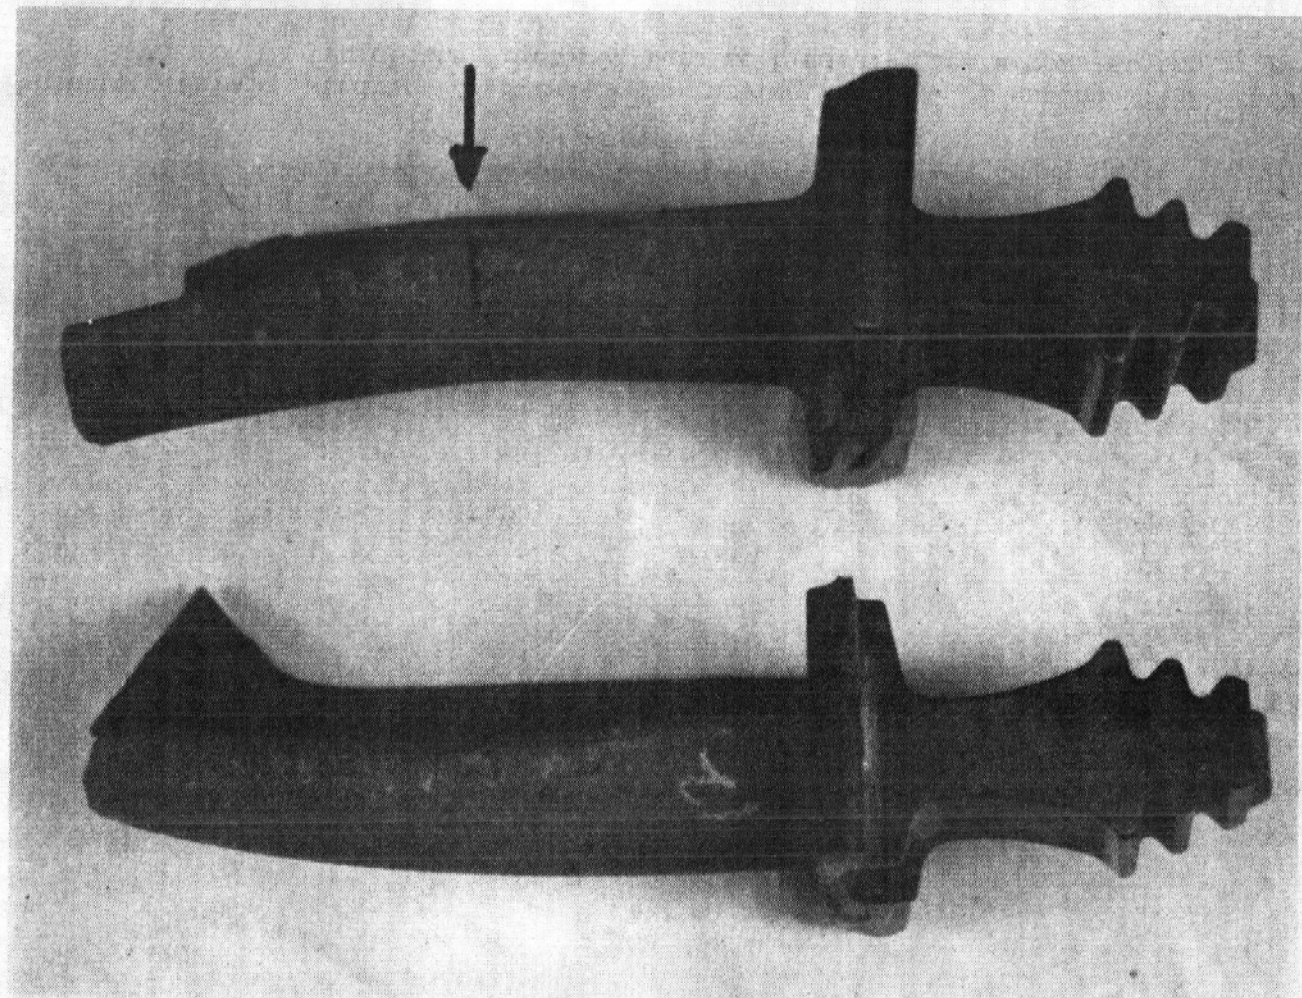
In the case of the JT9D-3 or -3A, which can operate at 43,500 or 45,000 pounds of thrust, respectively, the average metal temperature of the first-stage turbine blades is approximately 1,970° F. during takeoff thrust conditions. The solution heat treat temperature of these blades is 2,125° + 25° F. If for some reason the operating temperature of the blade closely approaches or exceeds this temperature, the blade's designed high-temperature strength and resistance to failure by stress rupture may be seriously impaired.

The laboratory analysis of the four failed first-stage blades disclosed relative depths of oxide scale and alloy depletion layers that suggest these blades had been fractured for some time prior to the turbine disk rupture. Fresh fracture surfaces of similar blades were statically exposed in air at various controlled temperatures to determine the time element required to attain certain alloy depletion depths. The results of these laboratory tests were conclusive in establishing that several hours of exposure to temperatures in excess of 2,050° F. were required to attain the degree of alloy depletion seen in four of the failed first-stage blades; however, engine overheating conditions of only a few seconds duration may be sufficient to alter significantly the alloy microstructure.

Photograph No. 6 Two first-stage turbine blades showing airfoil bending and stress rupture crack of one blade. Blade on top of photograph shows partial crack in the same general area where complete fractures occurred.
