Landed short, Southern Airways, Inc., DC-9, N97S, Tri-State Airport, Huntington, West Virginia, November 14, 1970

AIRCRAFT ACCIDENT REPORT

SOUTHERN AIRWAYS, INC. DC-9, N97S

REPORT NUMBER: NTSB-AAR-72-11

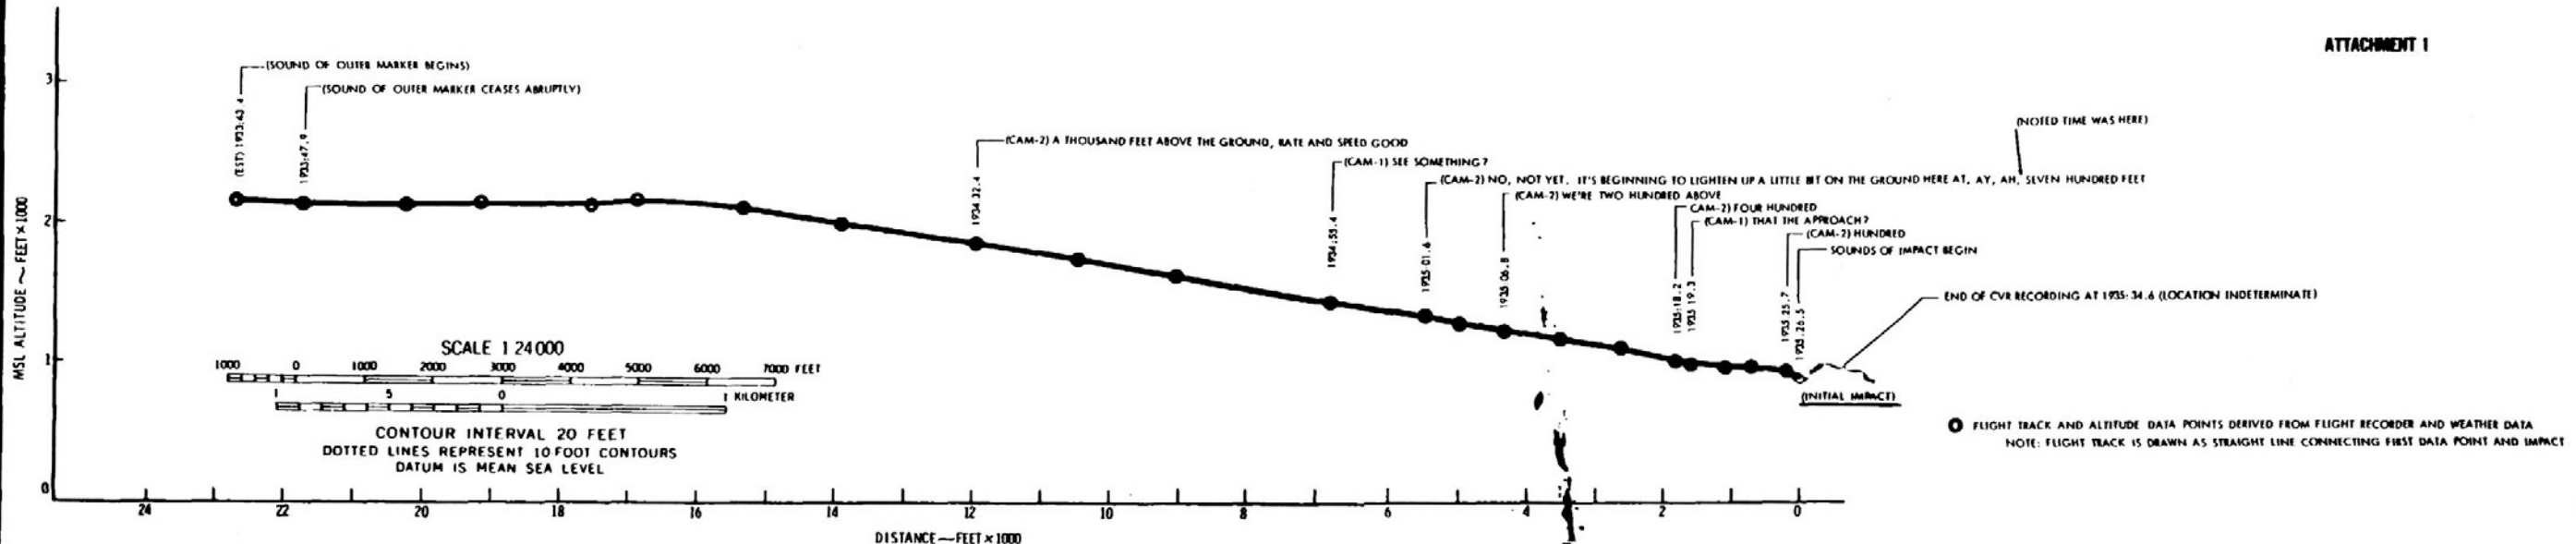
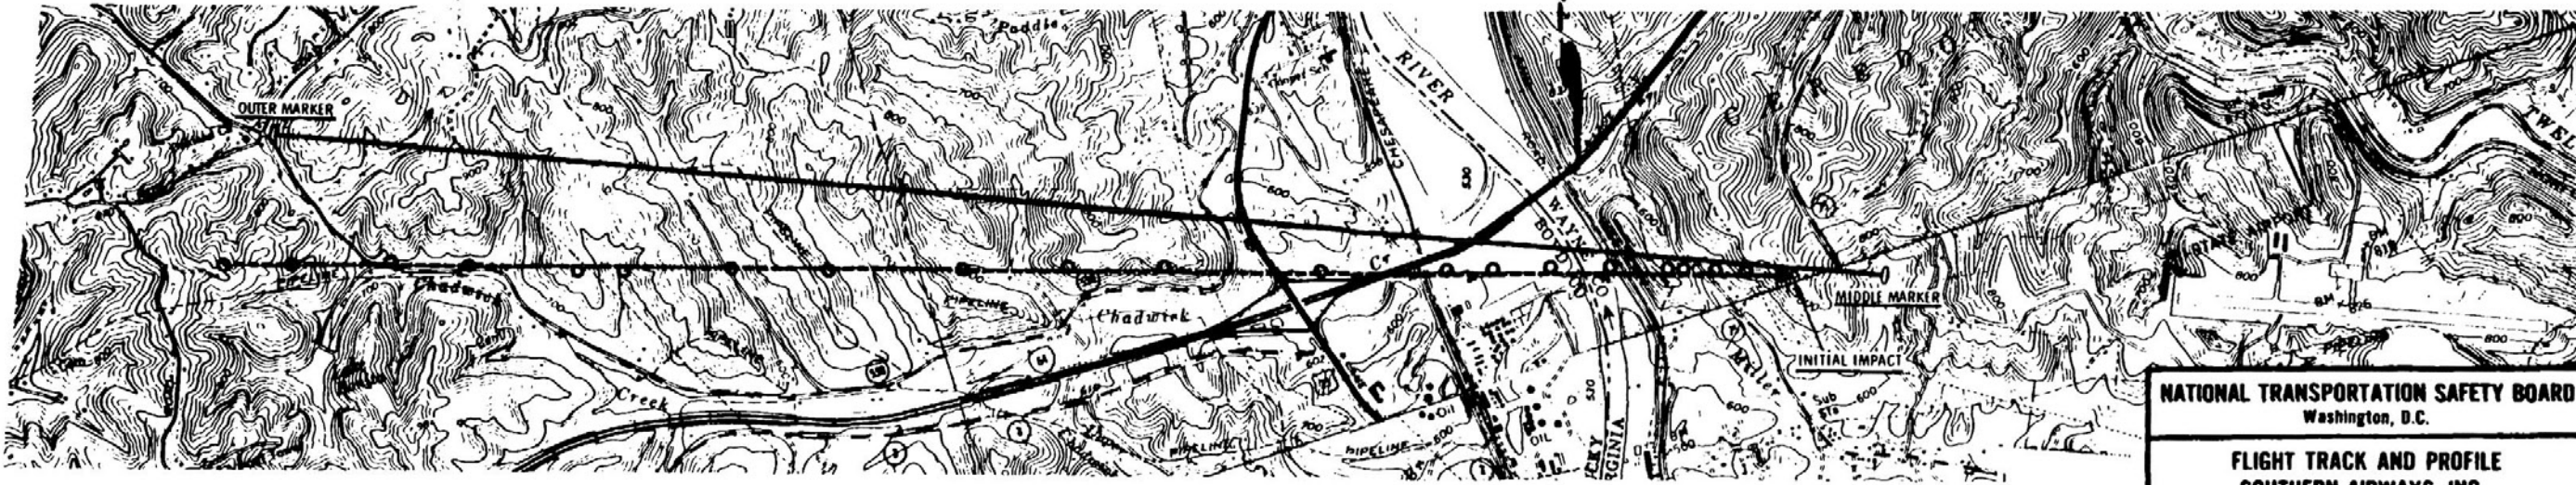
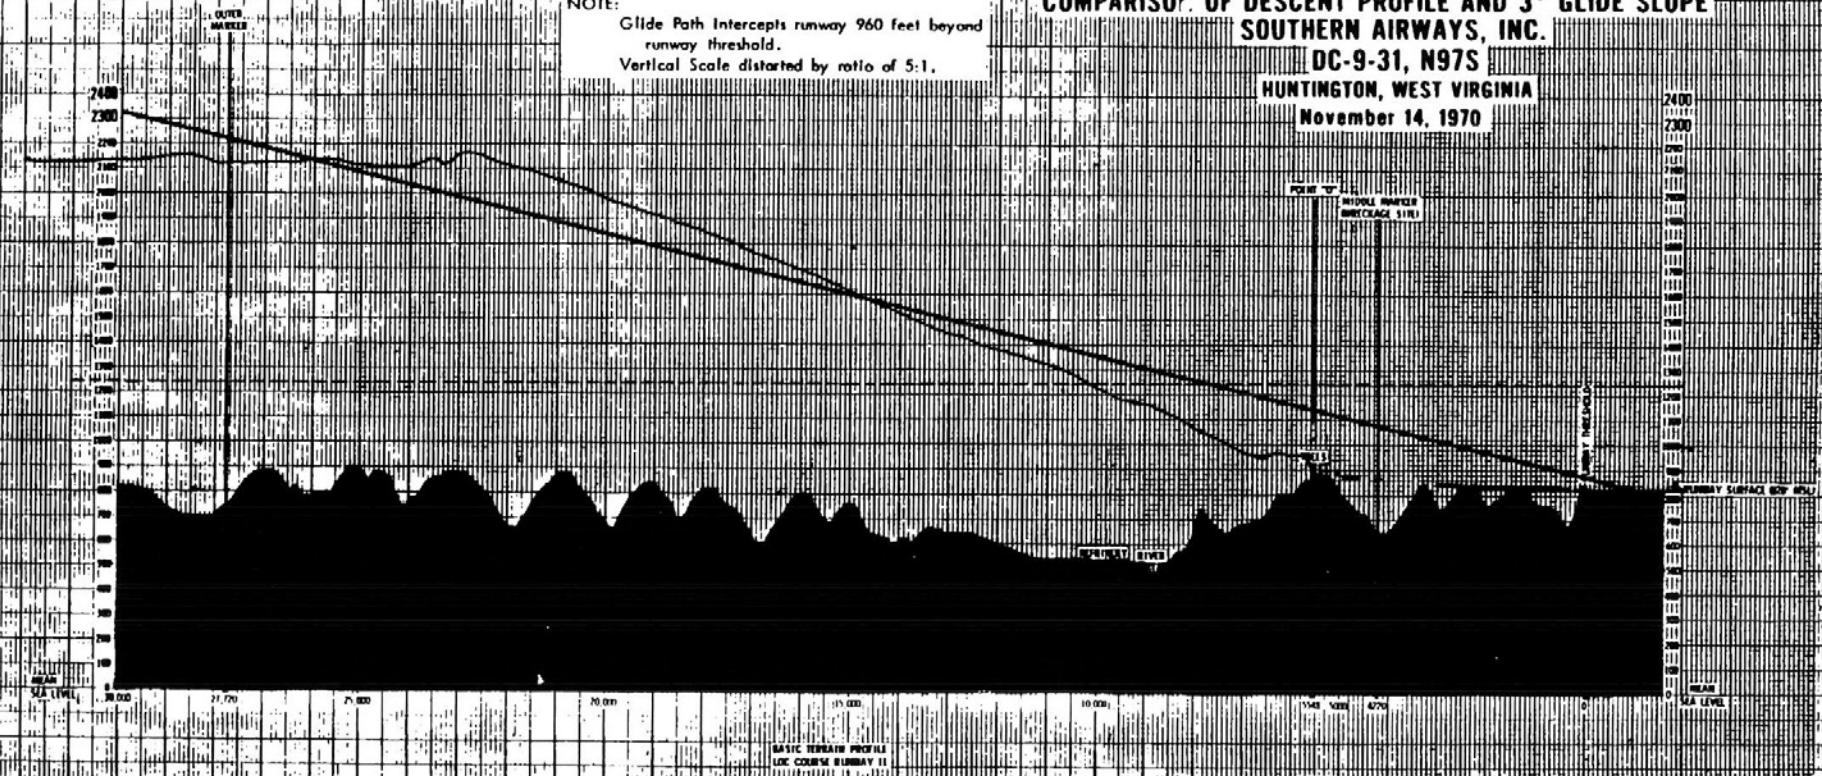
FLIGHT TRACK AND PROFILE
 SOUTHERN AIRWAYS, INC.
 DC-9-31, N97S
 HUNTINGTON, WEST VIRGINIA
 November 14, 1970

--- MINIMUM DESCENT ALTITUDE
— 3° GLIDE PATH
— DESCENT PROFILE
