Runway excursion, Trans Caribbean Airways , Inc., Boeing 727-200, N8790R, Harry S Truman Airport, Charlotte Amalie, St. Thomas, Virgin Islands, December 28, 1970

AIRCRAFT ACCIDENT REPORT

Boeing 727-200, N8790R

REPORT NUMBER: NTSB-AAR-72-8

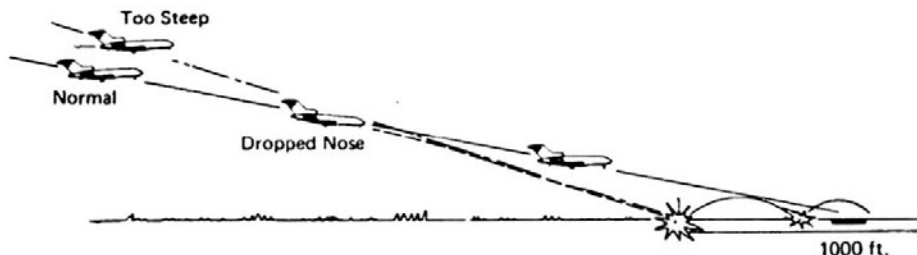
Figure 1. Bounce Landing

A normal approach aimed at the 1000 foot mark can result in a hard landing when the pilot unintentionally moves his eyes to the approach end of the runway as he nears the runway or "breaks out" on an instrument approach. Thus, the nose is dropped and the rate of descent increases--unnoticed--until too late. See Figure 1.

If a high hard bounce occurs, the thrust must be increased to control the rate of descent for the second touchdown, or to perform a go-around if excessive runway has been used.

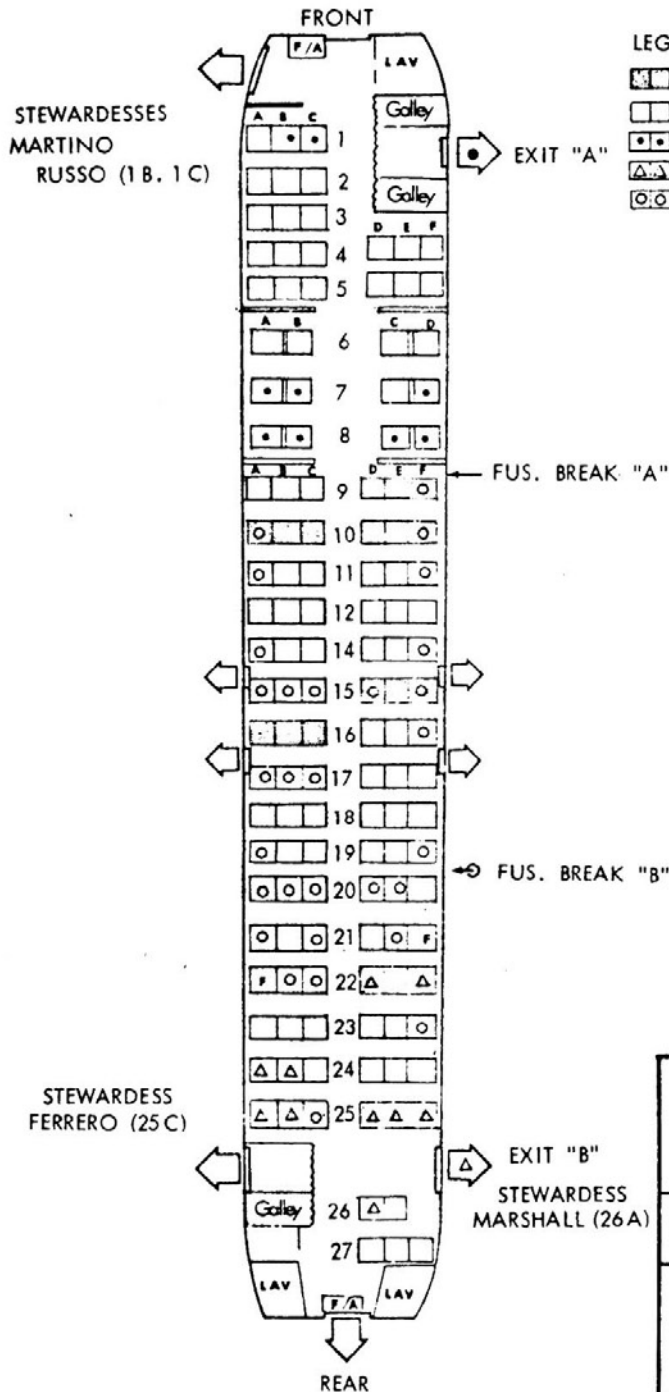
There were eight known passenger seat failures in the aircraft. However, the frame of only one seat unit was found, the others having been consumed by the fire. The seat frame, which was that of a right-hand triple unit, was found near the break at FS 940. All of the legs of the seat were fractured, and the entire seat showed a lateral deformation to the left.
