**Runway excursion, World Airways, Inc., Flight 30H, McDonnell Douglas DC-10-30 CF, N113WA, Boston-Logan International Airport, Boston, Massachusetts, January 23, 1982**

WORLD AIRWAYS, INC., FLIGHT 30H  
McDONNELL DOUGLAS DC-10-30CF, N113W  
BOSTON-LOGAN INTERNATIONAL AIRPORT  
BOSTON, MASSACHUSETTS  
JANUARY 23, 1982

NTSB/AAR-85/06  
(SUPERSEDES - - NTSB-AAR-82-15)

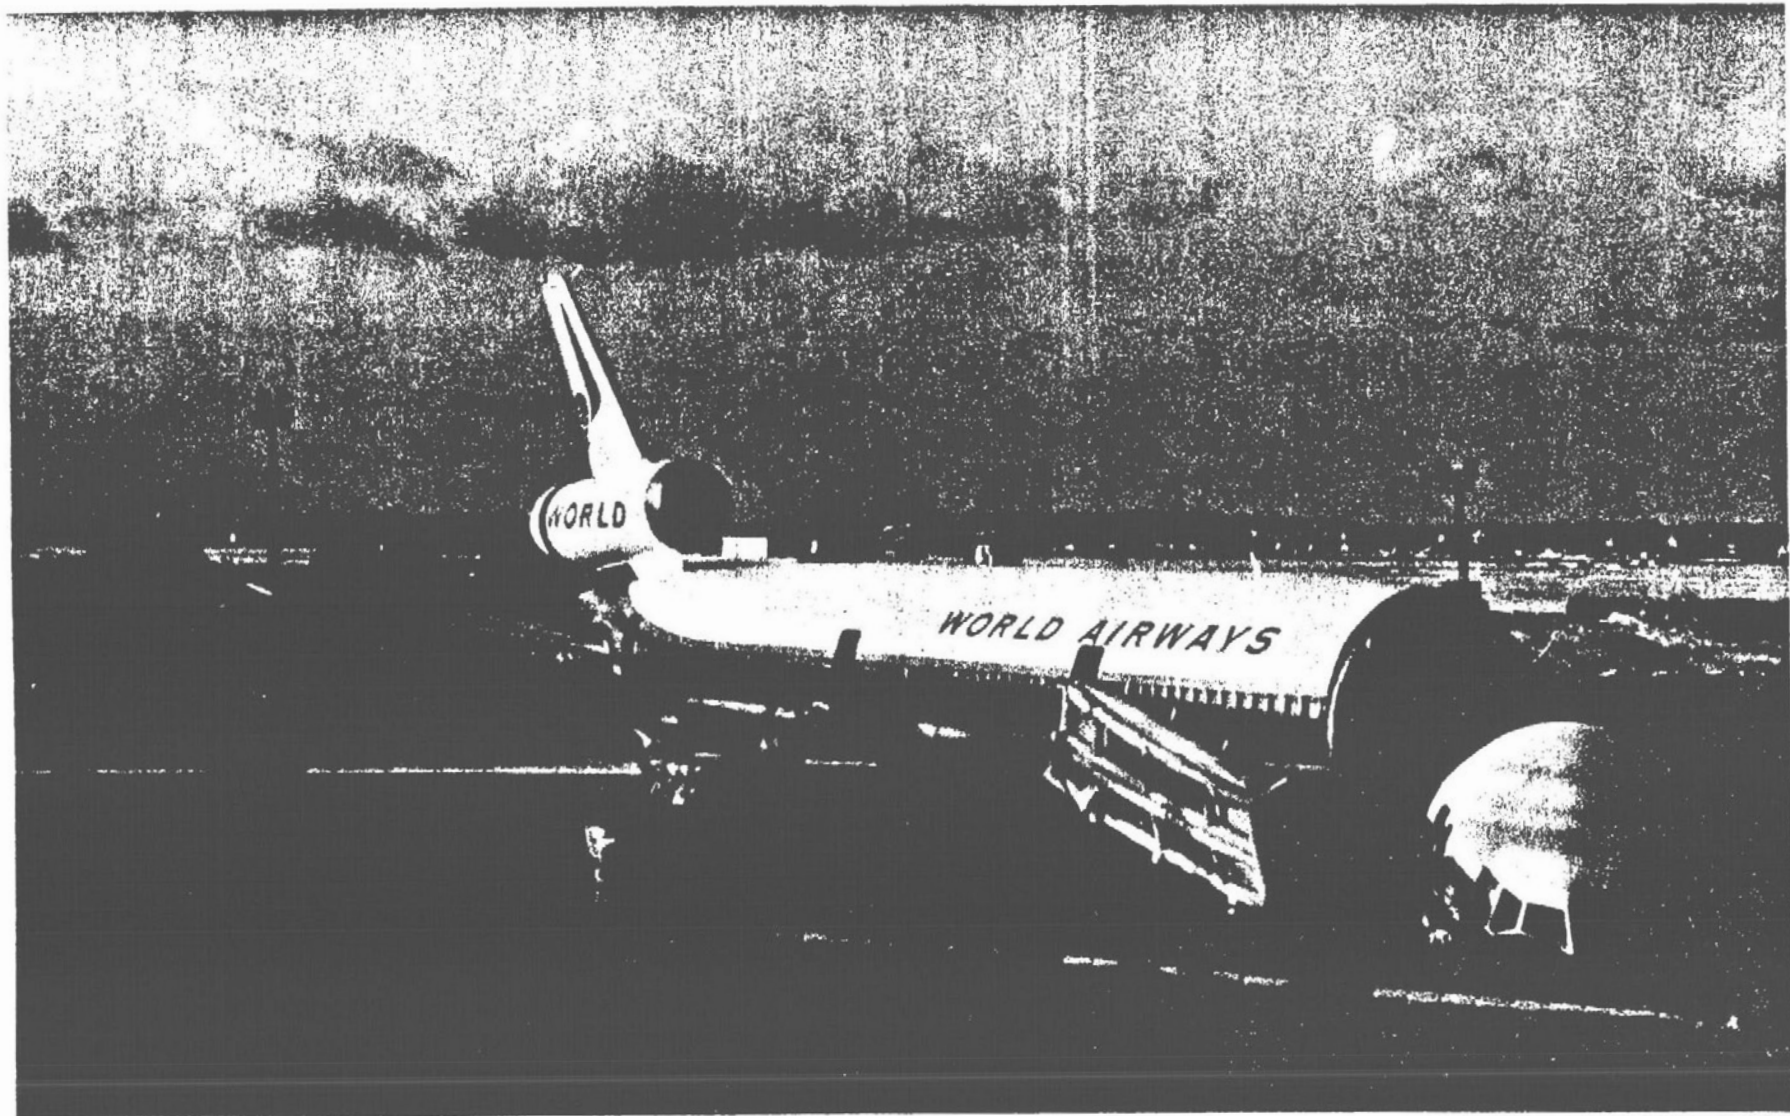
Figure 1.--Flight 30H as it rested in Boston Harbor.

The airplane came to rest immersed in water up to the wings at high tide and in a slightly nosedown attitude. The nose section, which included the cockpit area and first row of main cabin passenger seats, separated from the fuselage along a fracture line from fuselage station (FS) 370 to 475. The nose section remained attached to the main fuselage structure by control cables and electrical wire bundles. The pressure bulkhead at FS 275 had been crushed aft at the fuselage bottom centerline. The main cabin floor beams from FS 392 to FS 475 failed with a progressively downward displacement of each floor beam. The aft edge of this floor section was hanging down at a 45° angle. The cabin seat tracks in this area had fractured into short sections. The fractures were clean and bright, with the fractured surfaces about 45° to the local surface. There was no evidence of compression buckling or previous cracking. The first row of passenger seats, which consisted of a left side module of three seats, a center seat module of two seats, and a right module of three seats, had separated from the floor structure as the result of the seat track fragmentation. The three seat modules were installed in the immediate area of the nose-section/main-fuselage separation. The pressure bulkhead at the forward end of the nose wheel landing gear well had been crushed inward and aft. The shear web on the fore and aft nose landing gear support beams contained a 2-foot vertical fracture at the nose gear drag link support fittings. The fuselage attach fittings for the nose gear drag braces were torn from the fore and aft nose gear support beams, and the gear had folded aft while pivoting about the strut trunnion axis.
