Runway excursion, USAir Inc., Flight 183, McDonnell Douglas DC9-31, N964VJ, Detroit Metropolitan Airport, Detroit, Michigan, June 13, 1984

AIRCRAFT ACCIDENT REPORT

**US AIR, INC., FLIGHT 183
McDONNELL DOUGLAS DC9-31, N964VJ
DETROIT METROPOLITAN AIRPORT
DETROIT, MICHIGAN
JUNE 13, 1984**

NTSB/AAR-85/01

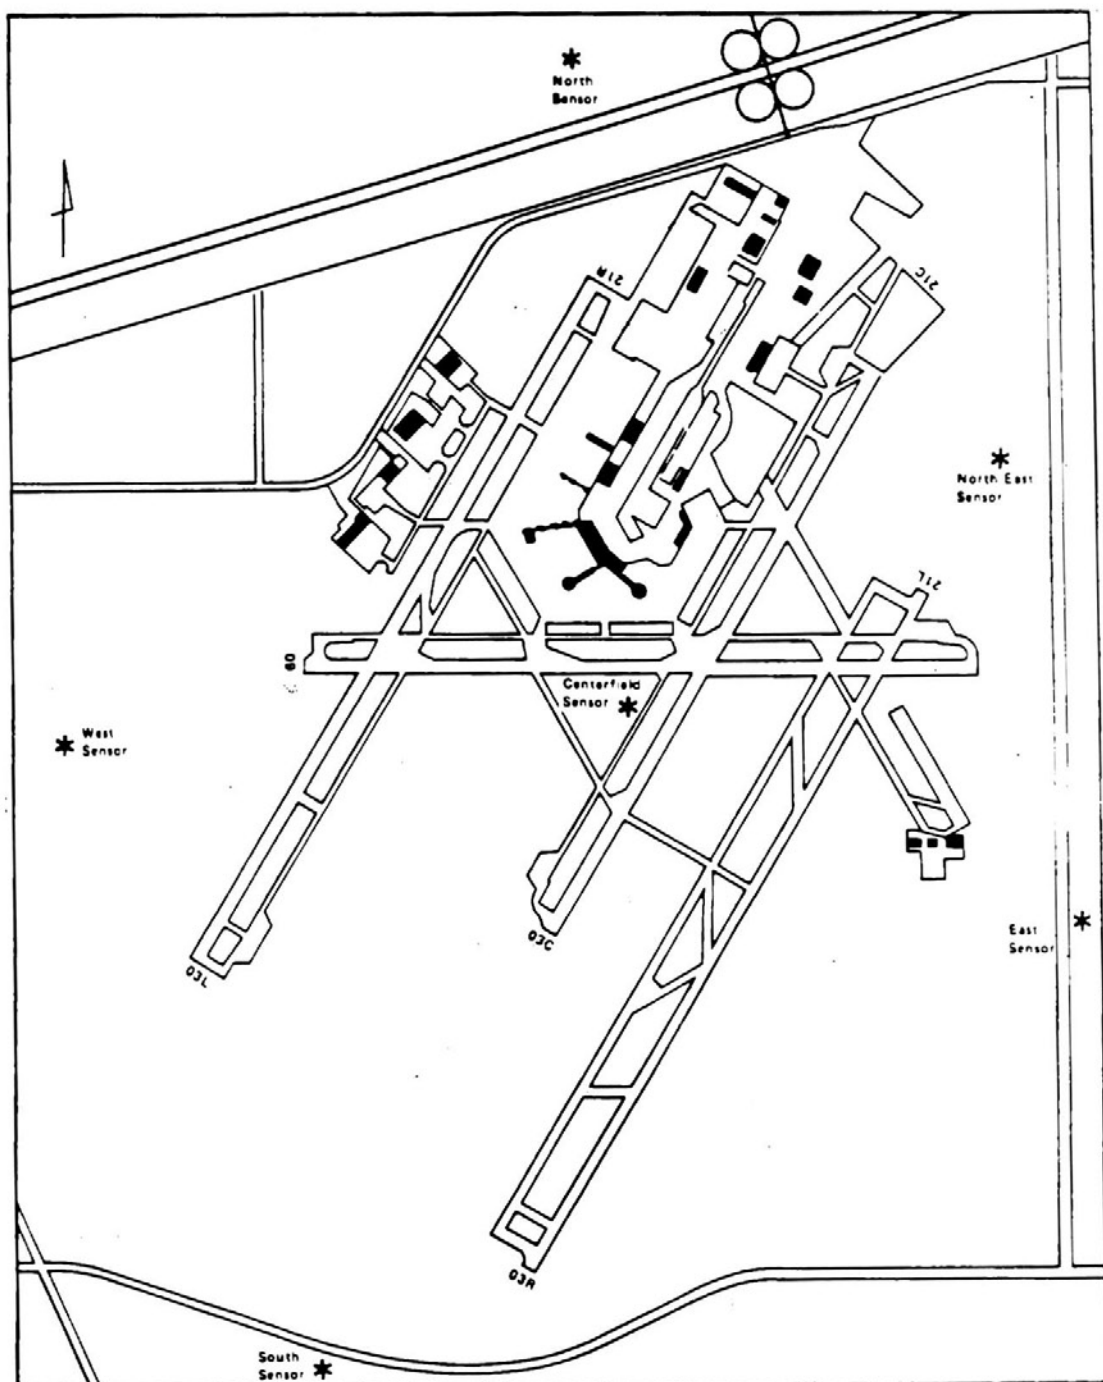
The landing area consists of four runways: 3L/21R, 3C/21C, 3R/21L, and 9/27. (See figure 1.) Runway 21R is 10,500 feet long and 200 feet wide, with a grooved concrete surface. Runway 21R has high-intensity runway edge lights, runway centerline lights, and a high-intensity approach light system with sequenced flashing lights.

Figure 1.-- Airport diagram/low level wind shear alert system.

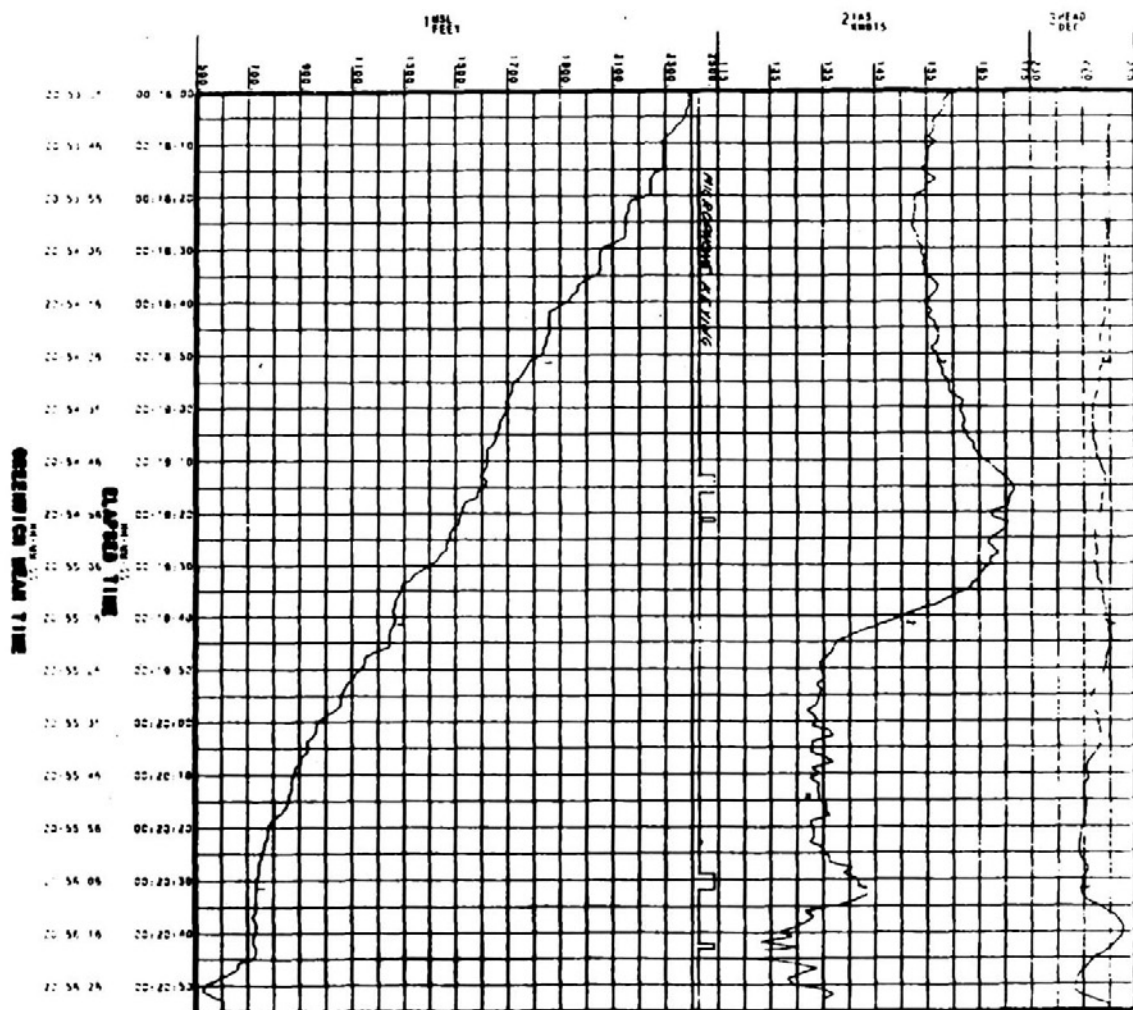
APPENDIX E
READOUT OF
FLIGHT DATA RECORDER

The flight recorder was undamaged and in working order. The data recovered from the recorder indicated that it operated normally during the flight of Flight 183, and that it stopped at 1656:31. However, the vertical acceleration values were invalid since the vertical acceleration sensor had failed before the start of Flight 183. (As a result of the accident investigation, USAir revised the DFDR test procedure for the accelerometer on August 2, 1984. The accelerometer is now checked at values of 1 "g", 0 "g", and -1 "g".)
