Runway collision of USAir Flight 1493, Boeing 737 and Skywest Flight 5569 FairChild Metroliner, Los Angeles International Airport, Los Angeles, California, February 1, 1991

Investigative Body: National Transportation Safety Board (NTSB), USA

AIRCRAFT ACCIDENT REPORT

**RUNWAY COLLISION
OF USAIR FLIGHT 1493, BOEING 737
AND SKYWEST FLIGHT 5569 FAIRCHILD METROLINER
LOS ANGELES INTERNATIONAL AIRPORT
LOS ANGELES, CALIFORNIA
FEBRUARY 1, 1991**

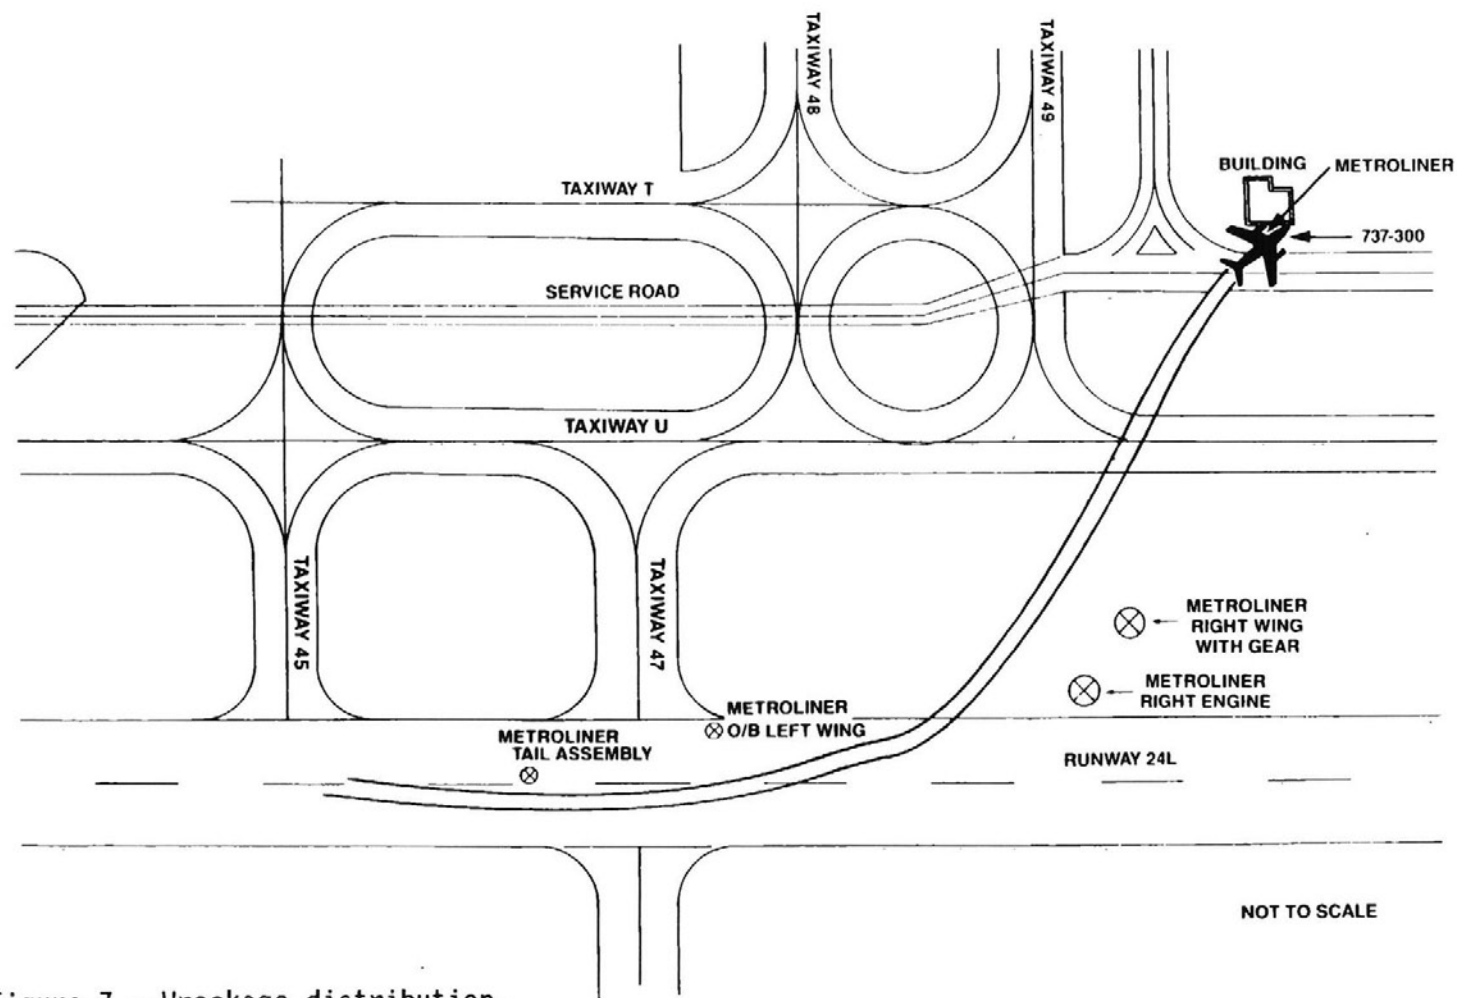
Figure 7 --Wreckage distribution.

After the collision, the B-737 and the part of the Metroliner that was crushed beneath the left side of the B-737 continued 600 feet down runway 24 left before veering left and impacting the vacant fire station, about 1,200 feet from the collision point and approximately 600 feet to the left (southeast) of the runway centerline (See figures 7 and 8). Although parts of the Metroliner were scattered among the wreckage, the only parts of the B-737 that separated from the airplane were the nose cone, nose gear doors, and left pitot tube. The B-737 was destroyed by the resulting ground fire, which burned through the top of the fuselage both forward and aft of the wing, the latter causing the aft fuselage to drop down. The impact with the building destroyed the B-737 cockpit and damaged the left engine and an area of the left wing leading edge. The top and left sides of the cockpit were crushed inward, and the forward section of the cockpit on the captain's side was crushed in, down, and to the right (See figure 9). Both forward cockpit windshields were cracked. Several propeller slashes were on the lower right side of the B-737 fuselage skin in the area of the forward galley door.

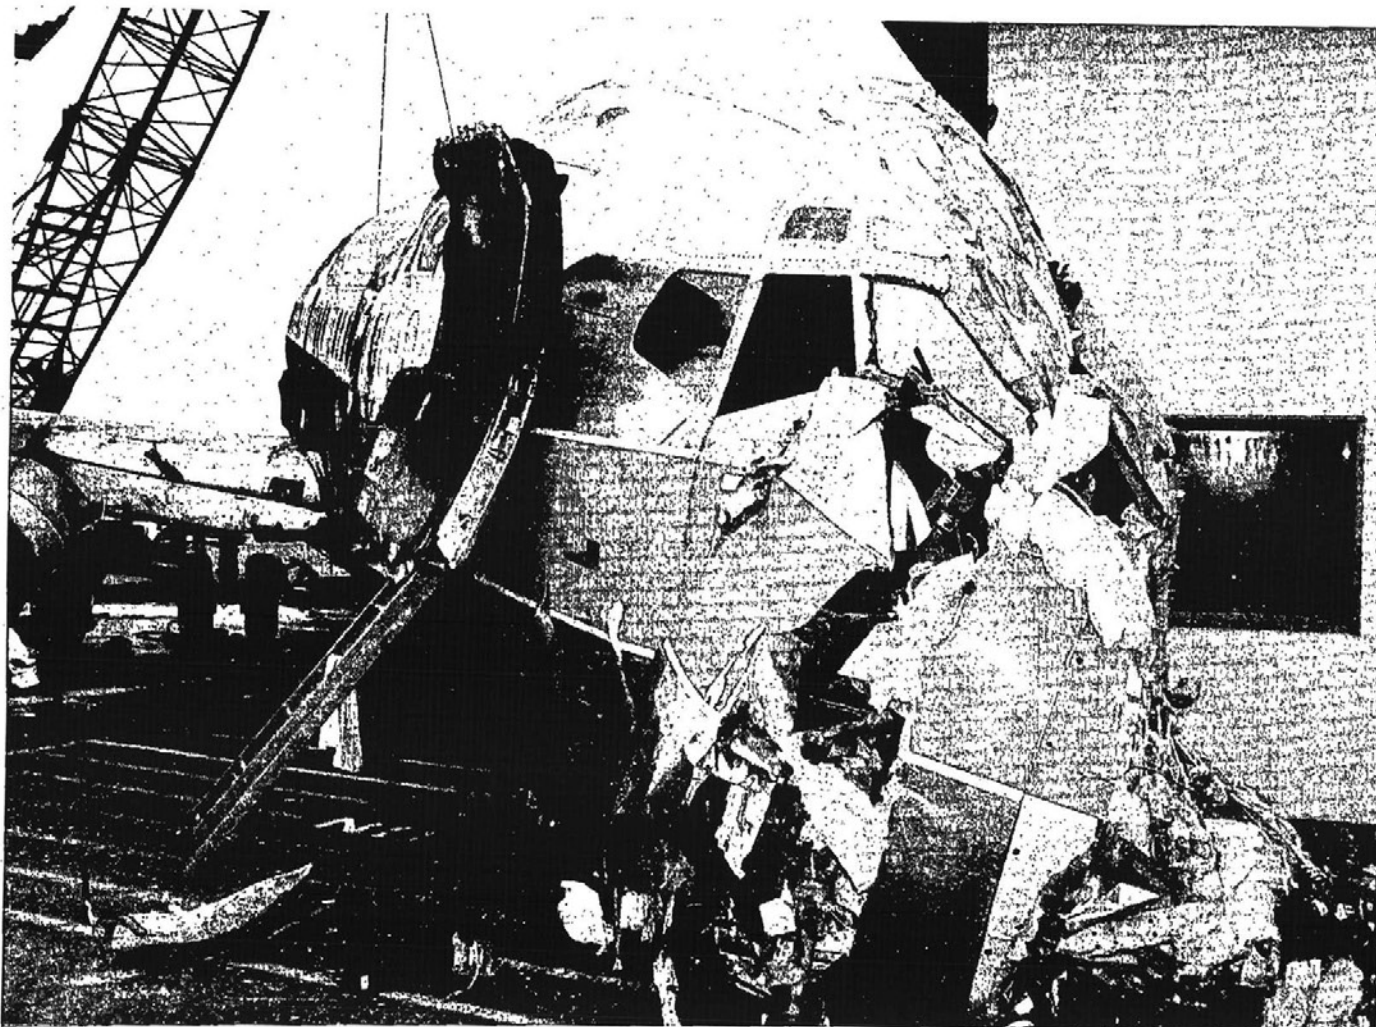
Figure 9.--Damage related to building impact.

The burned area in the top of the B-737's fuselage was in the forward cabin between the first-class and coach sections. Interior fire damage in this area was extensive. The right forward area of the forward cargo compartment, including the cargo liners, the cargo floor, and the cabin floor, was also severely damaged by fire. Several small holes in the right side of the fuselage below the floor line indicated inward penetrations and fire damage. This area also housed the crew oxygen cylinder, which was found loose. The cylinder contained heavy amounts of soot, except for the area of an attaching strap. The pressure gauge and regulator were extensively fire damaged, and the overpressure and supply lines were broken (See section 1.16.2 for further information).

Soot and fire had damaged both sides of the fuselage exterior from the forward area to the break in the fuselage aft of the wing. The most severe fire damage was on the left side of the fuselage around the wing, where much of the skin below the window line had burned through.

The top of the fuselage was also burned away from just aft of the wing to the aft doors. The fuselage along the floor beams was still attached near the fuselage break aft of the wing. However, the entire tail section drooped to the ground.

The forward passenger door (L-1) was jammed shut, and the lower half of the door was displaced inward approximately 6 inches. There was no fire damage to the exterior of the door. The forward service door (R-1) was open. The door was structurally intact, but its interior had sustained significant fire and heat damage. The exterior of the door contained soot near its bottom forward side. The aft passenger door (L-2) was open, and both sides of the door were fire damaged. The aft service door (R-2) was open. There was no soot on the interior surface of the door, and minor amounts of soot were evident on the exterior (See section 1.15 for details of emergency escape slide deployment).

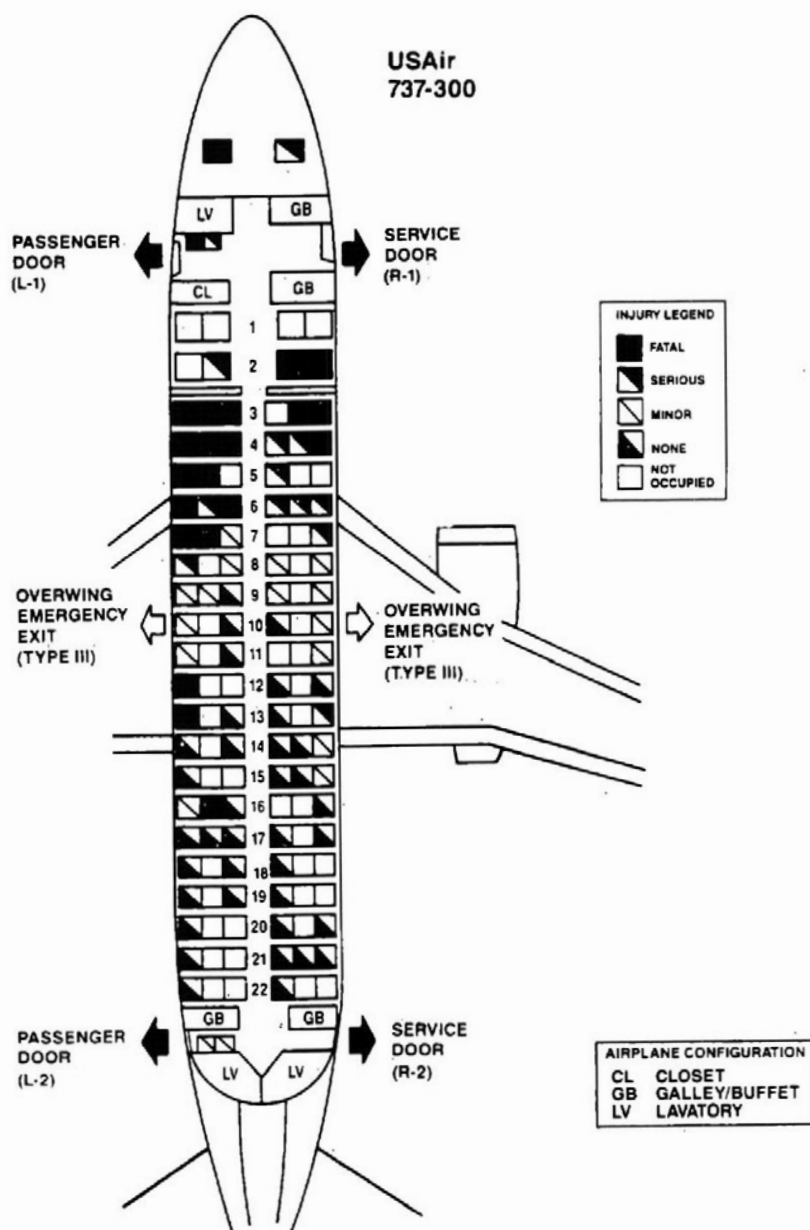
Figure 10.--Seating and injury chart.

Four of the six exits were used during the emergency evacuation: the R-1 forward service door, the left and right overwing emergency exits, and the R-2 service door. The L-1 exit was damaged subsequent to the secondary impact with the abandoned fire station. The L-2 exit was opened by the L-2 flight attendant during the slide to a stop between the first and second impacts; however, because of flames along the left side of the airplane, she stated that she closed the door and elected not to use it thereafter. Investigators found the door open with the slide deployed. It was determined that ARFF personnel had opened the door well after the accident.

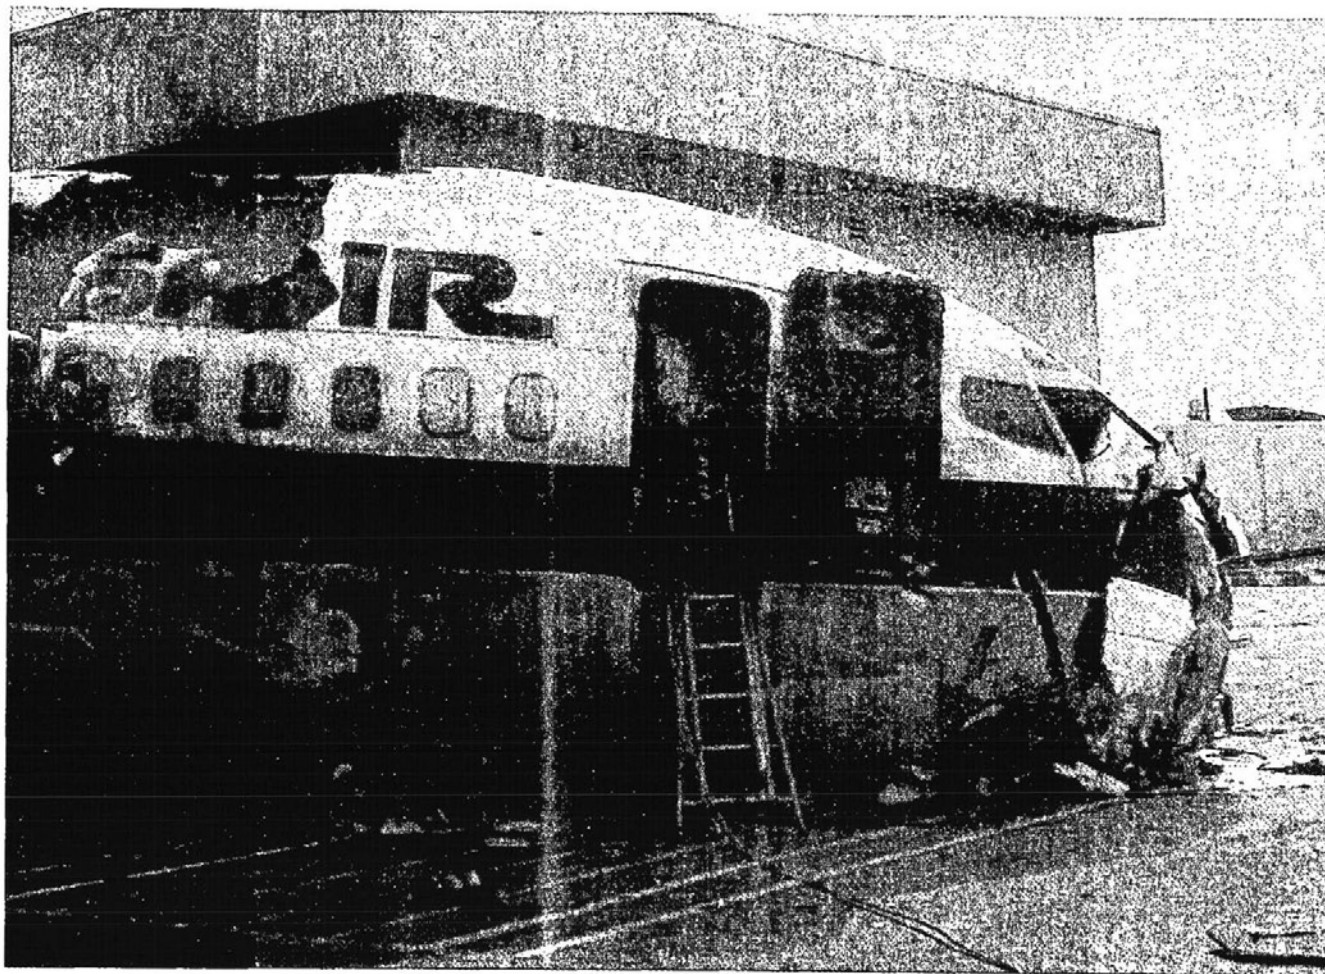
Figure 11.--Fuselage damage in area of oxygen cylinder.

The low-pressure supply line fractured in a ductile manner after the fire was extinguished;

The mode of fracture of the oxygen regulator could not be determined because of excessive heat damage;

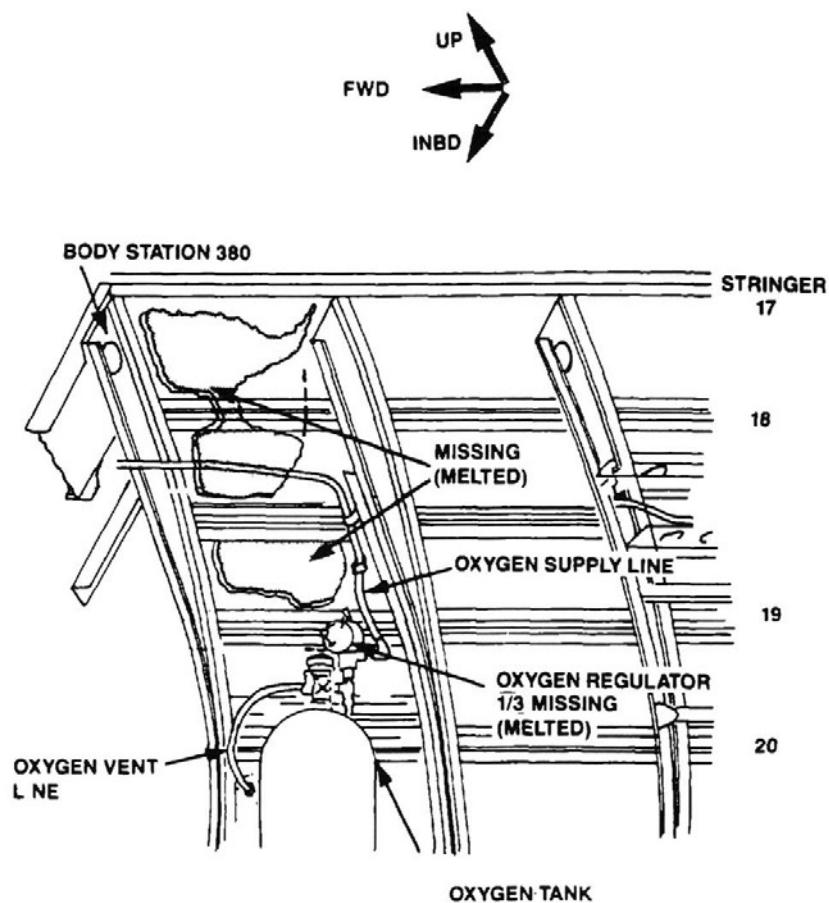
Figure 12 Fuselage damage/crew oxygen system installation

The fuselage skin near the oxygen system installation was damaged mechanically, prior to high temperature exposure.
