NATIONAL TRANSPORTATION SAFETY BOARD

AIRCRAFT ACCIDENT REPORT

IN-FLIGHT ICING ENCOUNTER AND LOSS OF CONTROL
SIMMONS AIRLINES, d.b.a. AMERICAN EAGLE FLIGHT 4184
AVIONS de TRANSPORT REGIONAL (ATR)
MODEL 72-212, N401AM
ROSELAWN, INDIANA
OCTOBER 31, 1994

VOLUME 1: SAFETY BOARD REPORT

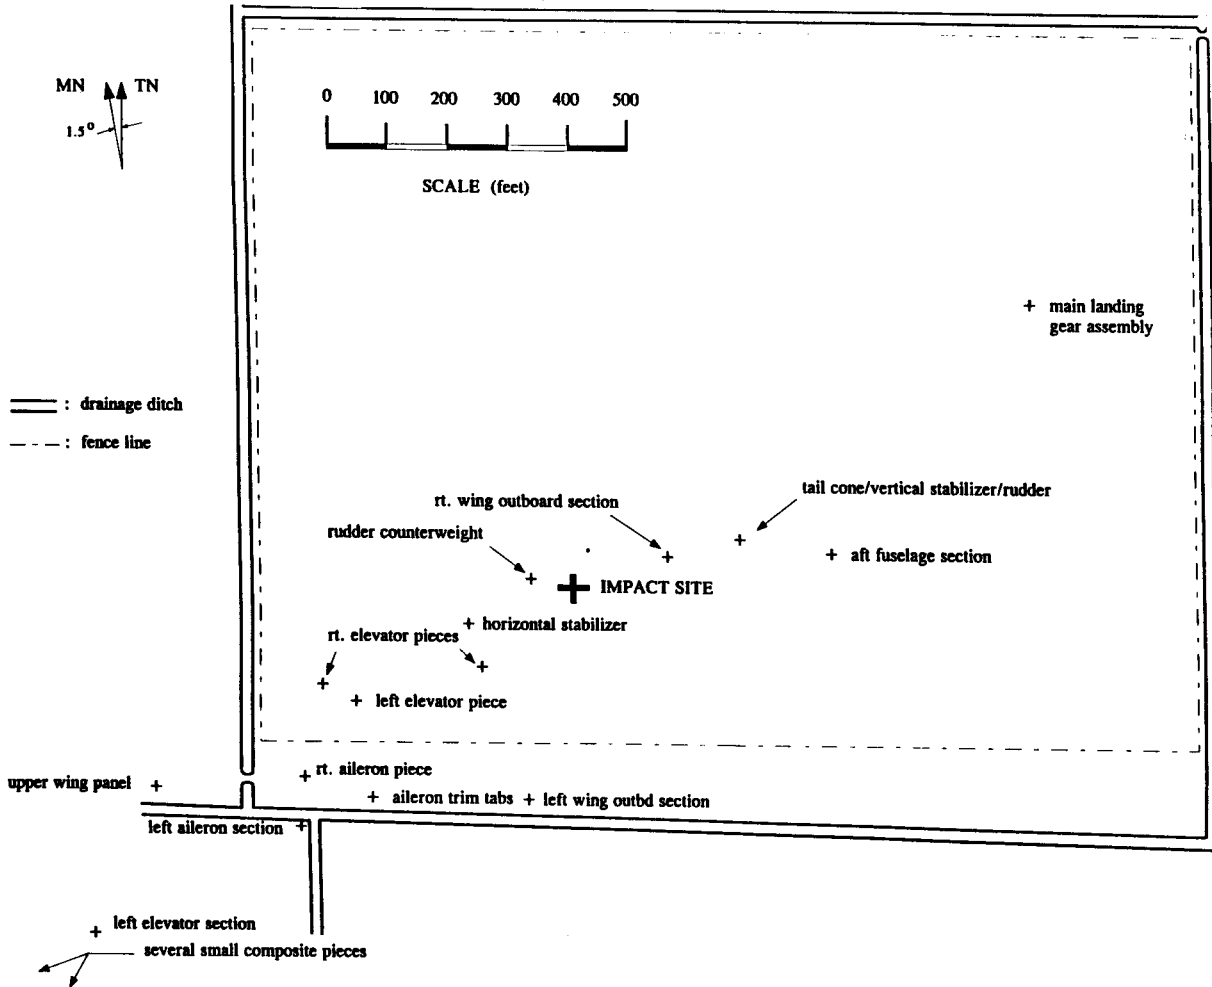
Figure 10a.--Wreckage distribution diagram.

Two smaller impact craters, consistent with the size of the left and right engines, were found on both sides of the larger, main impact crater (the size and orientation of the three craters, identified as crater 1, crater 2A, and crater 2B, are shown in Figure 10b). Most of the human remains, as well as portions of the

airplane structure and components, were located to the east-northeast of the impact craters. Portions of the wings and empennage were found to the south and southwest of the craters. The first major airplane structure found in the debris field, located farthest southwest from the impact craters, was a portion of the left elevator. Numerous small lightweight pieces of composite material were found about 1,000 feet southwest of the elevator. The last pieces in the debris field, farthest northeast from the impact craters, consisted of a main landing gear assembly (main landing gear wheel and tire) a portion of the flightcrew/passenger oxygen bottle, and two hydraulic pumps located in the lower section of the airplane.
