Crash during emergency landing, Phoenix Air, Learjet 35A, N521PA, Fresno, California, December 14, 1994

AIRCRAFT ACCIDENT REPORT

CRASH DURING EMERGENCY LANDING
PHOENIX AIR
LEARJET 35A, N521PA
FRESNO, CALIFORNIA
DECEMBER 14, 1994

Abstract: This report explains the accident involving the Phoenix Air Learjet 35A that crashed while attempting an emergency landing at Fresno Air Terminal, Fresno, California, on December 14, 1994. Safety issues in the report focused on maintenance, inspection and quality assurance. Safety recommendations concerning these issues were made to the Federal Aviation Administration, Phoenix Air, and the Department of Defense.

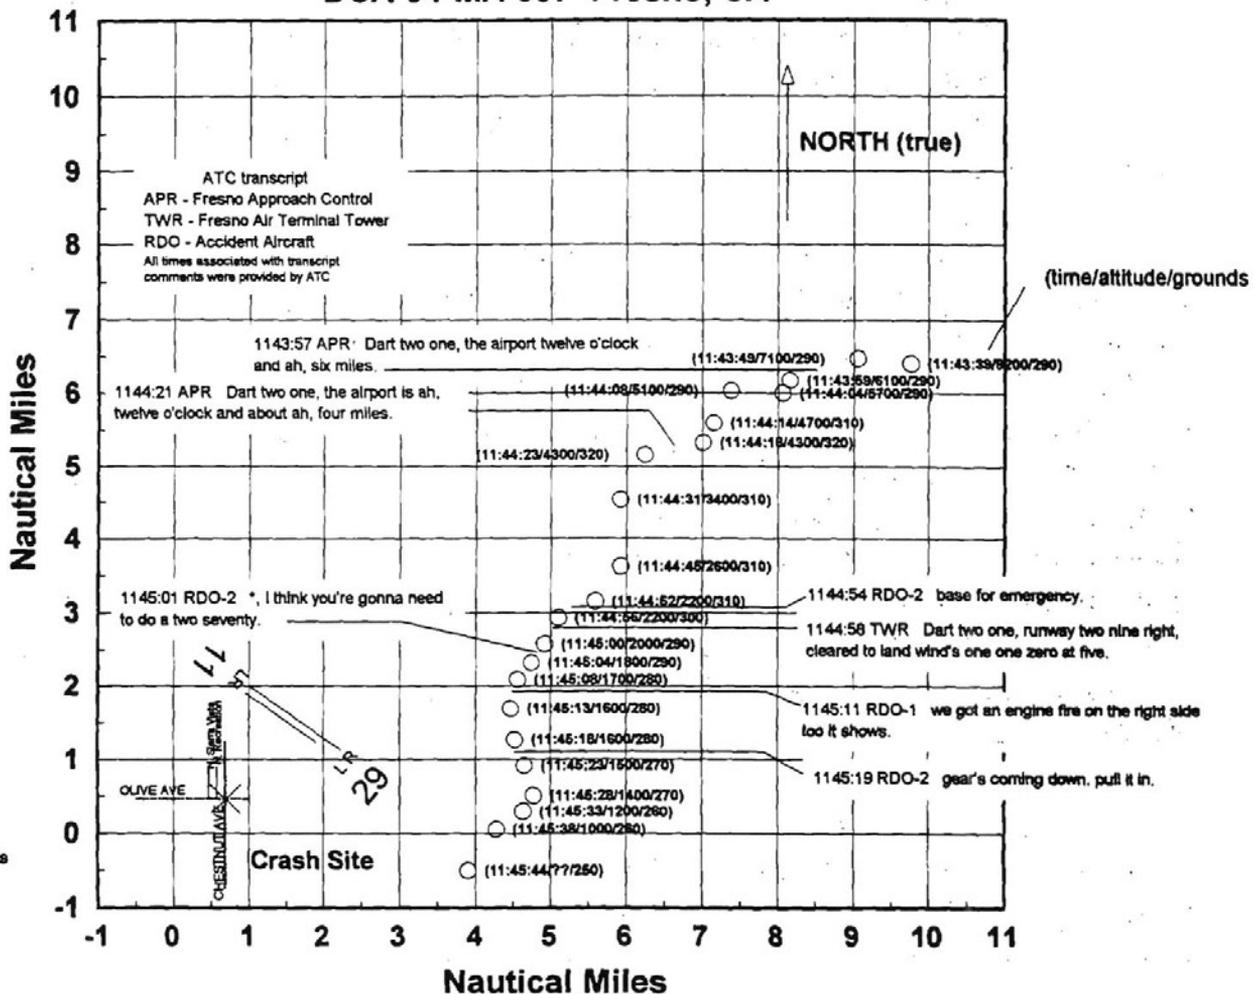
Figure 1a.--Ground track.

After the airplane passed to the southwest of the extended centerline, it appeared to tower controllers to gradually descend very low. The tower supervisor stated that the landing gear appeared to be down about that time. The airplane then climbed back up gradually from what appeared by line of sight to tower controllers to be above the tree tops. It then again gradually descended in an apparent westerly heading. The airplane climbed or "porpoised" up a second time, more severely. It then descended sharply until view was obstructed by trees. A fireball and smoke were then observed.

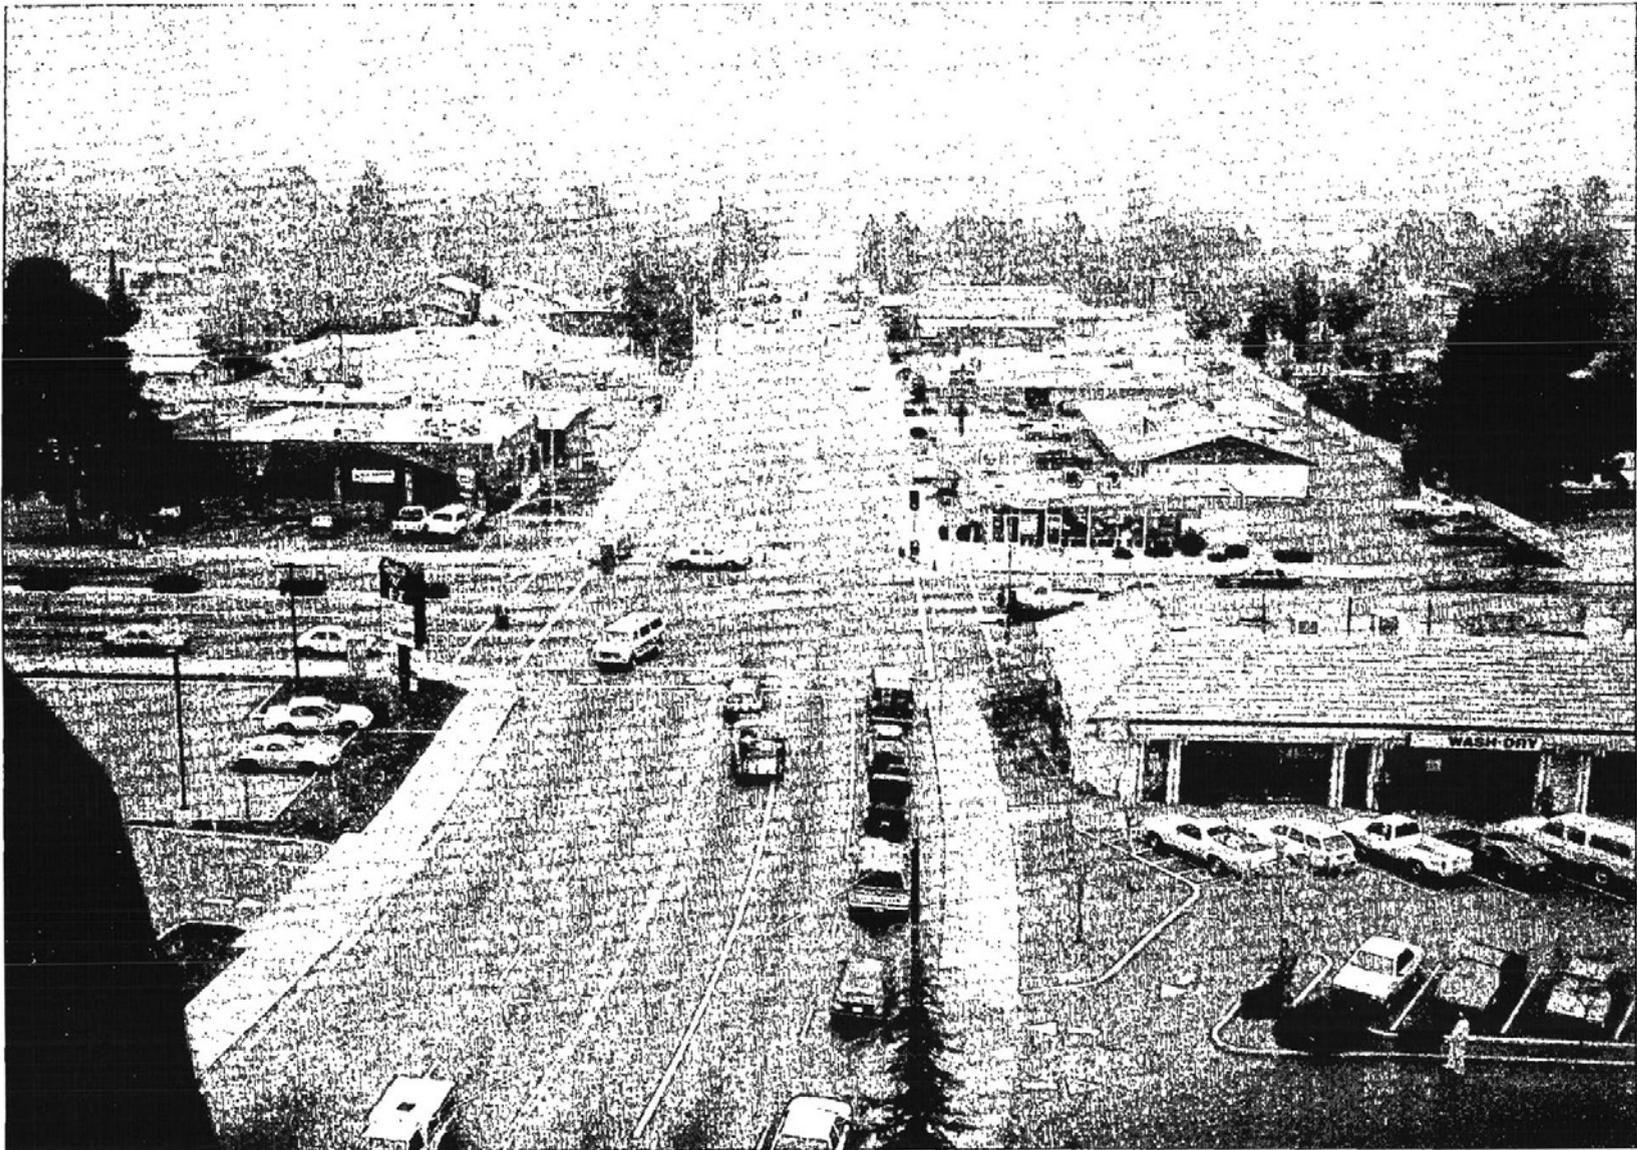
Two buildings in the Olivewood apartment complex facing E. Olive sustained the most severe damage. Of the two apartment buildings, the one to the east or the first building in the impact path sustained primarily impact damage. The westerly building sustained both impact and fire damage, and some of the apartment units in that building were destroyed by fire. Lesser damage, primarily flash-fire and minor impact damage occurred to businesses on the north side of E. Olive.

Figure 2a.--View to the west on E. Olive
looking approximately down the final flightpath.

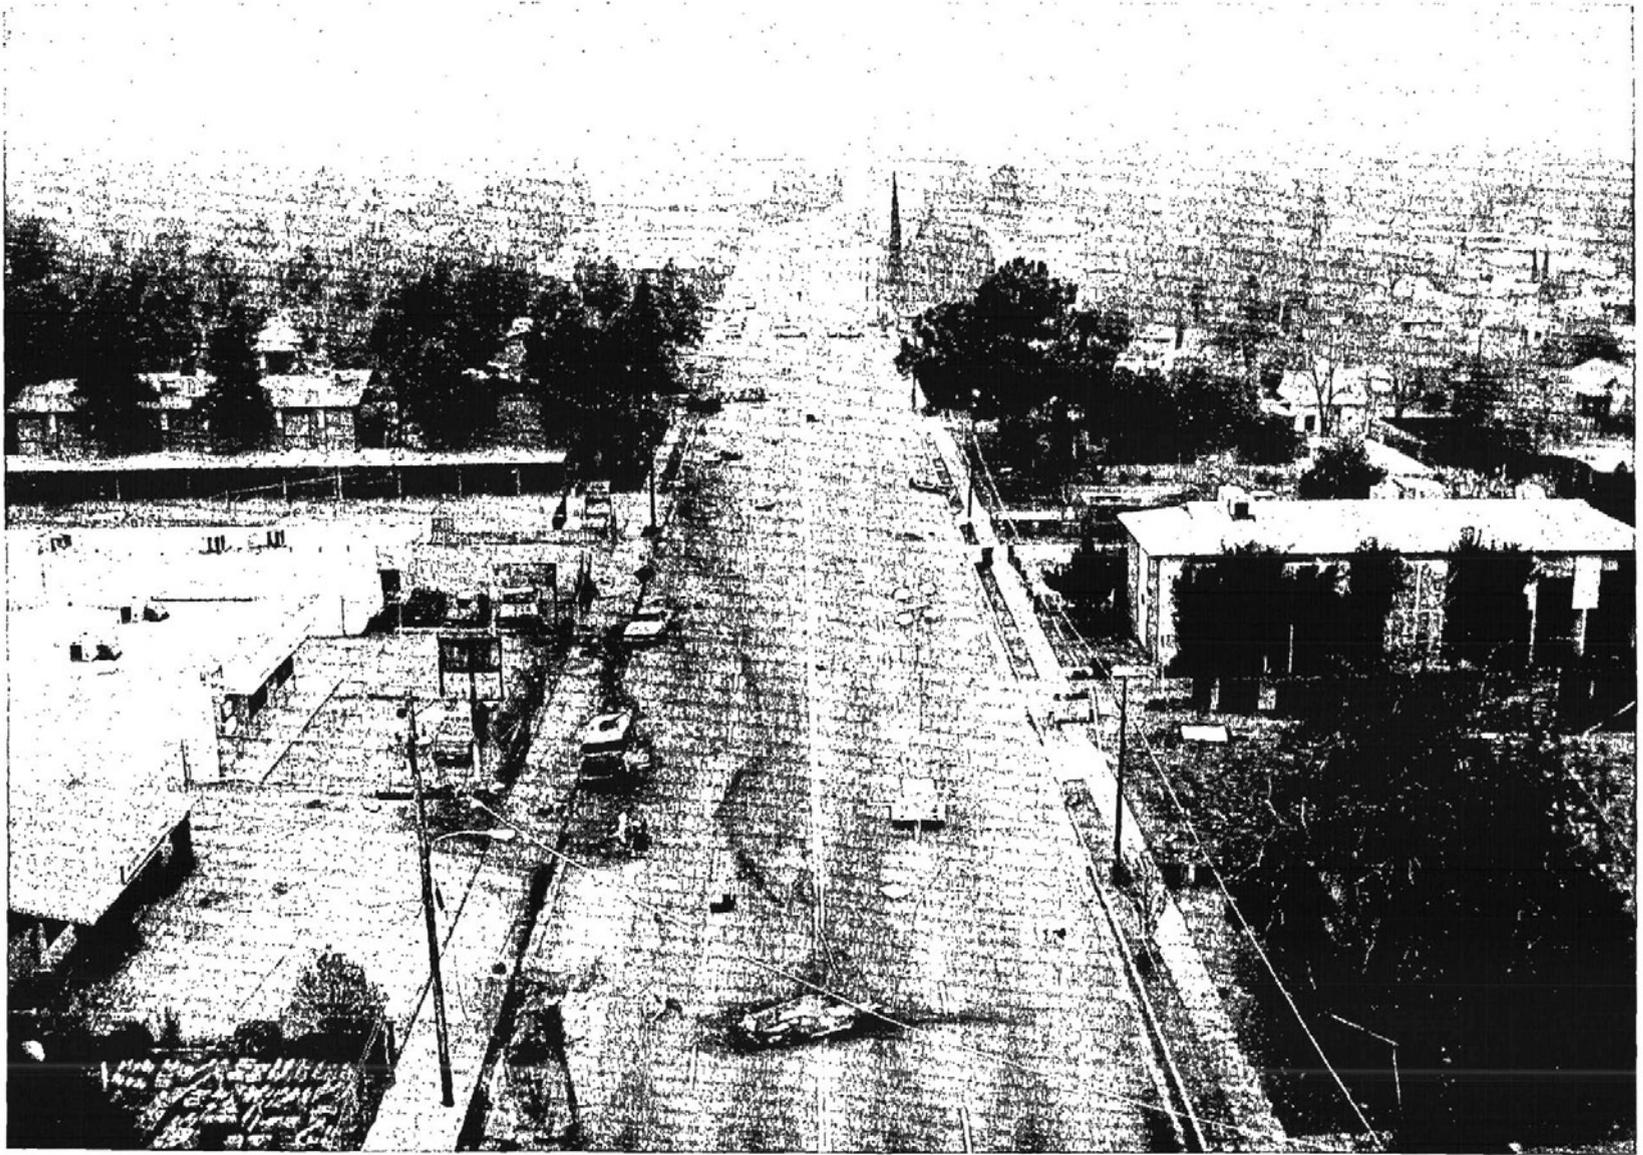
Figures 2b.--View to the east on E. Olive from immediately east of N. Sierra Vista. Last major portions of wreckage in wreckage path are near the bottom of the photograph.

Approximately 12 automobiles that were parked along the north curb of E. Olive were impacted by burning wreckage and were ignited and destroyed. E. Olive was generally clear of traffic in the 2-block wreckage path, and no persons in automobiles were seriously injured. Most of the 21 persons who were injured on the ground lived in units in the two damaged apartment buildings. One female resident sustained severe burn injuries.

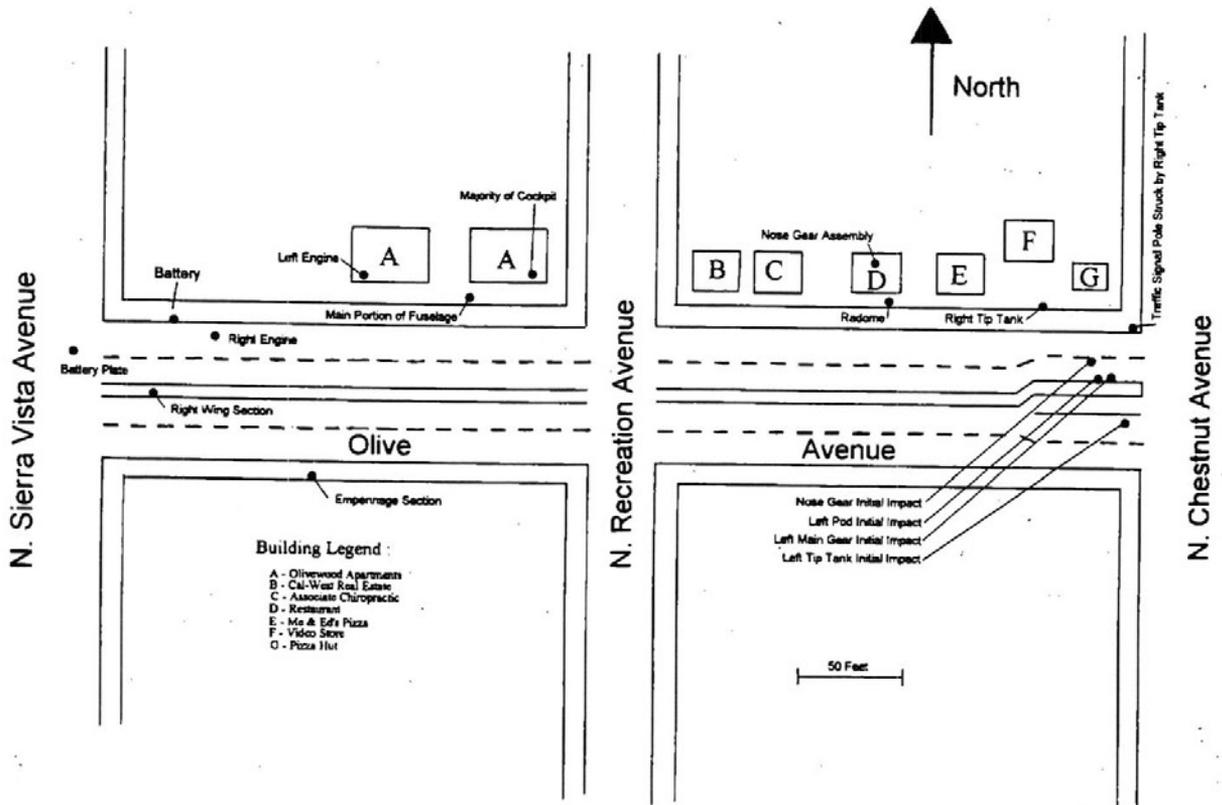
Figure 2c.--Wreckage path diagram.

The right wing and right engine came to rest, on fire, on E. Olive, approximately 100 feet east of the intersection with N. Sierra Vista and about 1,200 feet west of the initial impact marks. The right wing was fractured into several pieces. The inboard 10 feet of the wing came to rest near the center of E. Olive, immediately west of the right engine.

The ground fire was most severe along the north side of E. Olive, between N. Recreation and N. Sierra Vista. The remains of the left wing were combined with fuselage structure and found inverted in debris to the north side of E. Olive between the south-facing sides of the impacted apartment buildings. Most of the aluminum structure was melted, and the left wing was barely recognizable, except for the remaining steel components. Twelve vehicles, parked along the north curb of E. Olive, between N. Recreation and N. Sierra Vista, were ignited and destroyed by fire. Damage to structures along the south side of E. Olive was generally restricted to flash burns.

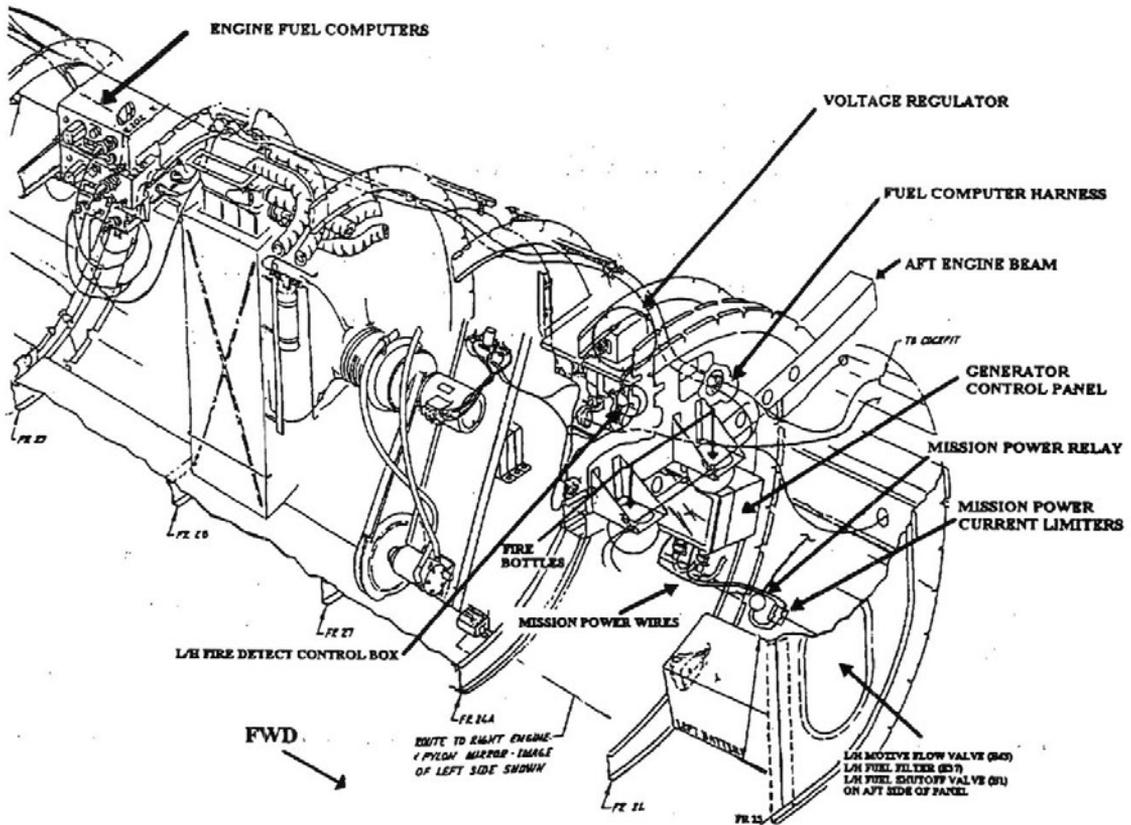
Figure 3a.--Components in tailcone.

The investigation found that in the actual mission equipment wiring of N521PA, the power wires were routed directly to the battery charging bus. (Figure 3a is a drawing of major components in the tailcone. Figure 3b shows the intended versus actual routing of the power wires in N521PA.)

There was evidence of in-flight fire damage in the aft fuselage area of the electronics bay (hell hole). Soot deposits were found around lightning holes in the vertical stabilizer. These holes were at the interface between the aft tailcone and the interior of the forward portion of the vertical stabilizer. A piece of fuselage skin from the left side of the fuselage, starting at approximately frame 26 and extending aft to about frame 28 under the left engine pylon, was recovered from the scene and examined. The inside surface of this fuselage section was heavily sooted with some actual flame damage. A small hole in the fuselage appeared to have pitting and "broom straw"¹² on the forward ends of the stringers. Sooting was not present where the stringers had been pulled away from the fuselage skin.

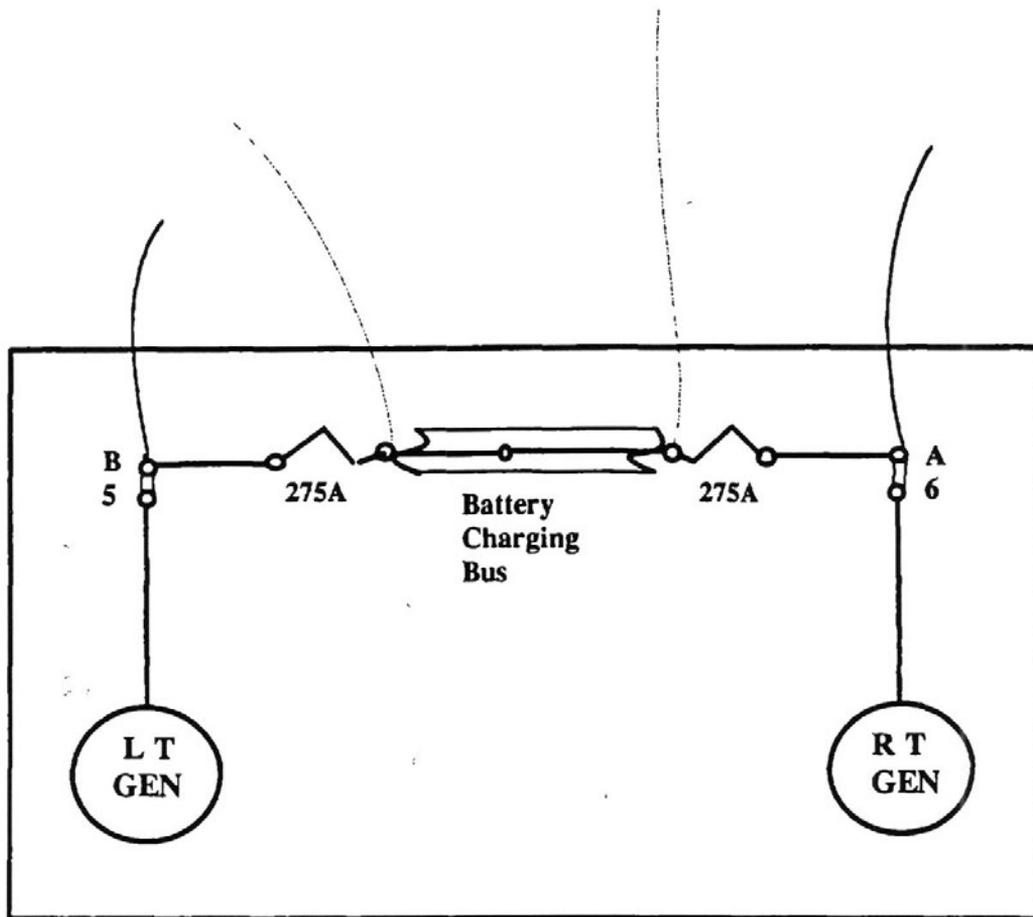
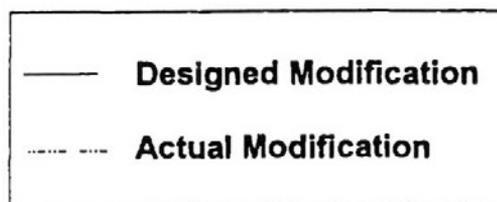
Figure 3b.--Mission power wiring.

asked where to install the wires was misdirected in the confines of the "hell hole." Another mechanic said, "put it there," and the mechanic working on that airplane thought that he was being pointed towards the battery bus, rather than properly towards the terminals for the generator bus. (The investigation found that the subject wires had been attached to terminals on the battery charging bus.) The Director of Maintenance stated that after the first airplane was miswired, the incorrect wiring alteration was copied on 14 subsequent Learjets and that a drawing was not referenced.

On December 20, 1994, 6 days after the accident, the Phoenix Air Director of Maintenance issued an "Immediate Airworthiness Action" to Phoenix Air's seven maintenance sites to immediately stop flying the remaining 17 mission-equipped Learjets until the wiring was inspected for chafing, then "disconnect the special mission power wire from the generator control panel to the current limiter and remove this entire section of wire." On December 23, 1994, Learjet sent a letter to its operators, worldwide, stating that, "It is strongly recommended that [an inspection] take place prior to the next flight."

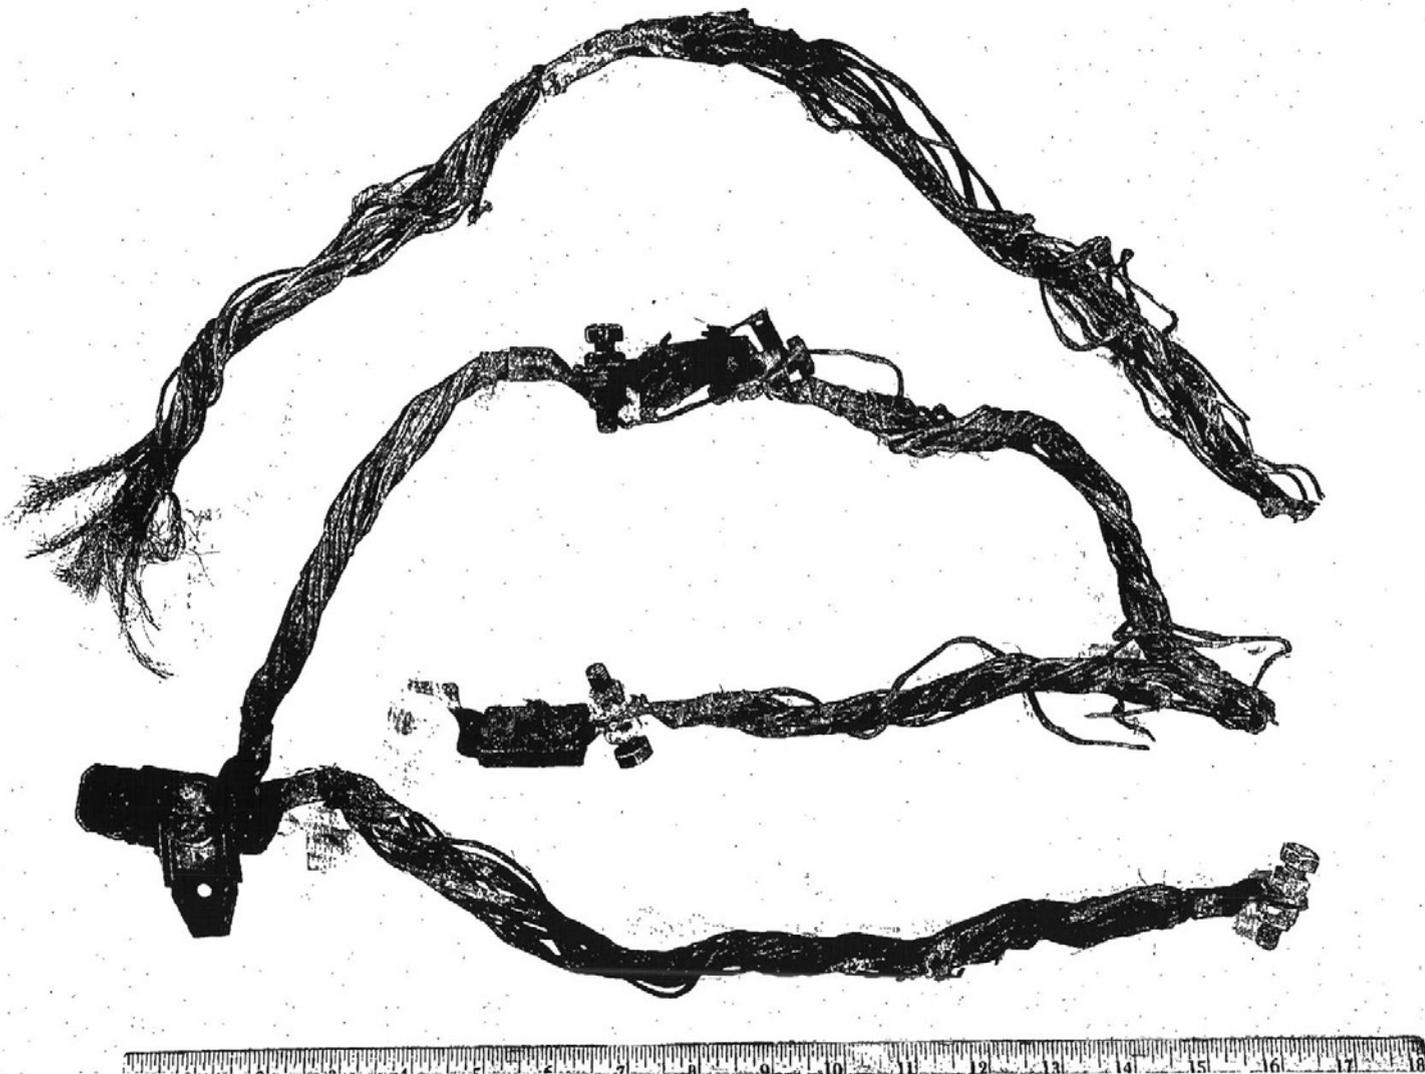
Portions of the wires, identified as part of the electrical power source for the special mission package, were size No. 0 awg and were found on E. Olive, near the wheel of an unburned vehicle. The wires had evidence of high heating prior to impact, including areas fused together for about 2 inches in length, and individual strands of the wires had a beaded appearance. (See figure 4.) Current limiters (fuses) were found attached to the nonwelded ends of one of the two sets of wires. In subsequent testing, the current limiters were found to provide electrical continuity (in the closed position).

Figure 4.--View of cables as received for examination.
