Uncontrolled Collision with Terrain, Air Transport International, Douglas DC-8-63, N782AL, Kansas City International Airport, Kansas City, Missouri, February 16, 1995

AIRCRAFT ACCIDENT REPORT

UNCONTROLLED COLLISION WITH TERRAIN
AIR TRANSPORT INTERNATIONAL
DOUGLAS DC-8-63, N782AL
KANSAS CITY INTERNATIONAL AIRPORT
KANSAS CITY, MISSOURI
FEBRUARY 16, 1995

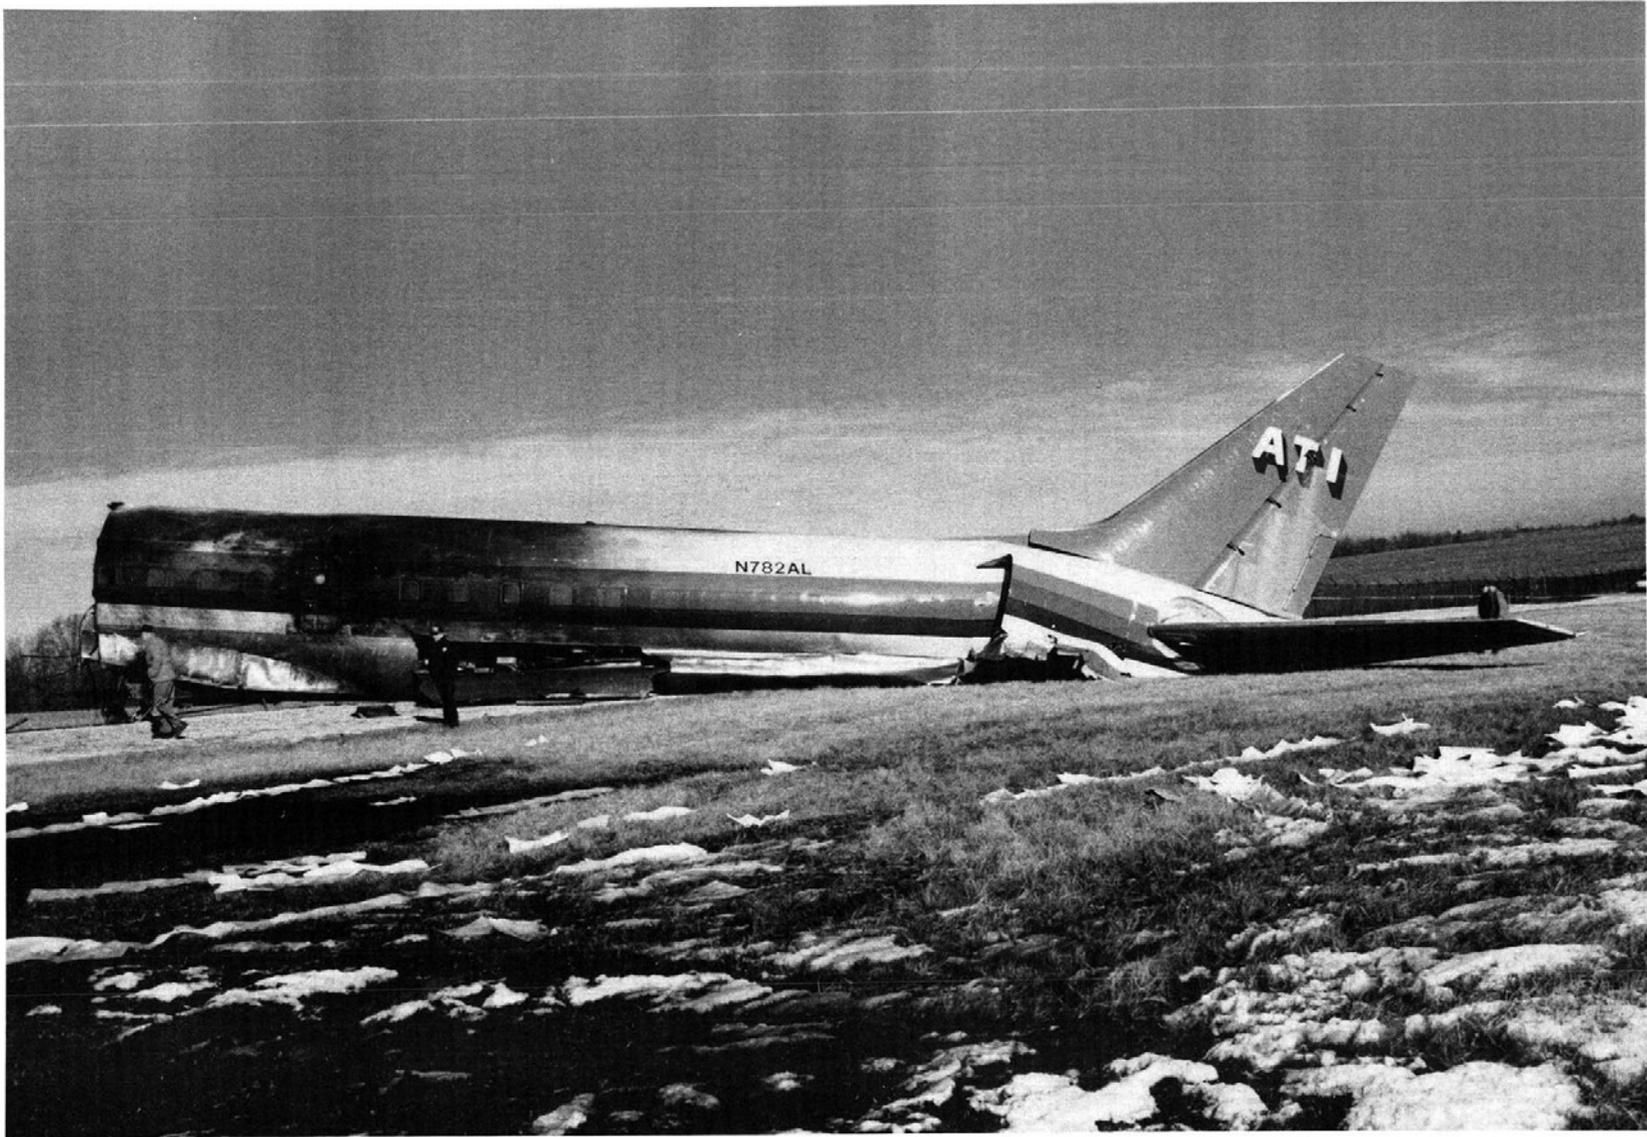
Figure 1.--Ground view of wreckage.

nose high attitude during rotation," and he observed a "bright yellowish-orange ball of fire from the exhaust of the No. 2 engine." He then saw the airplane enter a "slowly increasing left bank" just before impacting the ground. See figures 1 and 2.

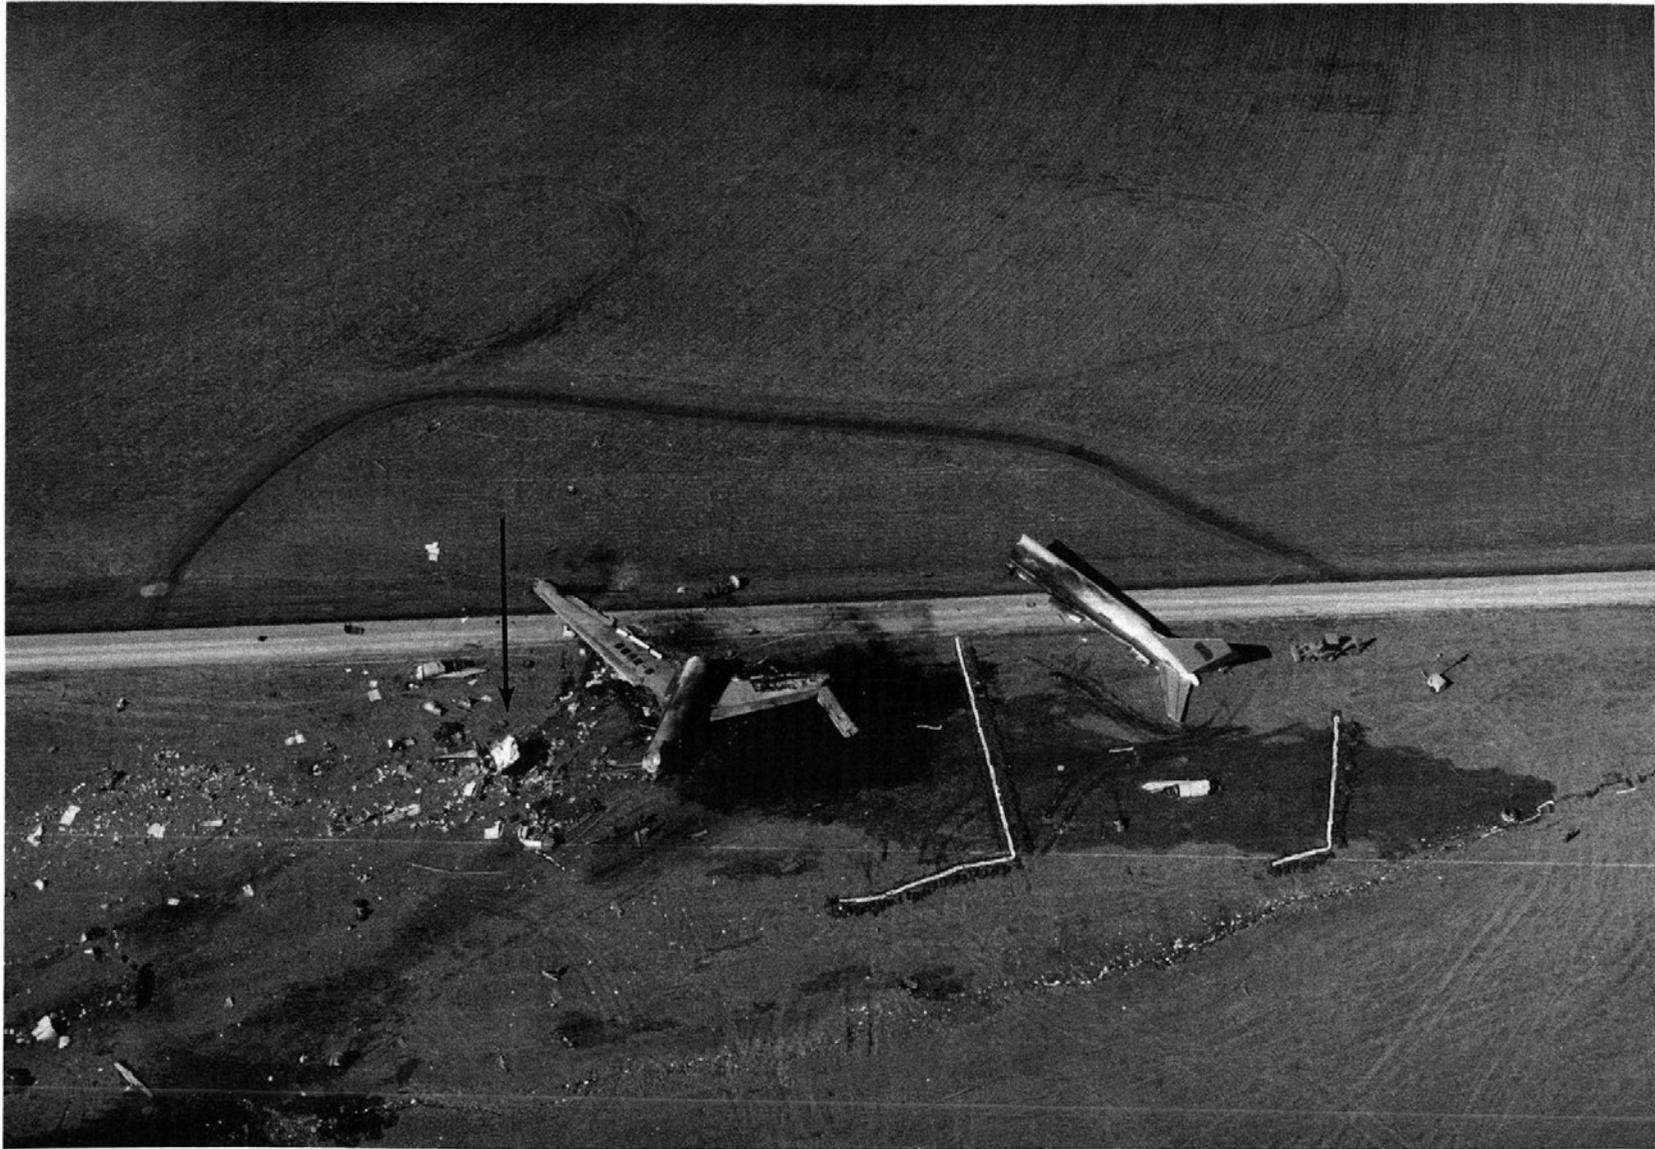
Figure 2.--Aerial view of wreckage.

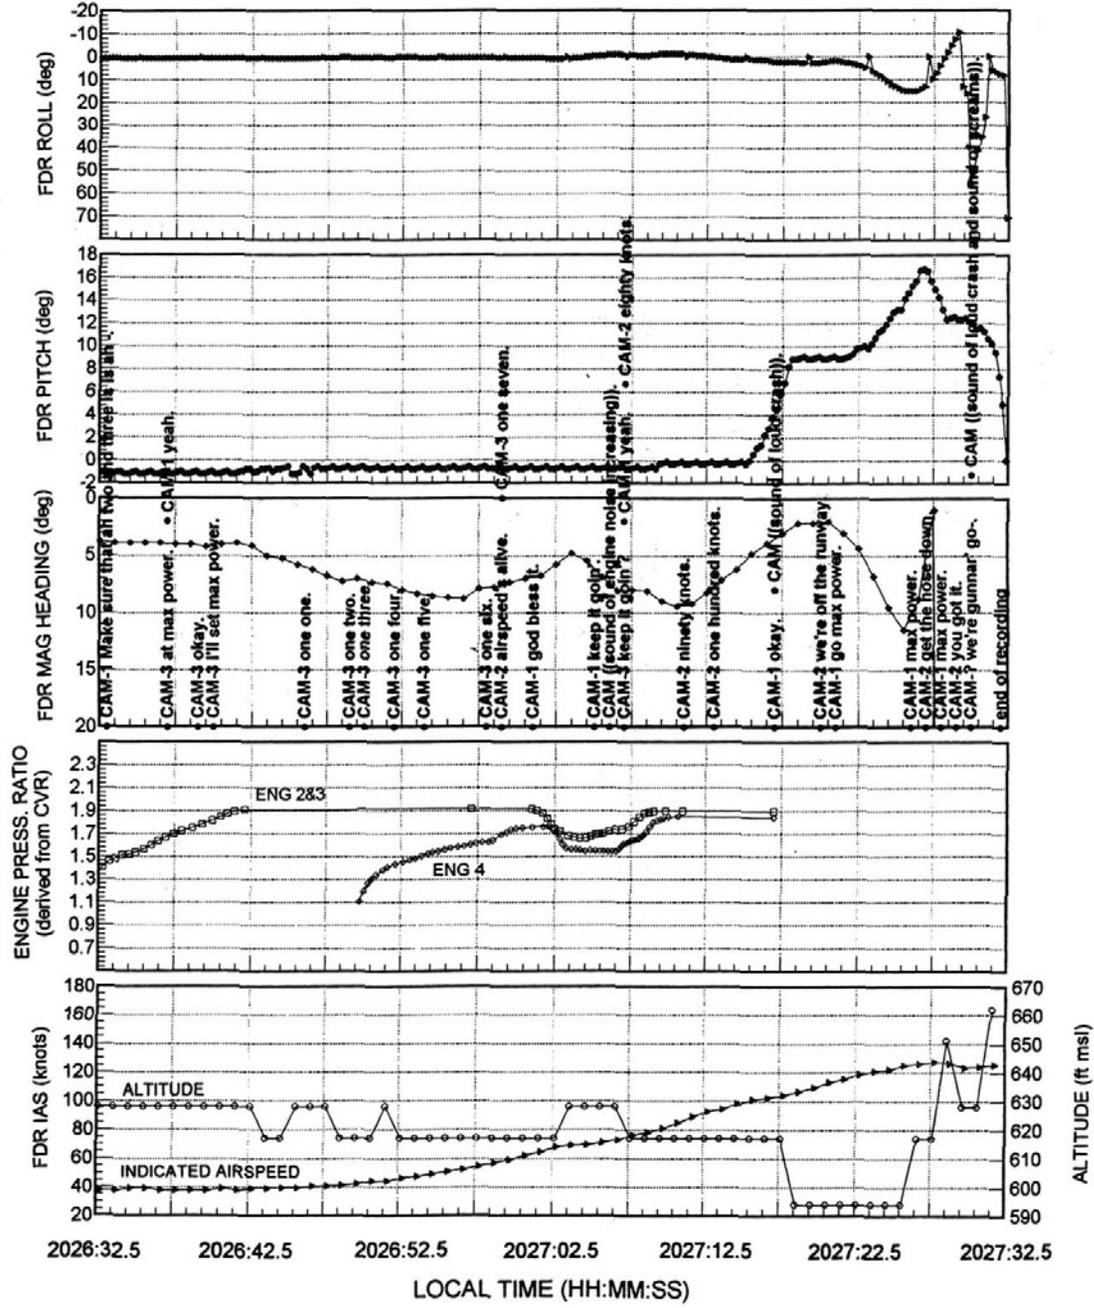
Figure 3.--FDR/CVR presentation.

The airplane was equipped with a Fairchild Model A100 cockpit voice recorder (CVR), S/N 2325, and a Sundstrand digital flight data recorder (DFDR), P/N 980-4100-60US, S/N 7768. Both units were mounted in a compartment in the aft fuselage below the cargo bay floor. Both units were found separated from their mounts. Only minor dents in the outer cases were seen. There was no evidence of fire damage. DFDR information is included in figure 3, and a transcript of the CVR recording is included in Appendix B.

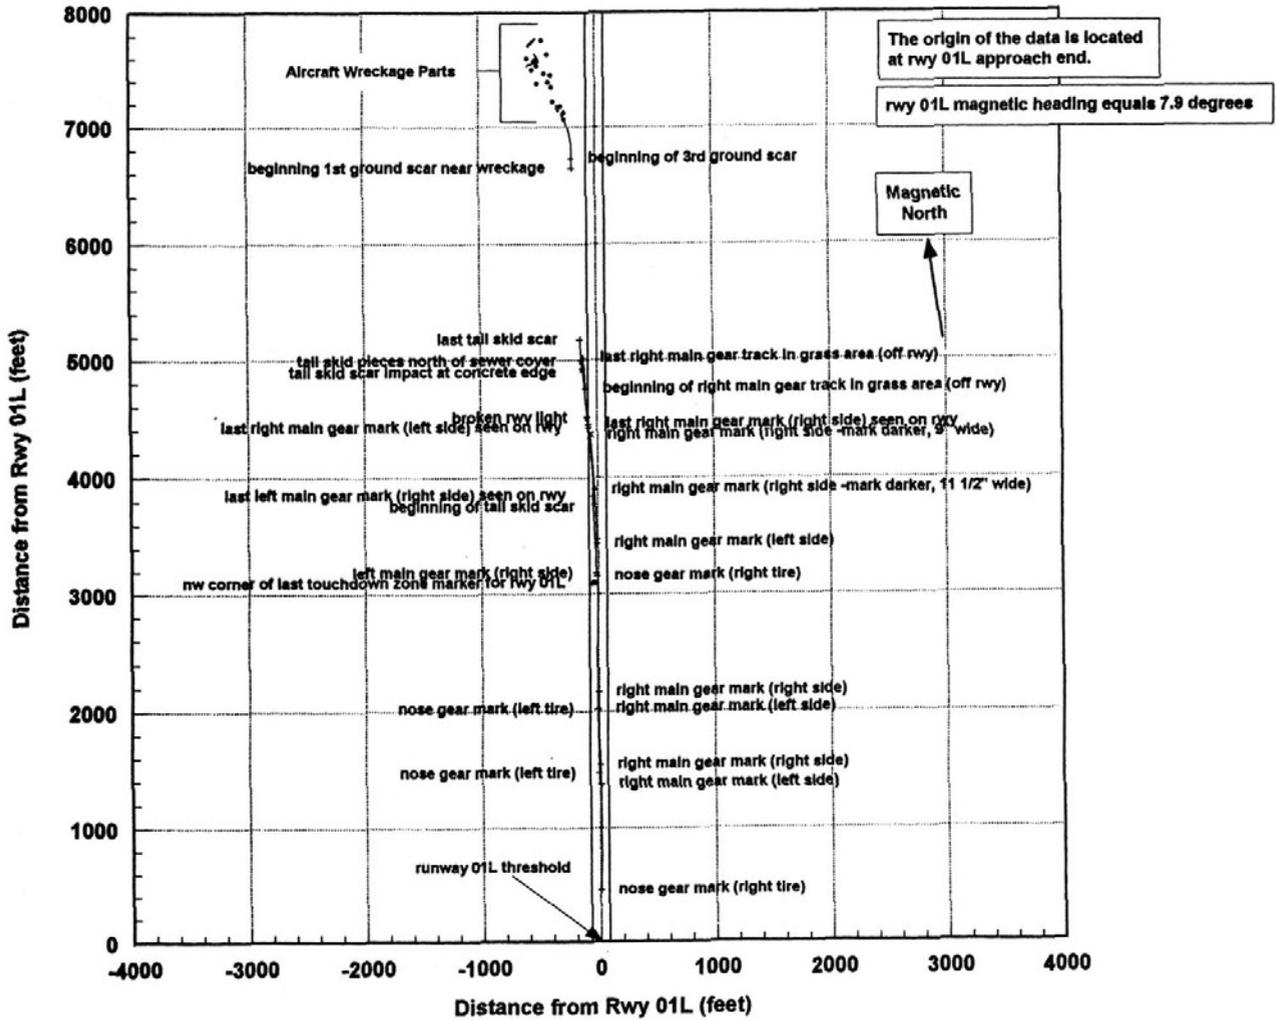
Several ground impact scars, containing pieces of left wing, were observed near the main wreckage site. The first of these ground scars began 1,470 feet from the end of the tail skid scar. Fuel was spilled throughout the area of the initial ground scars, and most of the grass in this area was burned. A large trench began approximately 300 feet from the initial ground scar. The trench was generally oriented along a magnetic heading of 350 degrees, although it curved to the west slightly.

Figure 4.--Ground scars, ground marks, and wreckage.

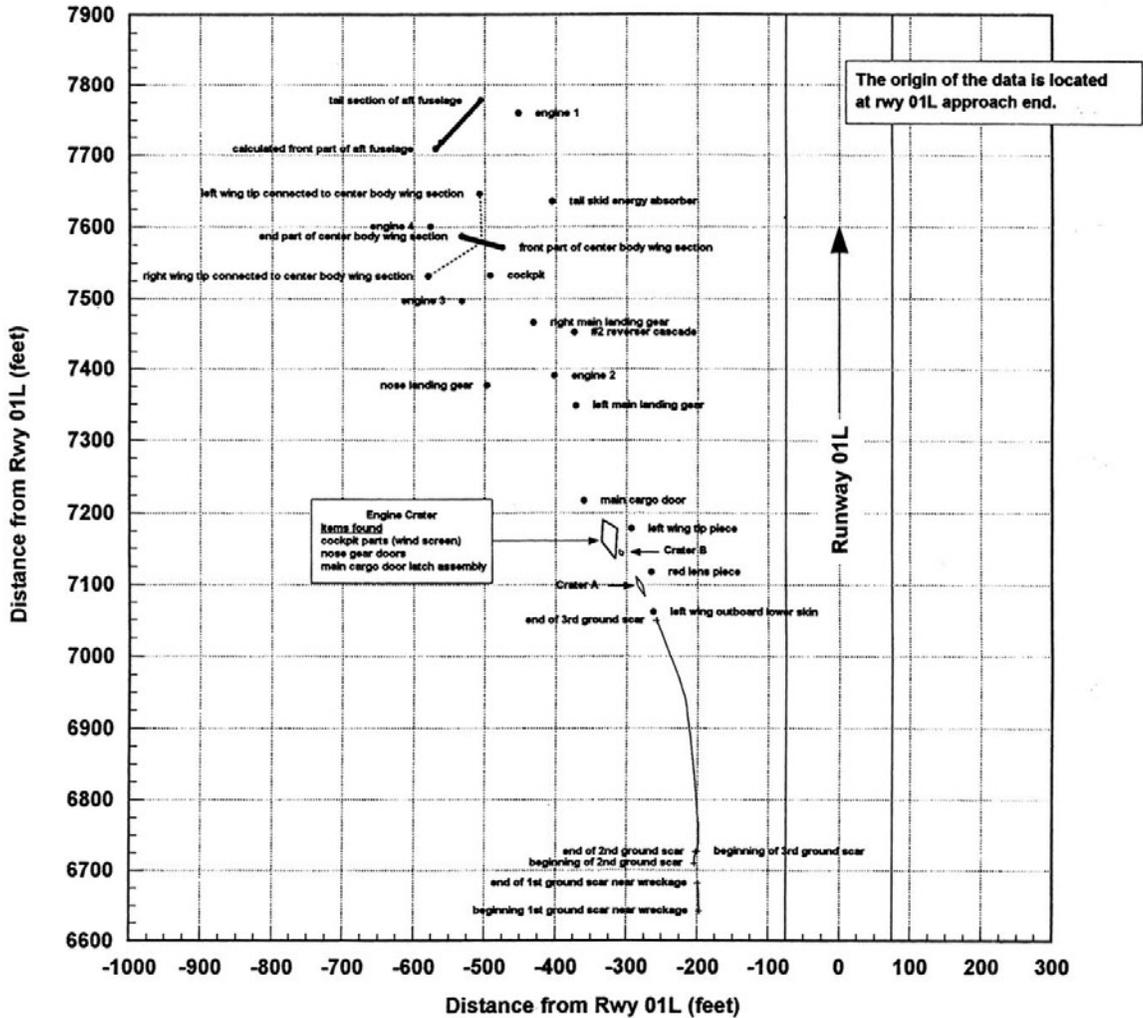
Figure 5.--Ground scars and wreckage.

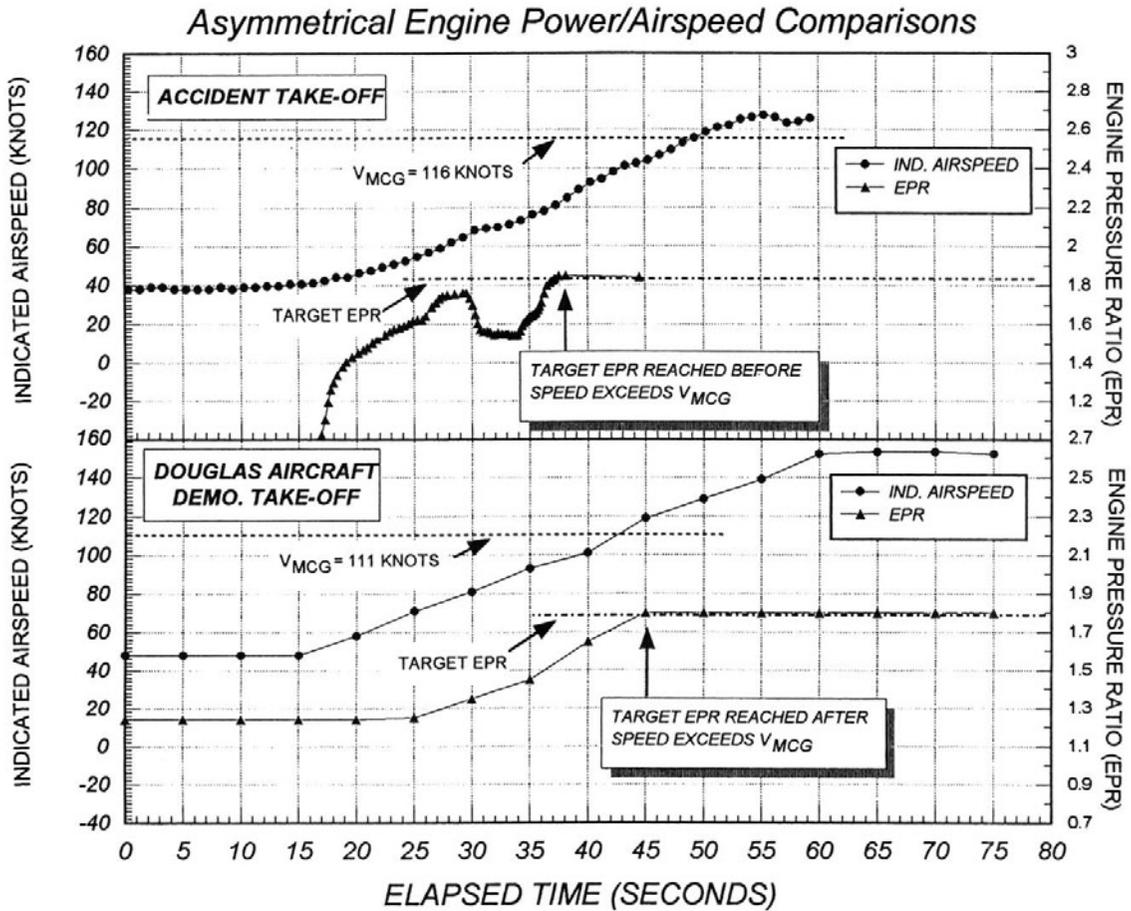
The high rate of asymmetric throttle application by crewmembers in both the attempted takeoffs precluded successful completion of the maneuver. However, the Safety Board believes that even with the proper application of asymmetric throttle during a three-engine takeoff, the margin of safety is quite small. The procedure now calls for arriving at full takeoff power on the asymmetric engine at the computed V_{mcg} to provide for the minimum possible takeoff roll. A properly executed three-engine takeoff also entails full rudder application at the computed V_{mcg} . Any adverse crosswind condition, for instance, would place the flightcrew in a position in which they could not have full control of the airplane due to a loss of rudder authority. In addition, it is very difficult to time the throttle application to arrive at full power at exactly the computed V_{mcg} given the spool-up lag inherent in turbine engine operation.

Figure 7.--No. 4 engine EPR/IAS comparison.
