Wheels-up Landing, Continental Airlines Flight 1943, Douglas DC-9, N10556, Houston, Texas February 19, 1996

Investigative Body: National Transportation Safety Board (NTSB), USA

AIRCRAFT ACCIDENT REPORT

WHEELS-UP LANDING
CONTINENTAL AIRLINES FLIGHT 1443
DOUGLAS DC-9 N10556
HOUSTON, TEXAS
FEBRUARY 19, 1996

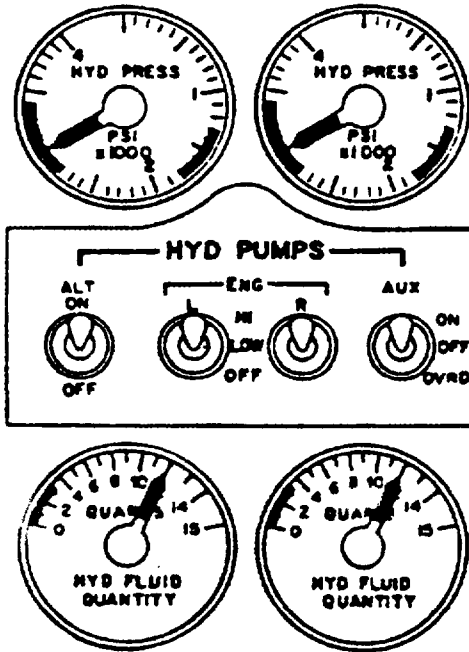
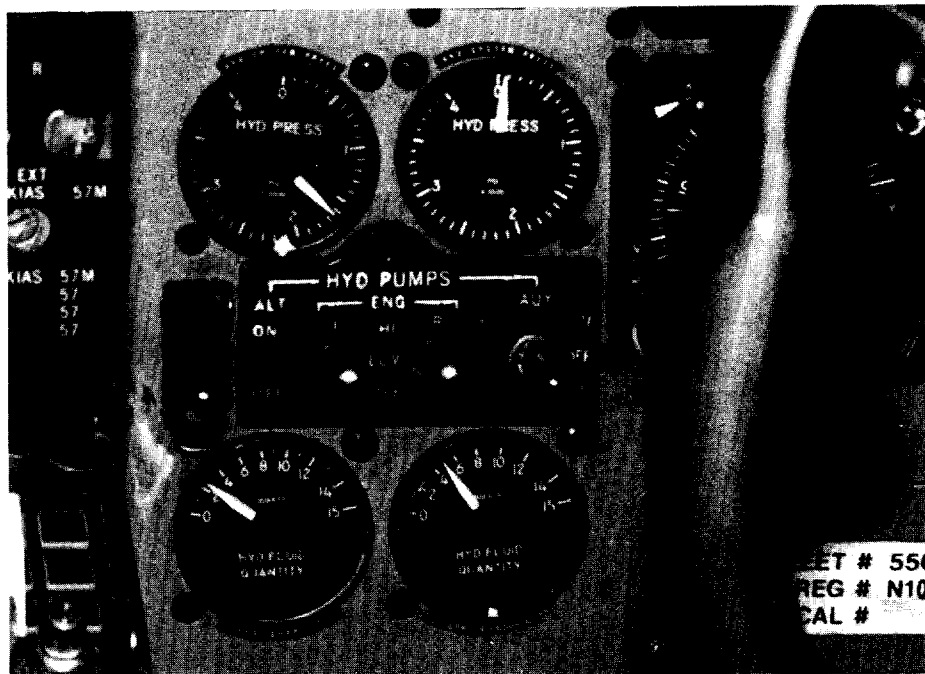
Figure 1 – Hydraulic switch panel.

Upper Illustration - Hydraulic switch panel in high pressure configuration.

Bottom Photo - Photo of accident airplane's hydraulic switch panel in low pressure configuration (see section 1.12).

requires hydraulic pressure greater than 2,000 psi. If the engine-driven pumps are in the “LOW” mode, the function of the flaps and the landing gear will be impaired. Douglas provides an “ON, OFF” hydraulic switch configuration as a customer option on the MD-80. Two operators have chosen this option, and as of December 31, 1996, there were 126 MD-80 airplanes in service worldwide with the “ON, OFF” switch configuration.

Examination of the cockpit revealed that the landing gear handle was in the down position and the flap handle was set to 50°. The left and right engine-driven hydraulic pump switches were in the “LOW” position, and the ALT and AUX hydraulic pump switches were in the “OFF” position. The left hydraulic system gauge indicated 1,600 psi, and the right gauge indicated 0 psi (refer to figure 1). The safety wire on the GPWS flap override switch was found broken; however, the switch was not in the “OVRD” position.
