# Crash During Landing, Federal Express, Inc., McDonnell Douglas MD-11, N611FE, Newark International Airport, Newark, New Jersey, July 31, 1997

## AIRCRAFT ACCIDENT REPORT

CRASH DURING LANDING  
FEDERAL EXPRESS, INC.  
MCDONNELL DOUGLAS MD-11, N611FE  
NEWARK INTERNATIONAL AIRPORT  
NEWARK, NEW JERSEY  
JULY 31, 1997

**NTSB/AAR-00/02  
DCA97MA055  
PB2000-910402  
Notation 7047B  
Adopted July 25, 2000**

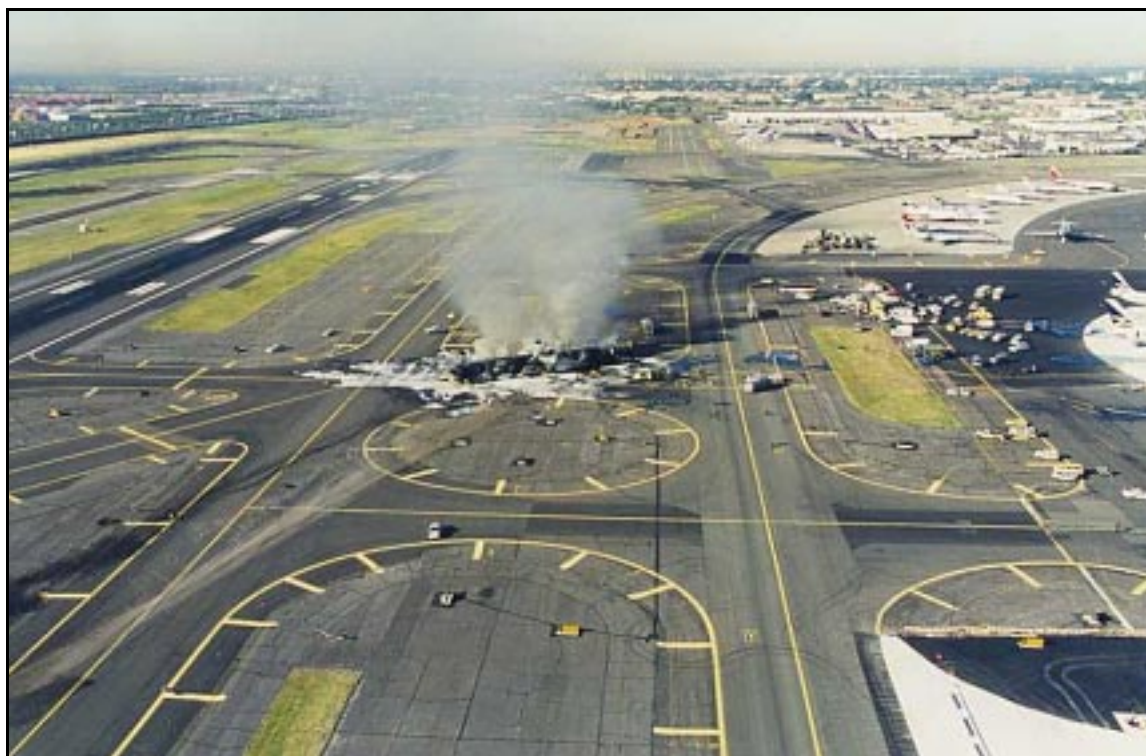
**Figure 1.** Aerial view of the accident site.

The airplane's wreckage was distributed along a 2,900-foot-long debris path that gradually arced to the right across runway 22R (see figure 7). Pieces of the right inboard trailing edge flap were found at the beginning of the wreckage path, about 2,226 feet from the runway's displaced threshold. The main wreckage, located about 5,126 feet from the runway threshold and 580 feet to the right of the runway centerline, comprised the fuselage, left wing, nose gear, left MLG, center MLG, and horizontal stabilizer. The fuselage came to rest inverted with the nose on a 95° heading. Other airplane components and structure separated from the airplane during the crash sequence and were located along the debris path.

Rubber marks consistent with the touchdown of the airplane's right MLG tires were found about 1,126 feet from the runway displaced threshold. Rubber marks consistent with the touchdown of the left MLG tires and center MLG tires were found at 1,151 feet and 1,160 feet from the runway displaced threshold, respectively. The location of the tire marks was consistent with a touchdown near the center of the runway. Rubber marks consistent with a second touchdown of the right MLG tires were found about 1,924 feet from the runway displaced threshold (798 feet after the tire marks consistent with the first touchdown). Rubber marks consistent with the center MLG tires were found again about 1,983 feet from the runway displaced threshold. The locations of the second touchdown tire marks were consistent with a touchdown near the center of the runway. The right MLG tire rubber marks veer to the right about 1,995 feet from the runway displaced threshold.

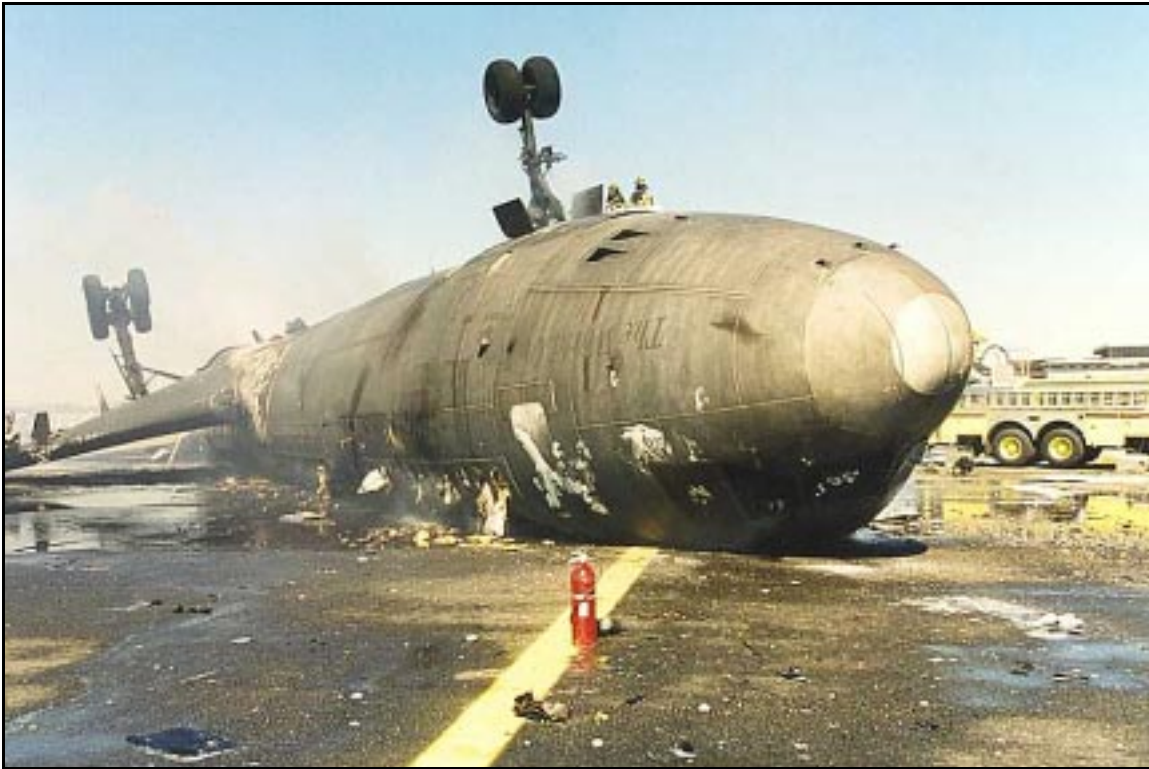
**Figure 4.** N611FE after the fire was extinguished.

The right wing, the vertical stabilizer, and all three engines separated from the airplane and were found in a grassy area to the right of the runway, about 4,577 feet from the runway threshold, and had sustained fire damage consistent with a postaccident fuel fire. The right MLG strut assembly and two MLG wheels and tires were found on the right edge of the runway, about 4,805 feet from the runway threshold. The other two right MLG wheels and tires were found about 235 feet to the right of the runway centerline and about 4,957 feet from the threshold.

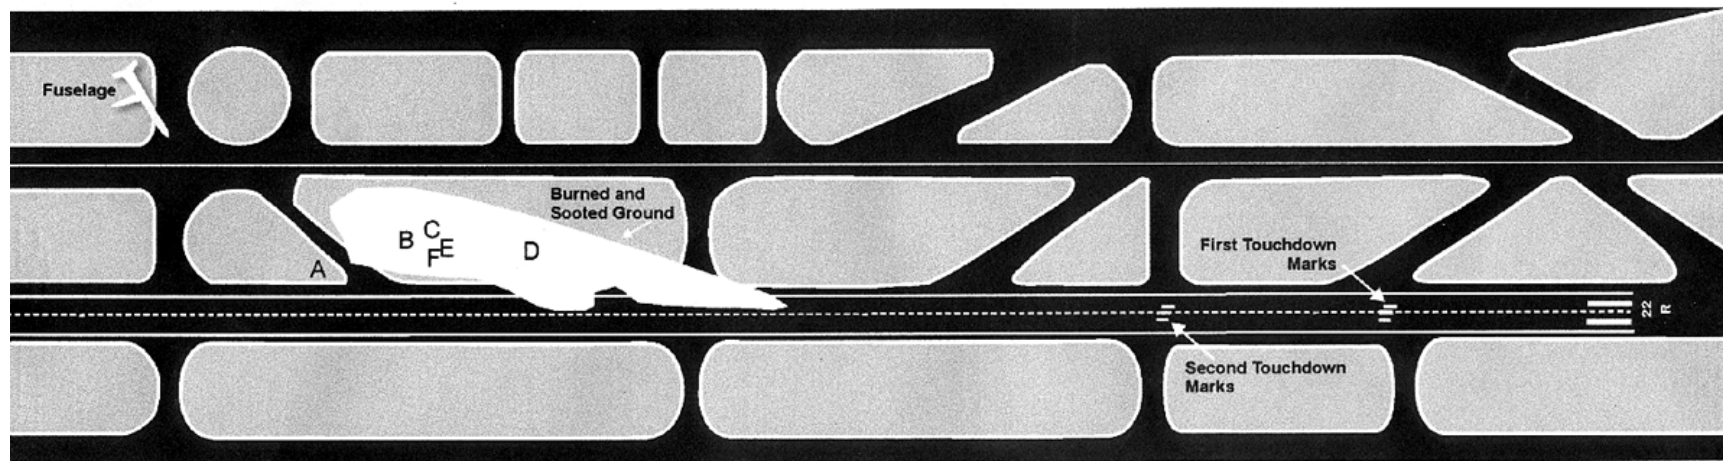
Ground scarring consistent with the No. 3 (right) engine nacelle contacting the runway were found about 2,164 feet from the runway displaced threshold and continued to about 3,476 feet from the runway threshold. Runway scarring consistent with impact of the right inboard trailing edge flap was found about 2,299 feet from the runway threshold, ending about 2,376 feet from the threshold (where the right inboard trailing edge flap was found). Soot marks consistent with burning fuel were found about 2,506 feet from the threshold and continued to the end of the wreckage path. Runway scrape marks and purple paint<sup>42</sup> consistent with the airplane's tail striking the runway were found about 2,644 feet from the runway threshold and ended about 3,060 feet from the threshold. About 2,826 feet from the threshold, runway scrapes, soot marks, and runway surface gouging began turning toward the right of the runway.

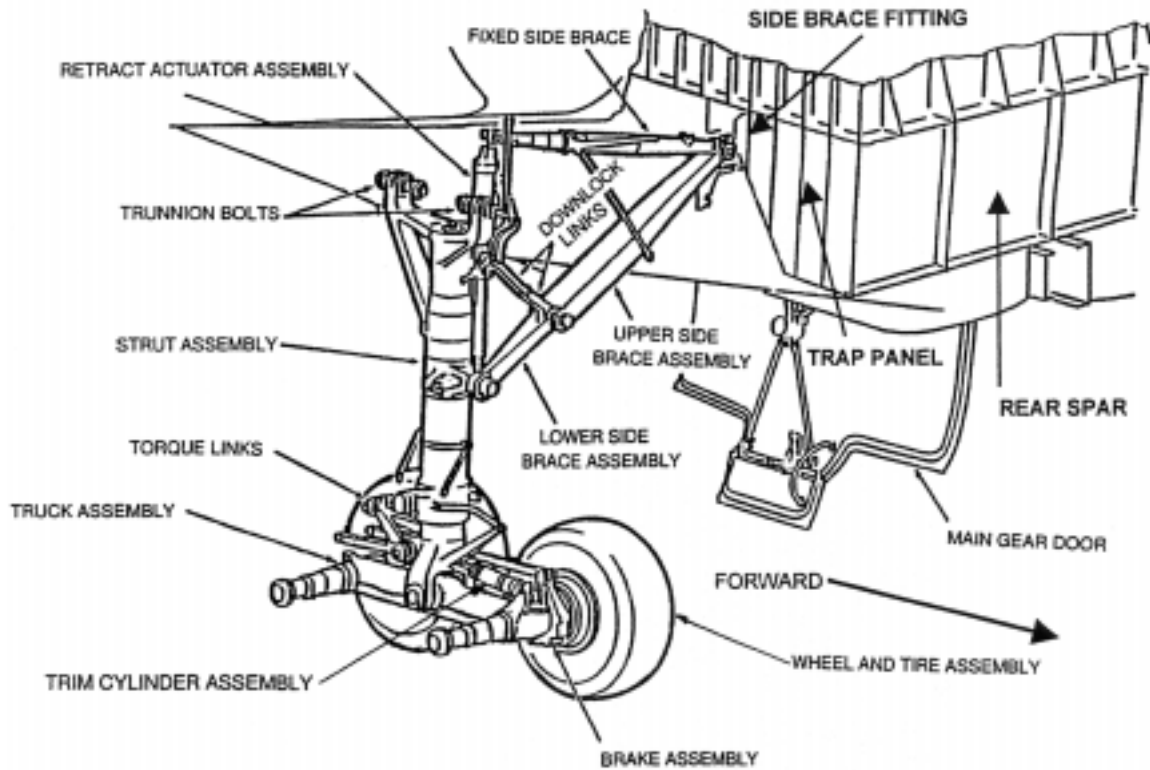
**Figure 8.** Right MLG components.

The right MLG was separated from its attach points on the right wing (see figure 8).<sup>43</sup> The attach points were broken from the wing, except for the forward lug, which remained attached to the wing with no evidence of failure. The right MLG truck assembly<sup>44</sup> was found separated into four parts: one part was attached to the aft axle, where the wheels and tires were found intact; a second part was found on the runway; a

third part was found attached to the forward axle, where the No. 3 and No. 4 wheels were found intact; and a fourth part was found attached to the strut assembly. The pivot pin was found intact between the truck beam and the oleo piston assembly. The oleo piston and cylinder were found intact, and the piston was fully extended. The torque links were intact and had no structural damage. Parts of a wing-to-gear fitting were found on the aft trunnion<sup>45</sup> bolt. The forward trunnion bolt, or fuse pin,<sup>46</sup> failed and had broken into two pieces along the shear plane.<sup>47</sup> The aft portion of the forward trunnion bolt was found on the runway, and the forward portion was found in the right wing-to-gear-fitting forward trunnion lug.

Scraping damage was found on the forward trunnion lug's forward face. The fixed side brace (to) folding side brace fitting joint was found intact with the side brace, the fixed brace, the side brace fitting (commonly referred to as the "pillow block"), and the pillow block hinge joint pin assembly (see figure 8). The inboard attach bolt was found intact with the pillow block and a part of the trapezoidal panel assembly. The remaining bolt was found detached and in two pieces. One piece was found in the remaining part of

the trapezoidal panel that had broken off from the fuselage and the pillow block assembly. The other bolt piece was found on the runway. The fixed side brace was found fractured about 6 inches from the wing fitting lug and was bent in the aft direction where it failed.

A metallurgical examination of the recovered right MLG components determined that all fracture surface evidence was consistent with overload failure. No evidence of fatigue cracking or corrosion was found. In addition, the examination found no indications of preimpact failures or anomalies. An examination of the right MLG tires found no evidence of pretouchdown failures or malfunctions.
