**Loss of Pitch Control on Takeoff, Emery Worldwide Airlines, Flight 17,
McDonnell Douglas DC-8-71F, N8079U, Rancho Cordova, California,
February 16, 2000**

Aircraft Accident Report
NTSB/AAR-03/02

**Loss of Pitch Control on Takeoff
Emery Worldwide Airlines, Flight 17
McDonnell Douglas DC-8-71F, N8079U
Rancho Cordova, California
February 16, 2000**

The National Transportation Safety Board determined that the probable cause of the accident was a loss of pitch control resulting from the disconnection of the right elevator control tab. The disconnection was caused by the failure to properly secure and inspect the attachment bolt.

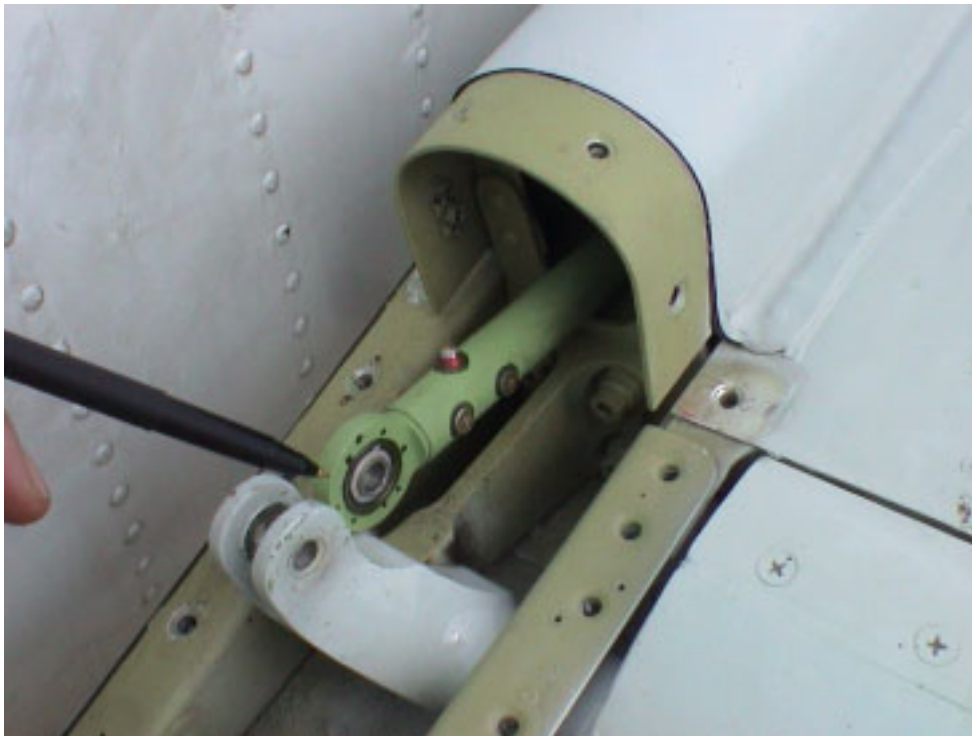
When the aft end of the test airplane's pushrod cleared the crank fitting, it shifted slightly inboard so that it was aligned with the inboard leg of the forward face of the crank fitting. When the test airplane's control tab was manually raised TEU (simulating the effects of aerodynamic forces that would be experienced during the takeoff roll), the crank fitting contacted the aft rod end, obstructing any attempt to further deflect the elevator control tab in the TEU direction. Figure 10 shows the test airplane's pushrod in this position.

Figure 10. Photograph of the test airplane's right elevator control tab pushrod contacting the crank fitting.

When the test airplane's elevator surfaces were manually moved to their TEU limit (about 27° TEU) in this condition, the control columns moved aft from 15.0° forward of vertical (the position in which they were held by the centering device) to about 8.8° forward of vertical, and both elevator geared tabs moved to 27.5° TED. The left elevator control tab deflected fully to about 8.5° TEU; however, the right elevator control tab could not be moved further in the TEU direction than 15.9° TED because of interference with the disconnected pushrod.

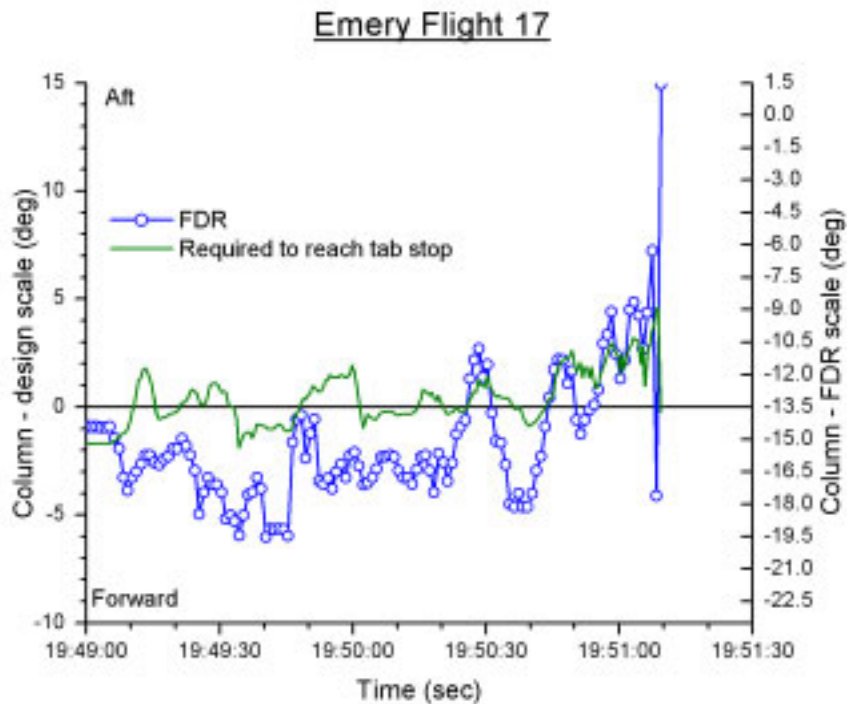
Figure 12 shows the control column position required for the left elevator control tab to reach its TEU physical stop (with no cable stretch) and the recorded control column position for the recorded elevator position during the accident flight. The plot indicates that at most points during the accident flight, the flight crew was trying to command additional forward control column.

Figure 12. The control column position required for the left elevator control tab to reach its TEU physical stop (for the recorded elevator position) and the actual recorded control column position for the accident flight.
