Stall on takeoff, Bombardier CL-600-2B16 (CL-604), C-FTBZ , Mid-Continent Airport, Wichita, Kansas, October 10, 2000

Aircraft Accident Brief

Accident Number:	CHI01MA006
Aircraft and Registration:	Bombardier CL-600-2B16 (CL-604), C-FTBZ
Location:	Mid-Continent Airport, Wichita, Kansas
Date:	October 10, 2000
Adopted On:	April 14, 2004

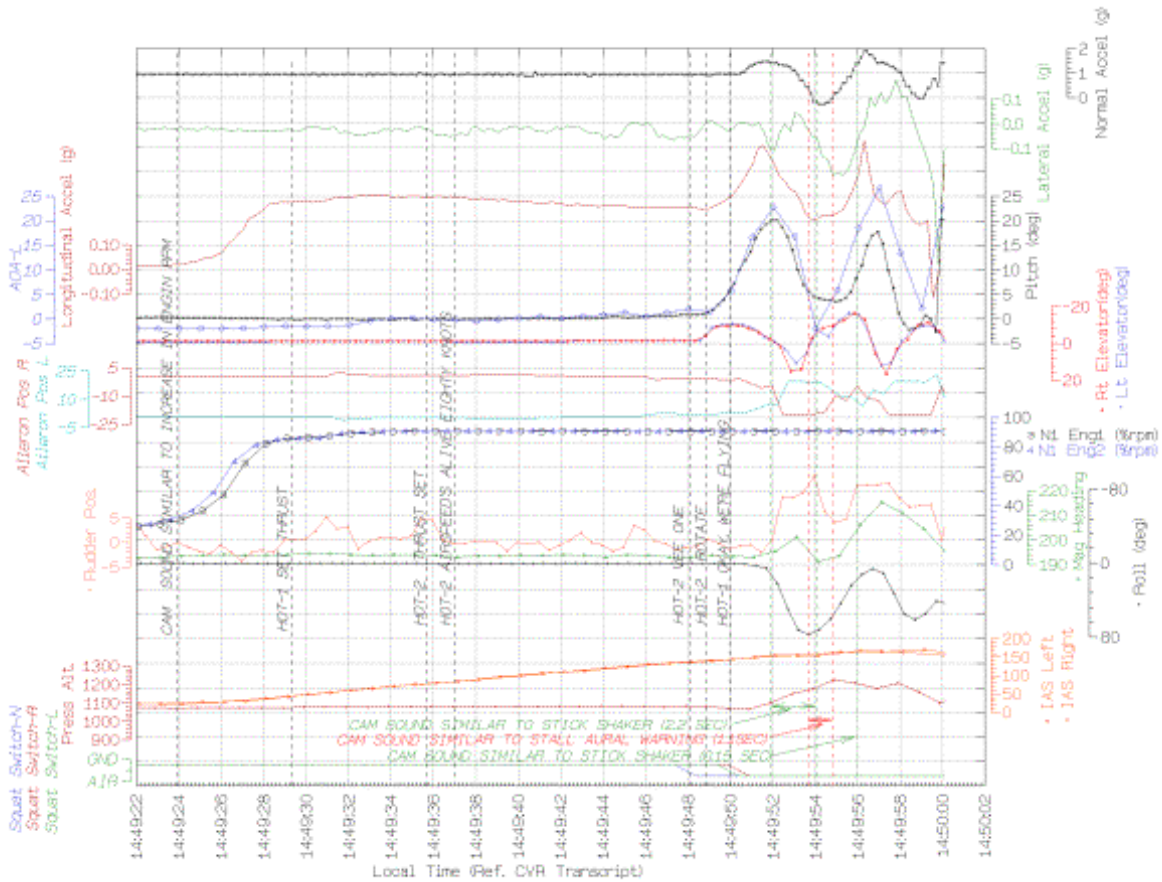
Figure 2.

The CVR recorded the intermittent activation of stick shaker, aural stall, and bank angle warnings beginning with the first pitch up to 20° until about 1 second before impact. After initial rotation, all elevator, rudder, and aileron inputs by the pilot were consistent with inputs to counter pitch and roll oscillations, according to FDR information. FDR data indicated a peak pitch rate of 8.4° per second. (The airplane's ADAS, which recorded test flight data at a higher sampling rate, indicated a pitch rate of 9.6° per second).

According to FDR data and information derived from the Safety Board staff's integration study of FDR data (flightpath integration), the airplane's peak airspeed was 170 knots. The flightpath integration indicated that the airplane's peak altitude was about 70 feet. FDR information indicated that the engines were operating at 90 percent fan speed until impact.
