Loss of Control and Impact With Terrain, Aviation Charter, Inc., Raytheon (Beechcraft) King Air A100, N41BE, Eveleth, Minnesota, October 25, 2002

**Loss of Control and Impact With Terrain
Aviation Charter, Inc.
Raytheon (Beechcraft) King Air A100, N41BE
Eveleth, Minnesota
October 25, 2002**

Aircraft Accident Report
NTSB/AAR-03/03

Aircraft Accident Report

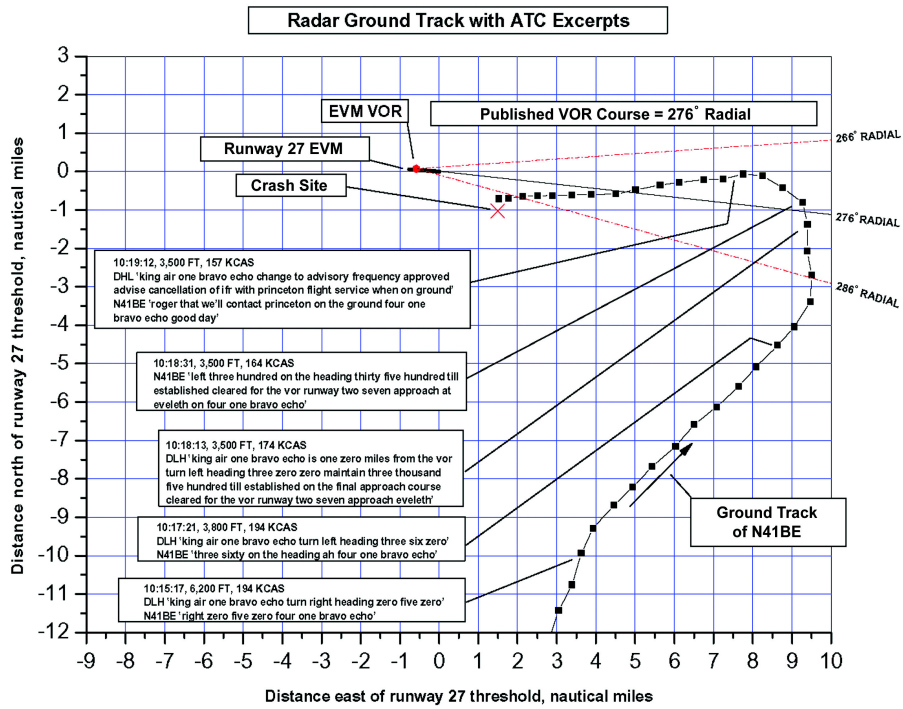
Figure 2. Ground track of the accident flight.

The airplane impacted the ground about 1.8 miles southeast of the approach end of runway 27. The main wreckage was found at 47° 24.36' north latitude and 92° 27.05' west longitude at an elevation of 1,361 feet. The wreckage location was about 1/4 mile south-southwest of the last radar return.

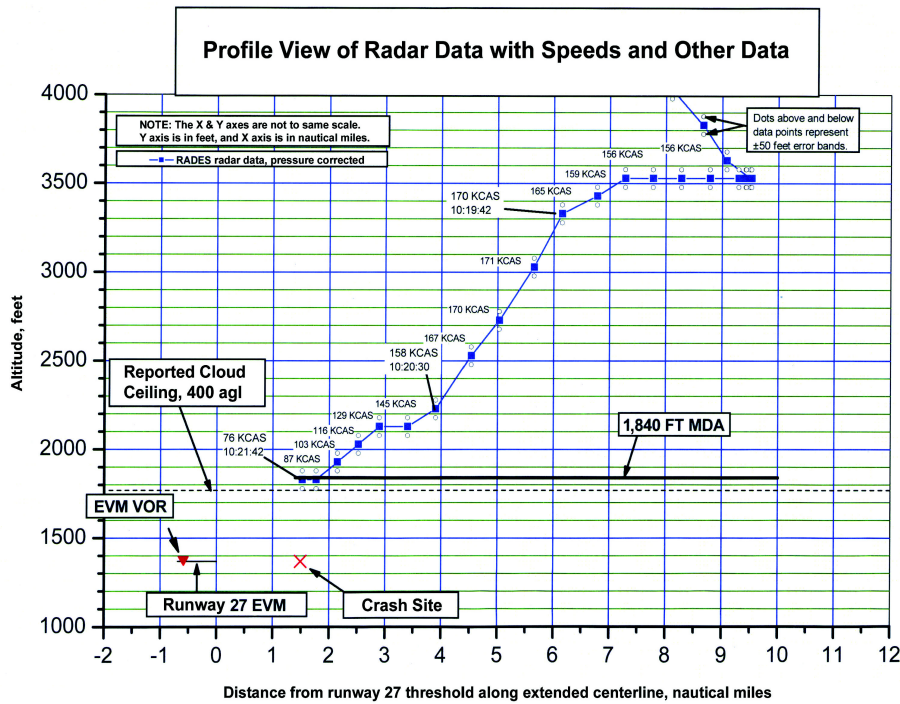
Figure 3. Profile view of the accident flight.

At 1019:12, the controller stated, “king air one bravo echo change to advisory frequency approved[;] advise cancellation of ifr with the princeton flight service when on the ground.” The copilot acknowledged the instruction at 1019:20. This was the last transmission received by ATC from the accident airplane. Radar data indicate that at this time, the airplane began its descent from 3,500 feet and that its airspeed stopped decreasing about 155 KCAS and began increasing.

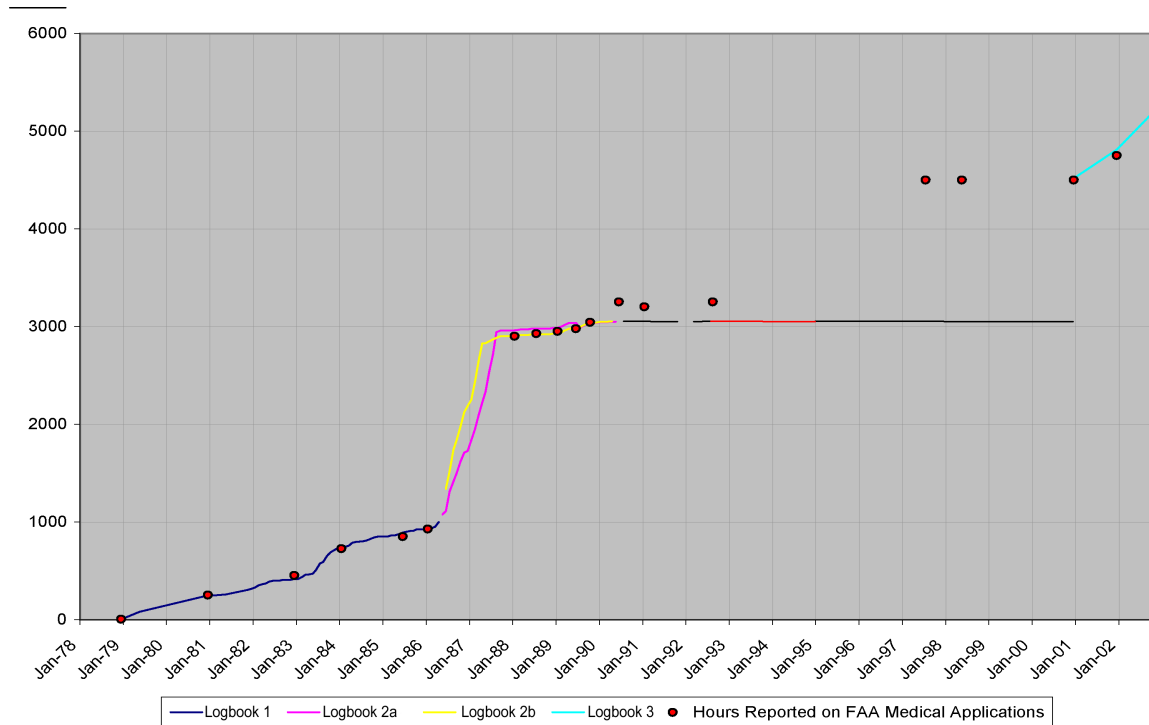
Figure 4. Reconstruction of pilot's reported flight hours.

hours from the flight hour totals in the final entries of the two conflicting logbooks. Further, in August 1992, the pilot reported on an FAA medical certificate application form that he had a total of 3,250 flight hours, which is 1,268 fewer hours than he claimed in the notarized statement to have acquired as of December 1994.²⁴ Safety Board investigators did not find any records that could verify the hours reported by the pilot in his private logbooks. See figure 4 for a reconstruction of the pilot's reported flight hours.
