Landing gear failure on landing, Accident of aircraft Fokker MK-100, registration I-ALPL, at Barcelona Airport (Barcelona), on 7 November 1999

TECHNICAL REPORT A-068/1999

Accident of aircraft Fokker MK-100, registration I-ALPL, at Barcelona Airport (Barcelona), on 7 November 1999

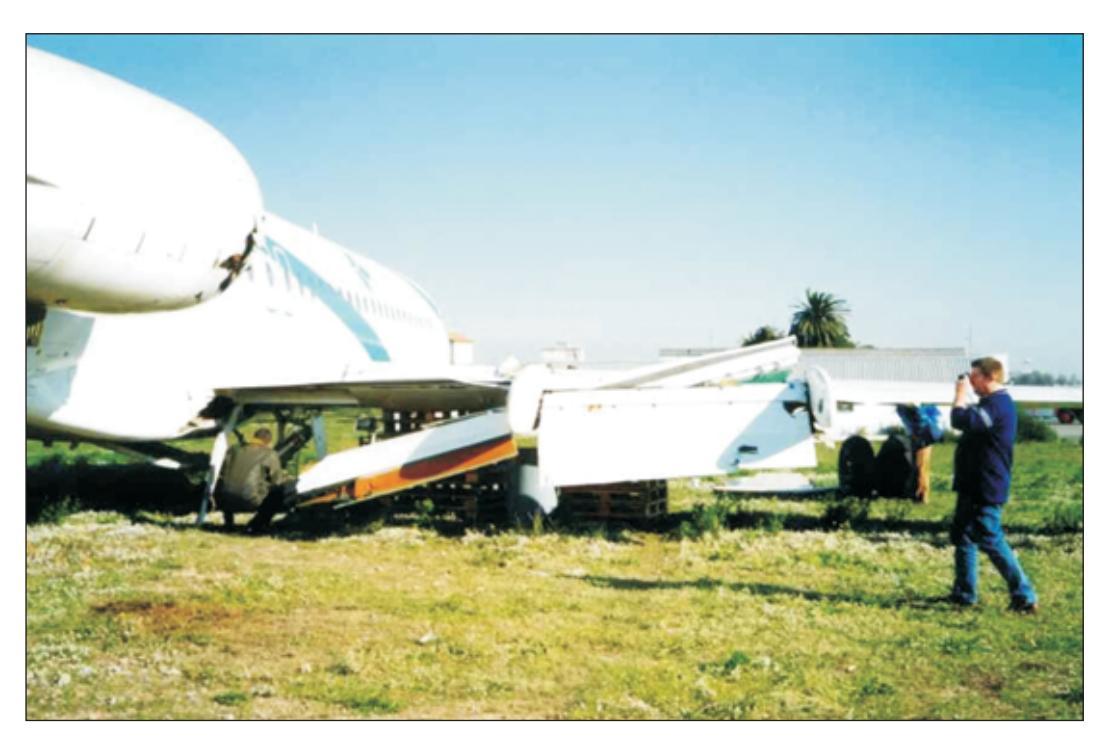
Photo 1.1.1

The aircraft suffered considerable damage to the wing and the cowlings of the righthand engine, and also to the doors of the right-hand main landing gear leg.

The air inlet cowling and the side cowling of the right-hand engine showed damage and perforations produced by the blow from the wheel carriage, formed by the two wheels of the right-hand main leg mounted on the sliding member unit, broken off from the leg. In this engine zone a fuel leak occurred, lasting several hours (Photo 1.1.1).

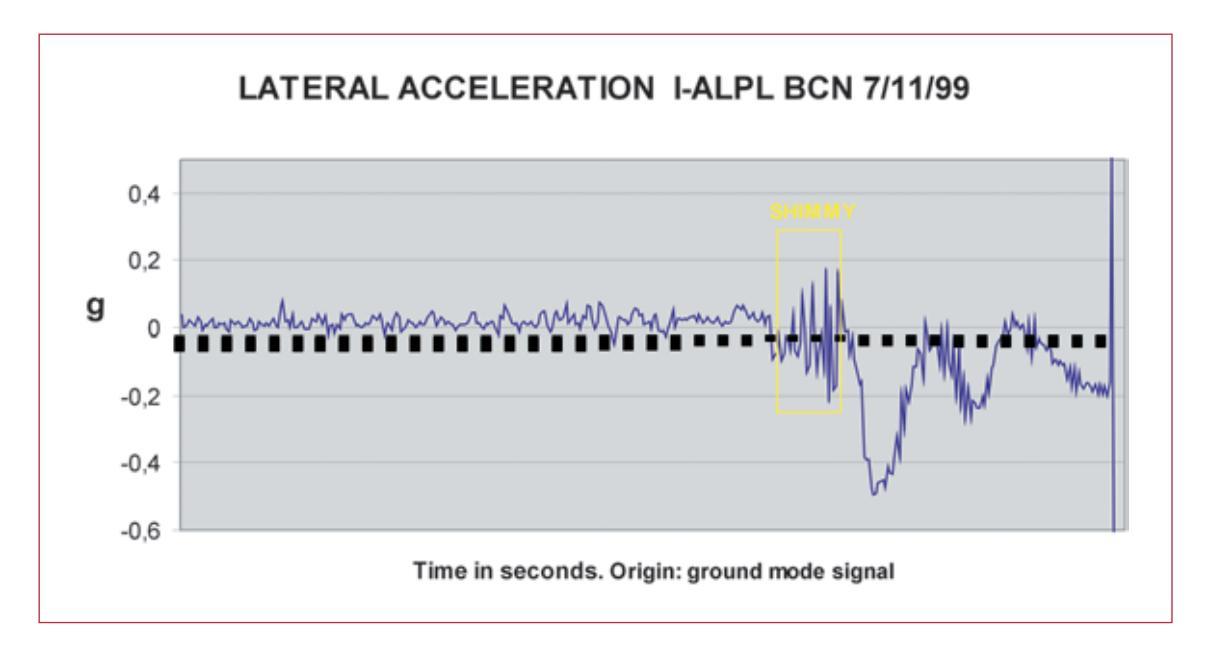
Figure 1.11.1

The installed DFDR records the parameter of lateral acceleration with a periodicity of a quarter of a second. The series of data recorded during the approach, touchdown and braking run until the aircraft came to a halt are shown in graphic form in figure 1.11.1. It can be seen that although the levels of lateral acceleration were low at all times, at touchdown they increased in absolute values and the frequency of the changes of direction of those accelerations also increased. After the breakage of the main landing gear leg, the aircraft zigzagged for several seconds, tending to pull to the right. The maximum acceleration in that direction reached almost 0.5 g, some 13 s after touchdown.

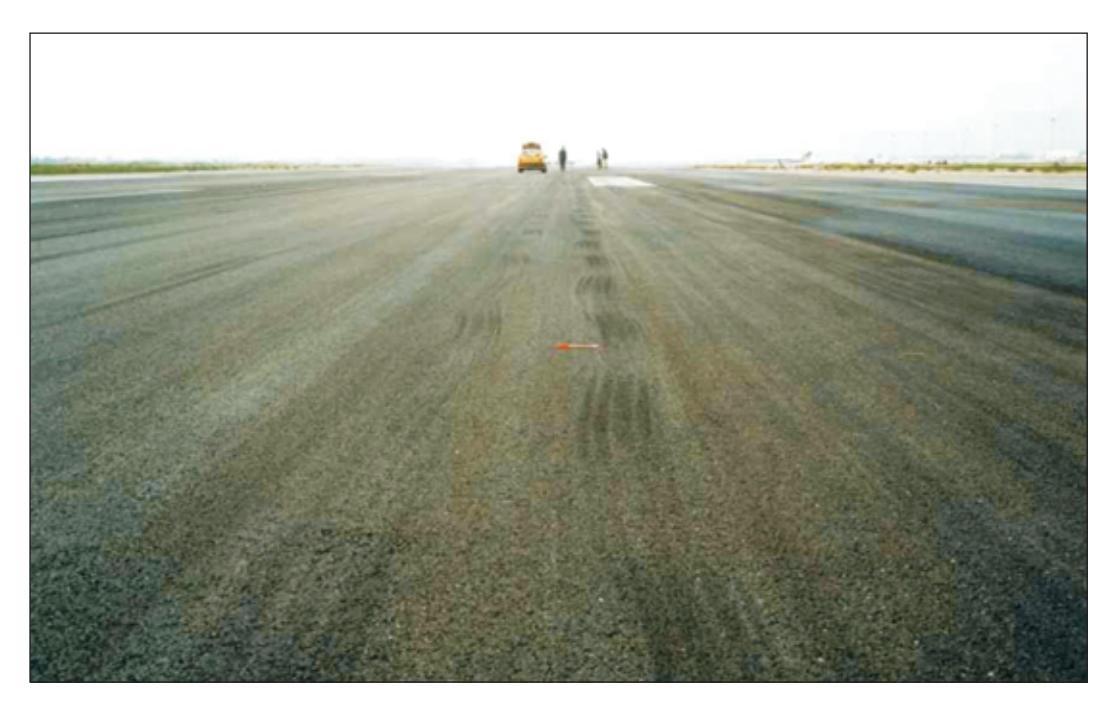
Photo 1.12.1

Finally, tracks were detected of the tyres of the nose and left-hand landing gear, which had left cycloid traces which crossed on two occasions and continued until the aircraft's stopping point.

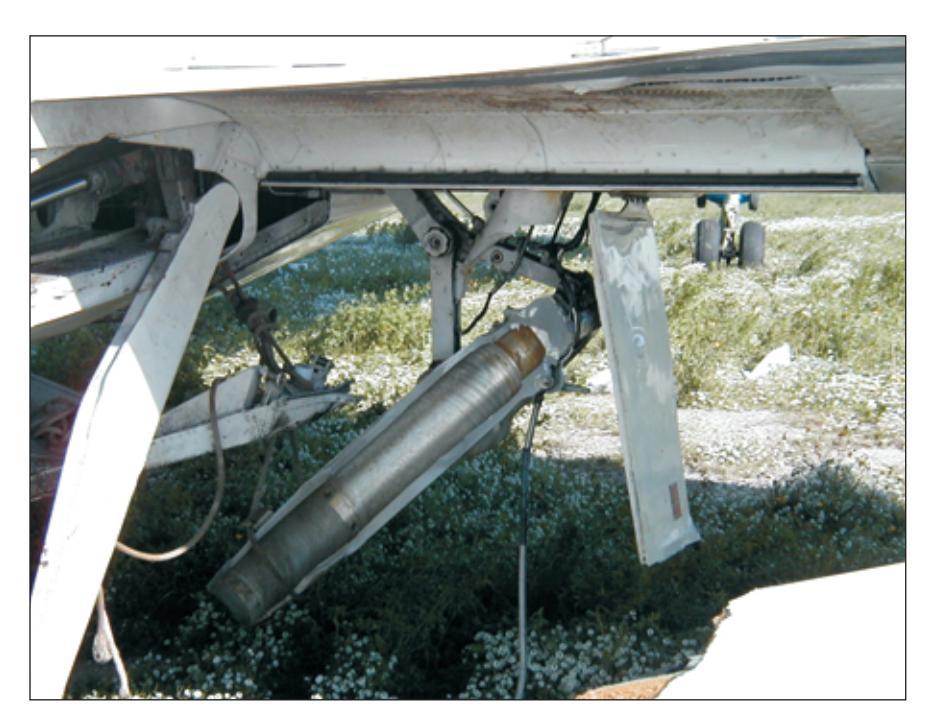
Photo 1.12.2

The right wing landing gear fixing was fractured. Of the main fitting of the right main leg, which had broken into fragments, there remained the front half-shell (Photo 1.12.2), attached to the wing structure by the extension/retraction joint.

The main joint was destroyed. The other fragments of the main fitting had broken off. The sliding member with wheels was separated.

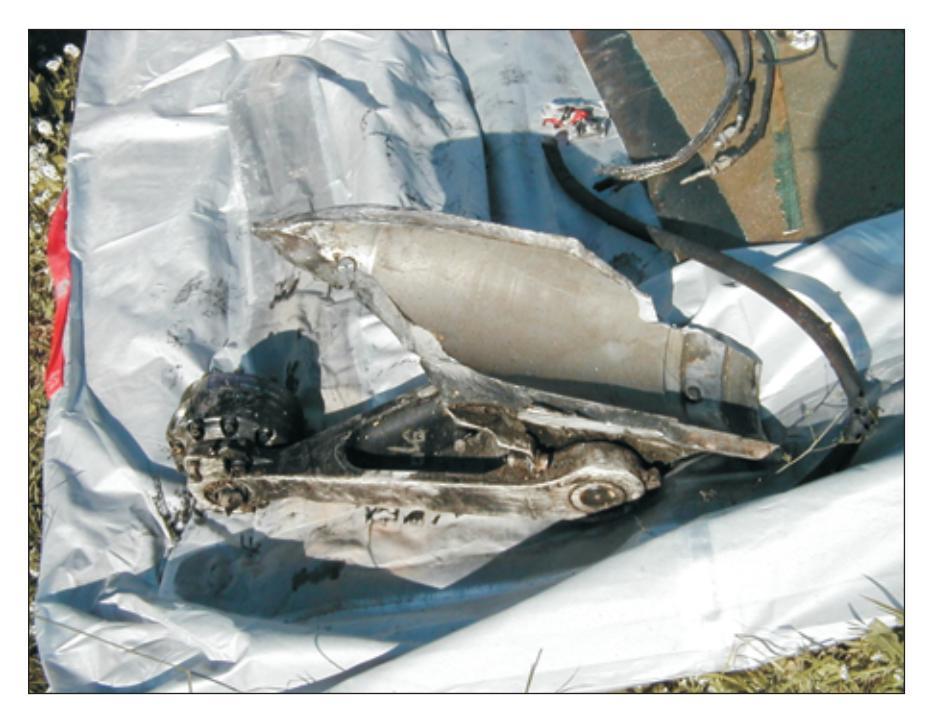
Photo 1.12.3

Another large piece of the main fitting included a triangular surface joined to the upper torque link (Photo 1.12.3). This arm of the torque link turned freely, and some play

could be appreciated in it in its connection with the main fitting. The housing of the shimmy damper was connected to the torque link.

After the breakage of the apex bolt of the torque links, the shimmy damper remained connected to the upper torque link (Photos 1.12.3 and 1.16.3). Its housing showed some damage but was still intact. The reservoir, (reserve hydraulic tank) of the damper was found broken off and separated.

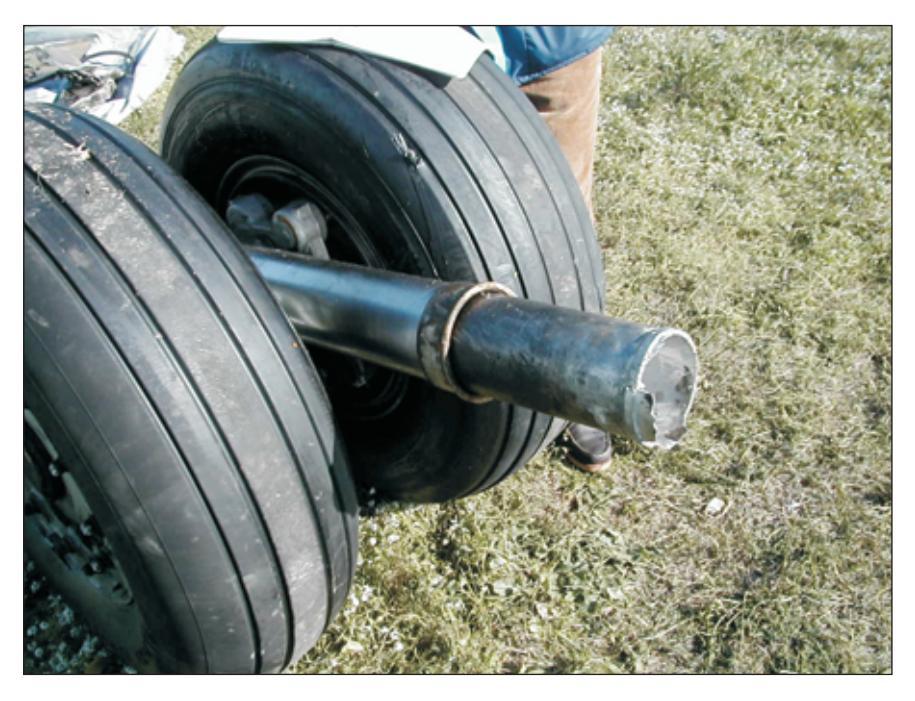
Photo 1.12.4

The tyres had not burst and they maintained pressure. No previous defects such as flat spots were observed. The circumferential damage they showed was due to friction with the upper torque link before shearing off.

The wheel units (tyres, brakes and rims) did not show any apparent anomalies or damage, apart from those mentioned in the tyres and a few small impact traces on the outer rims.

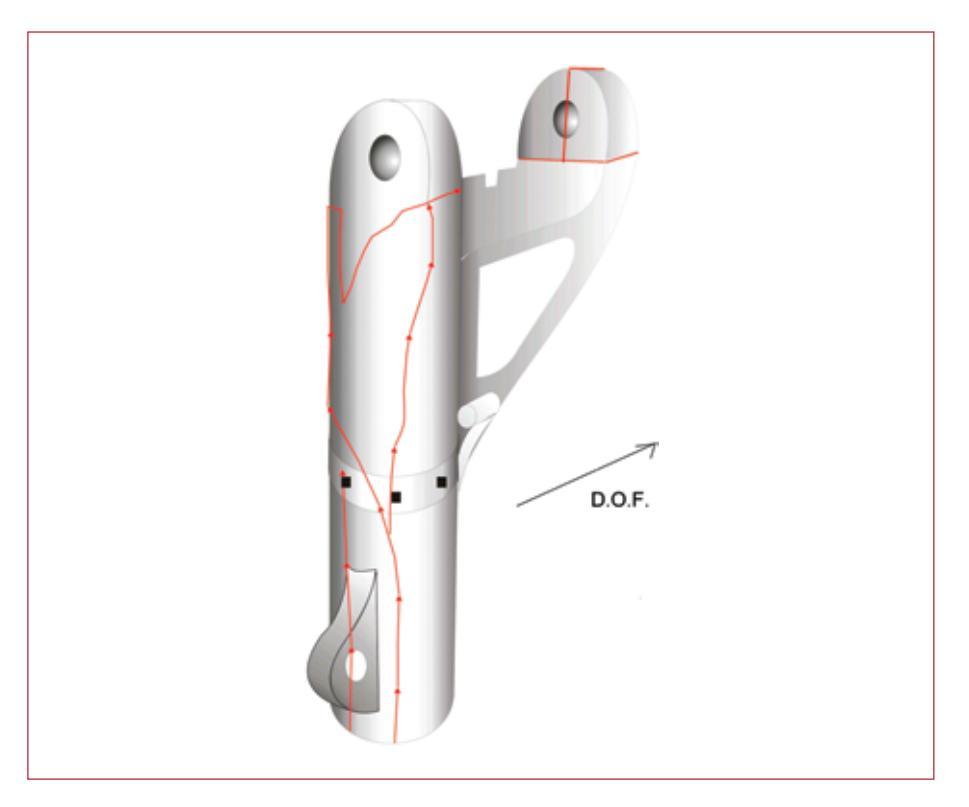
The crack that is expected to be the primary initial crack was located at the outer surface of the main fitting adjacent to the RH centreline of the upper main fitting torque link section. This is the location where the highest stresses occur in case of local bending due to torsion introduced by torque links. From this location the crack run upwards and downwards.

A second crack initiation was observed at the LH side of the main fitting torque link lug section. The position of this initiation site was located closer to the lower end of the main fitting and started not at the outer surface but at the inner surface, suggesting that this initiation was caused by similar torsion bending loads following from the RH crack. Also from this initiation the crack ran to lower and upper direction.

Figure C.2. Extension lines of the cracks in the collapse of the right-hand main fitting

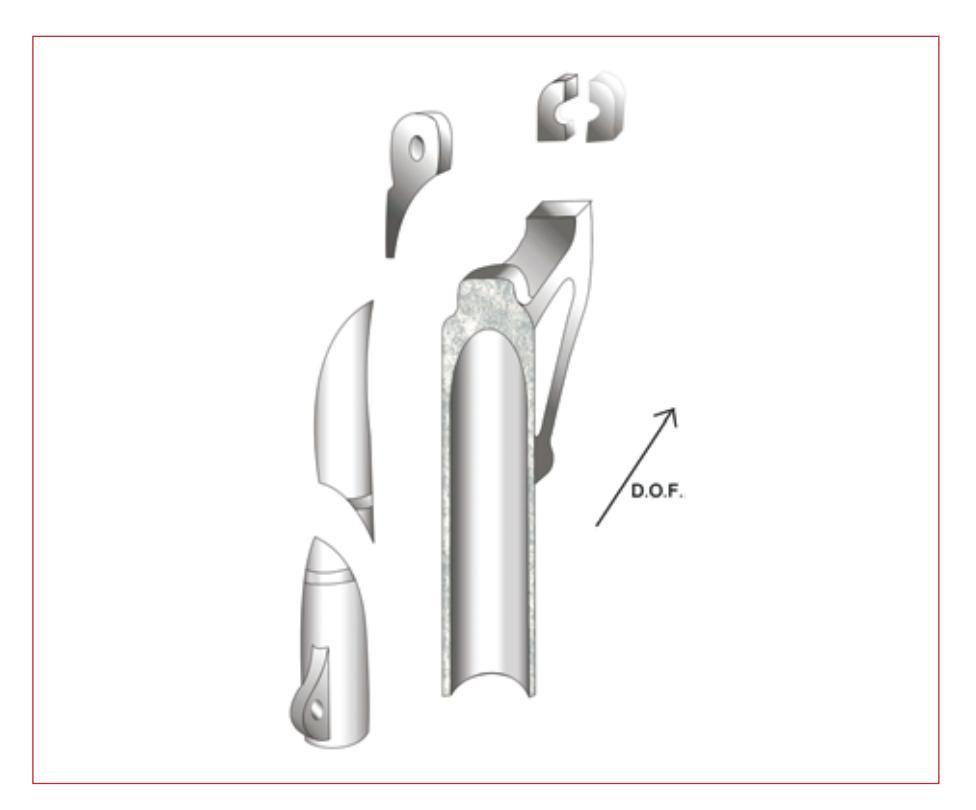
Two secondary initial cracks were observed on fragmented parts of the main fitting. These cracks most likely were caused by the sliding member splitting the main fitting open during separation.

Figure C.3. Principal fragments of the right-hand main fitting

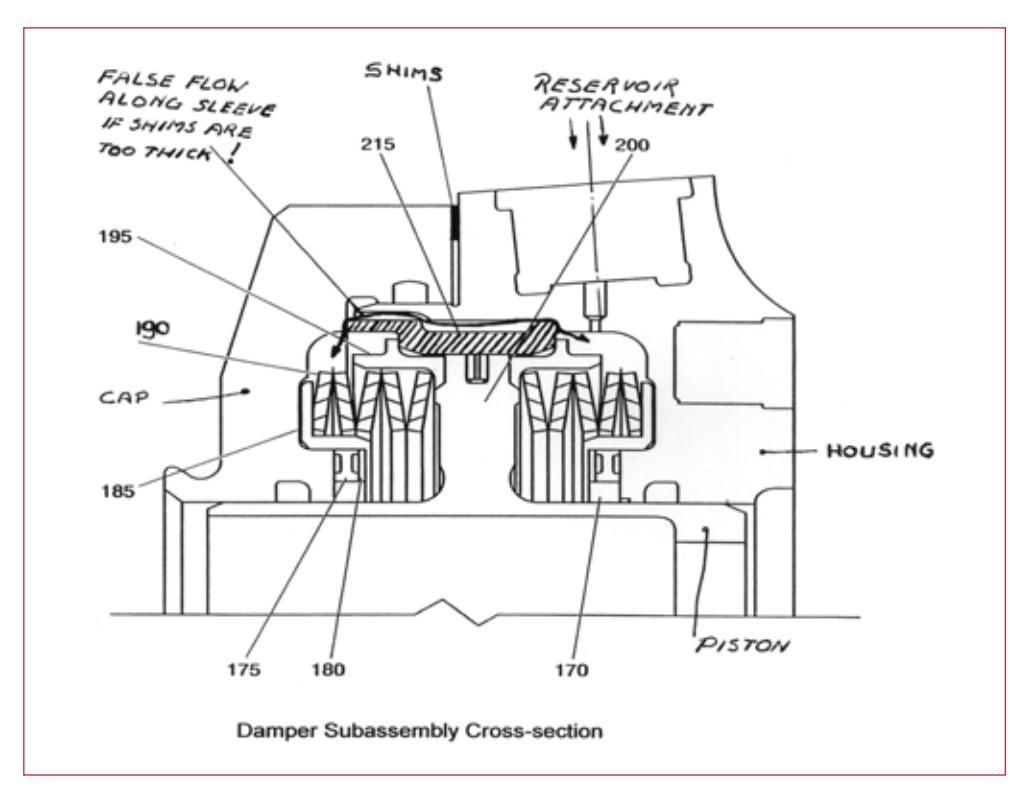
In the assembly procedure, it was specified that the gap in the casing of the sleeves must be measured and that a pack of shims of thickness equal to that gap with a tolerance of +0/-0.076 must be installed. However, the workshop measurements record only one value, corresponding either to the play or to the thickness of the shim pack, although subsequent clarifications confirmed that they referred to the shim thickness installed. It has also been observed that the measurements of the shim thickness after the accident coincide with the only measurement recorded during the general inspection.

Figure C.5. Cross-section of the damper (observe the shim pack and route of the false inner flow in the damper)

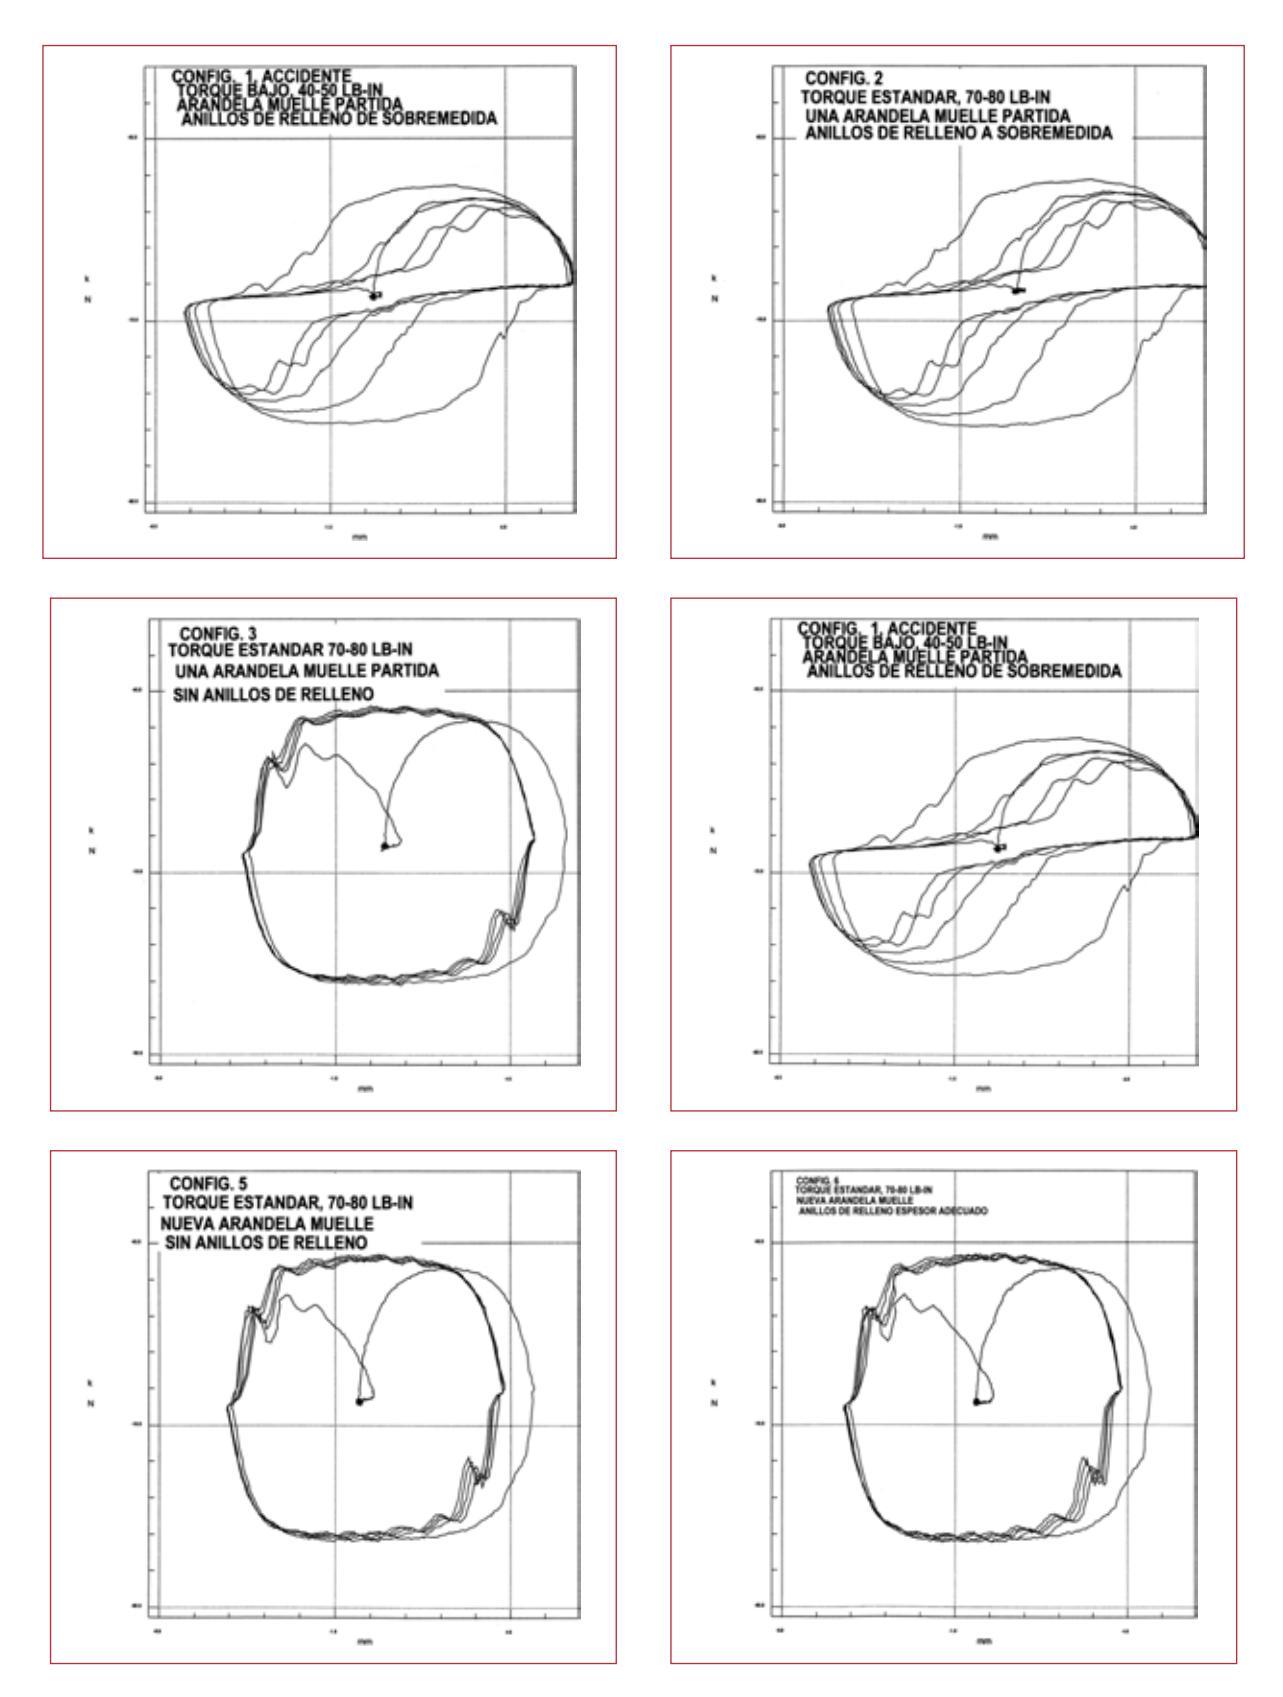
- At frequencies of over 16 Hz the damper in the accident configuration had a much lower damping capacity, less than 50%, than the damper in the configuration complying with the requirements of the functional test CMM 1.C (1).
- The defect of one split washer had no influence on the damping capacity.
- The increase in the tightening torque did not improve the performance of the damper in the configuration of excess shim thickness.

Figure D.1. Comparison of the results of dynamic excitation tests on the shimmy damper s/n MAL176
