Runway departure, Accident of aircraft FOKKER 50, registration PH-FZE, at Melilla Airport (Spain), on 17 January 2003

Investigative Body: Civil Aviation Accident and Incident Investigation Commission (CIAIAC), Spain

TECHNICAL REPORT A-002/2003

Accident of aircraft FOKKER 50, registration PH-FZE, at Melilla Airport (Spain), on 17 January 2003

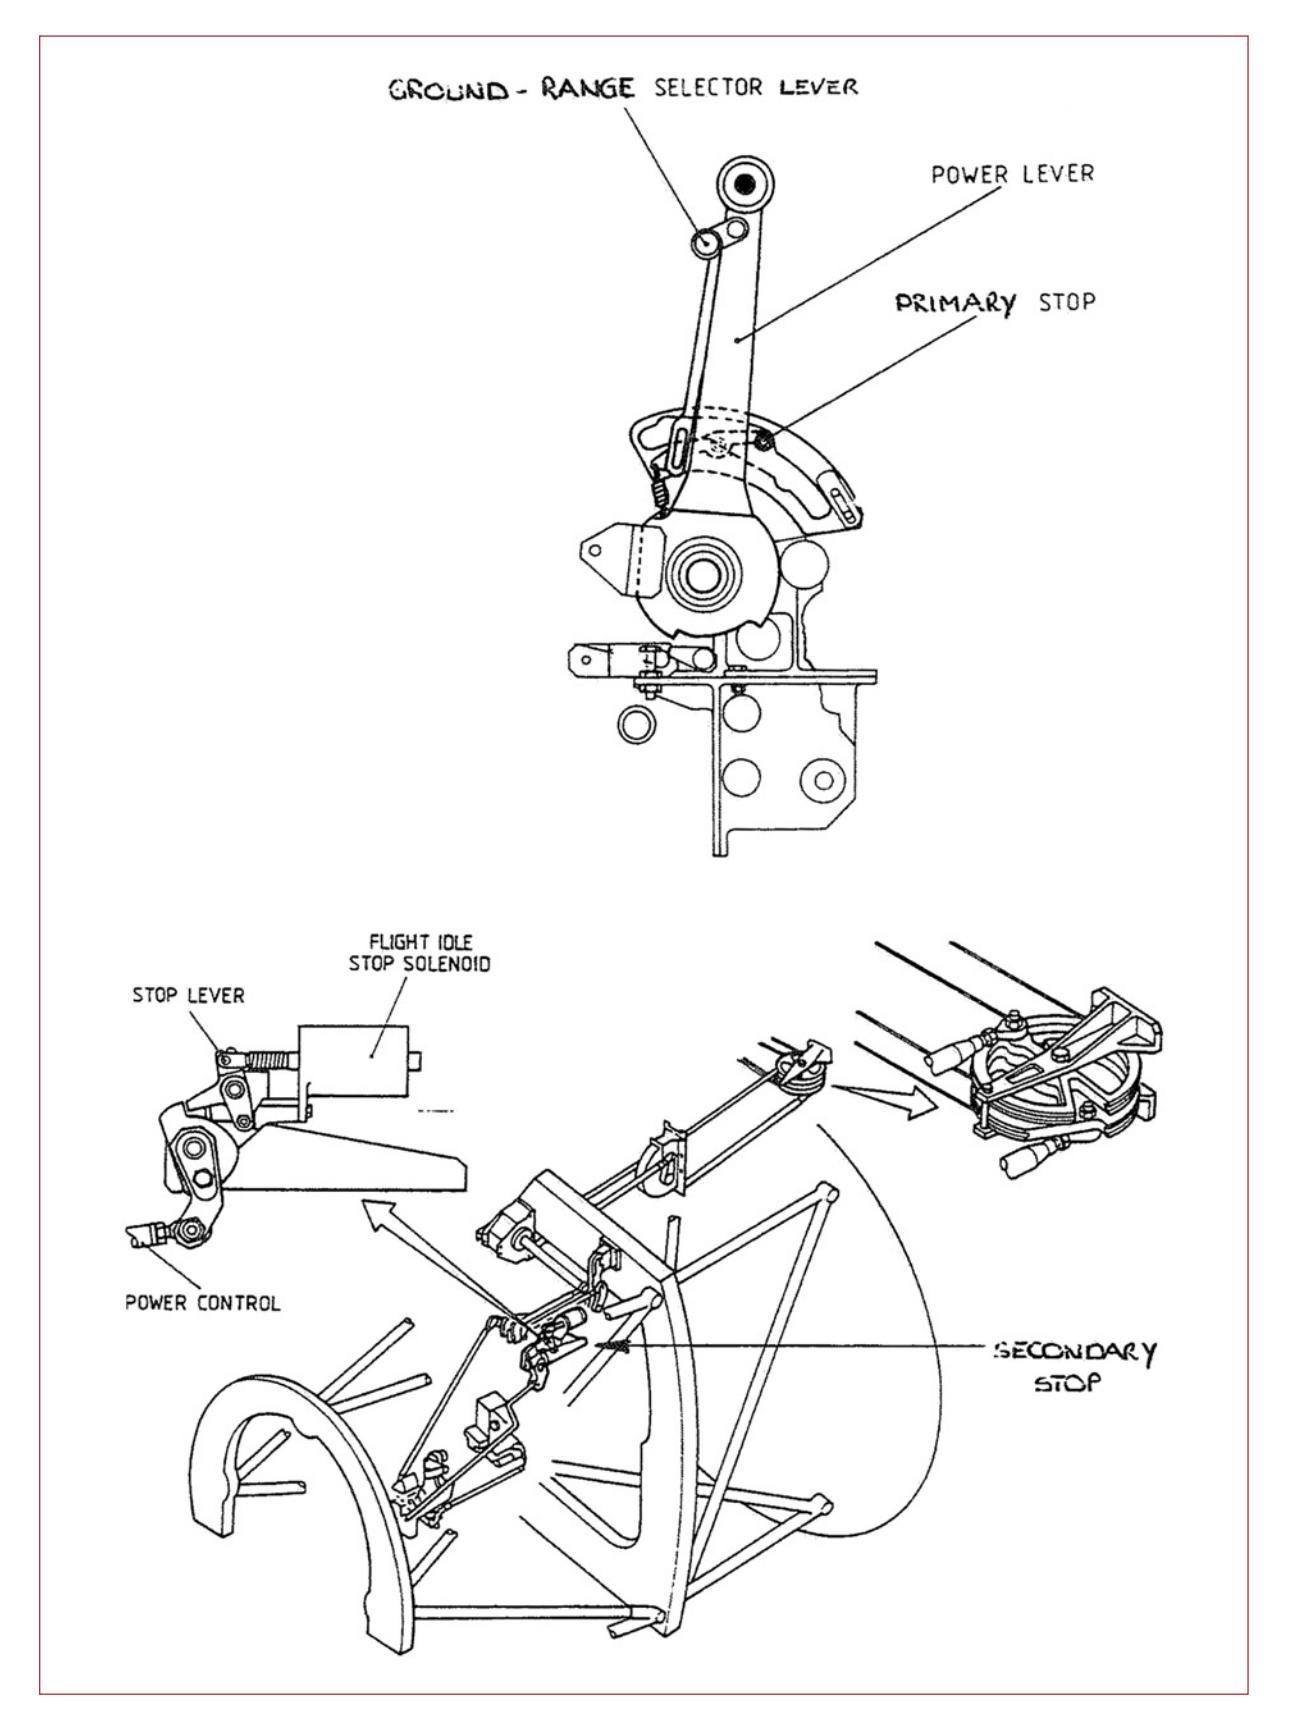
Figure 1.6.3.2. Detail of the automatic flight idle stop assembly (from Fokker SL 137)

However, the contrary is also true: if certain failures happen, and the solenoid is not energized on the ground, the automatic flight idle stop is not removed and ground idle or thrust reverse cannot be selected when desired by the pilot. There is no «override» feature on the cockpit to overcome this possible fault.

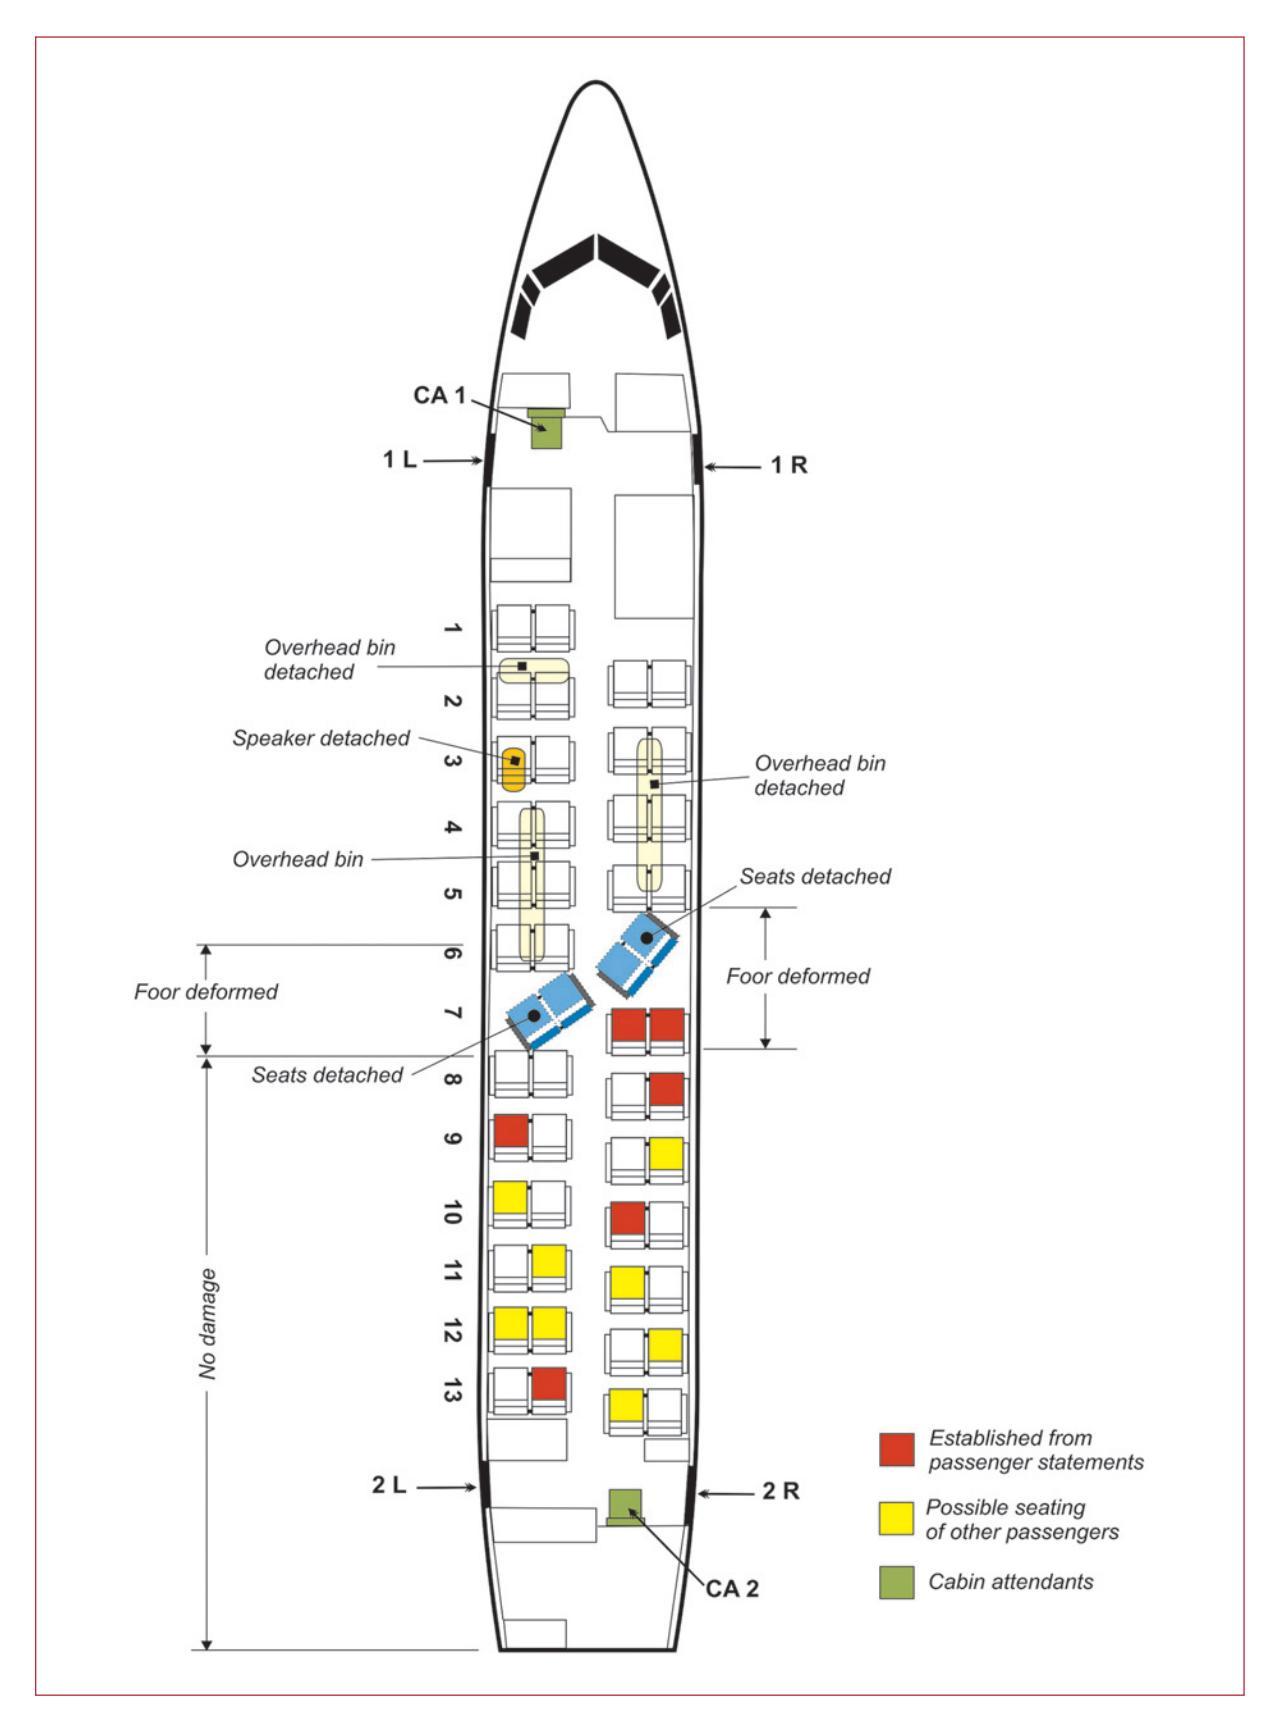
Figure 1.15.1. Drawing of the passenger cabin damage

As a result of the impacts when the aircraft jumped through the slope (the highest and latest recorded value of vertical acceleration was 5 g), the passenger cabin suffered important damage in its central part, where the wing was detached from the fuselage. The four seats of row 7 were detached and 2 overhead bins detached and fell towards the seats (see Figure 1.15.1). However, there was no noticeable damage to the seats, overhead bins or floor from row 8 towards the tail of the aircraft.

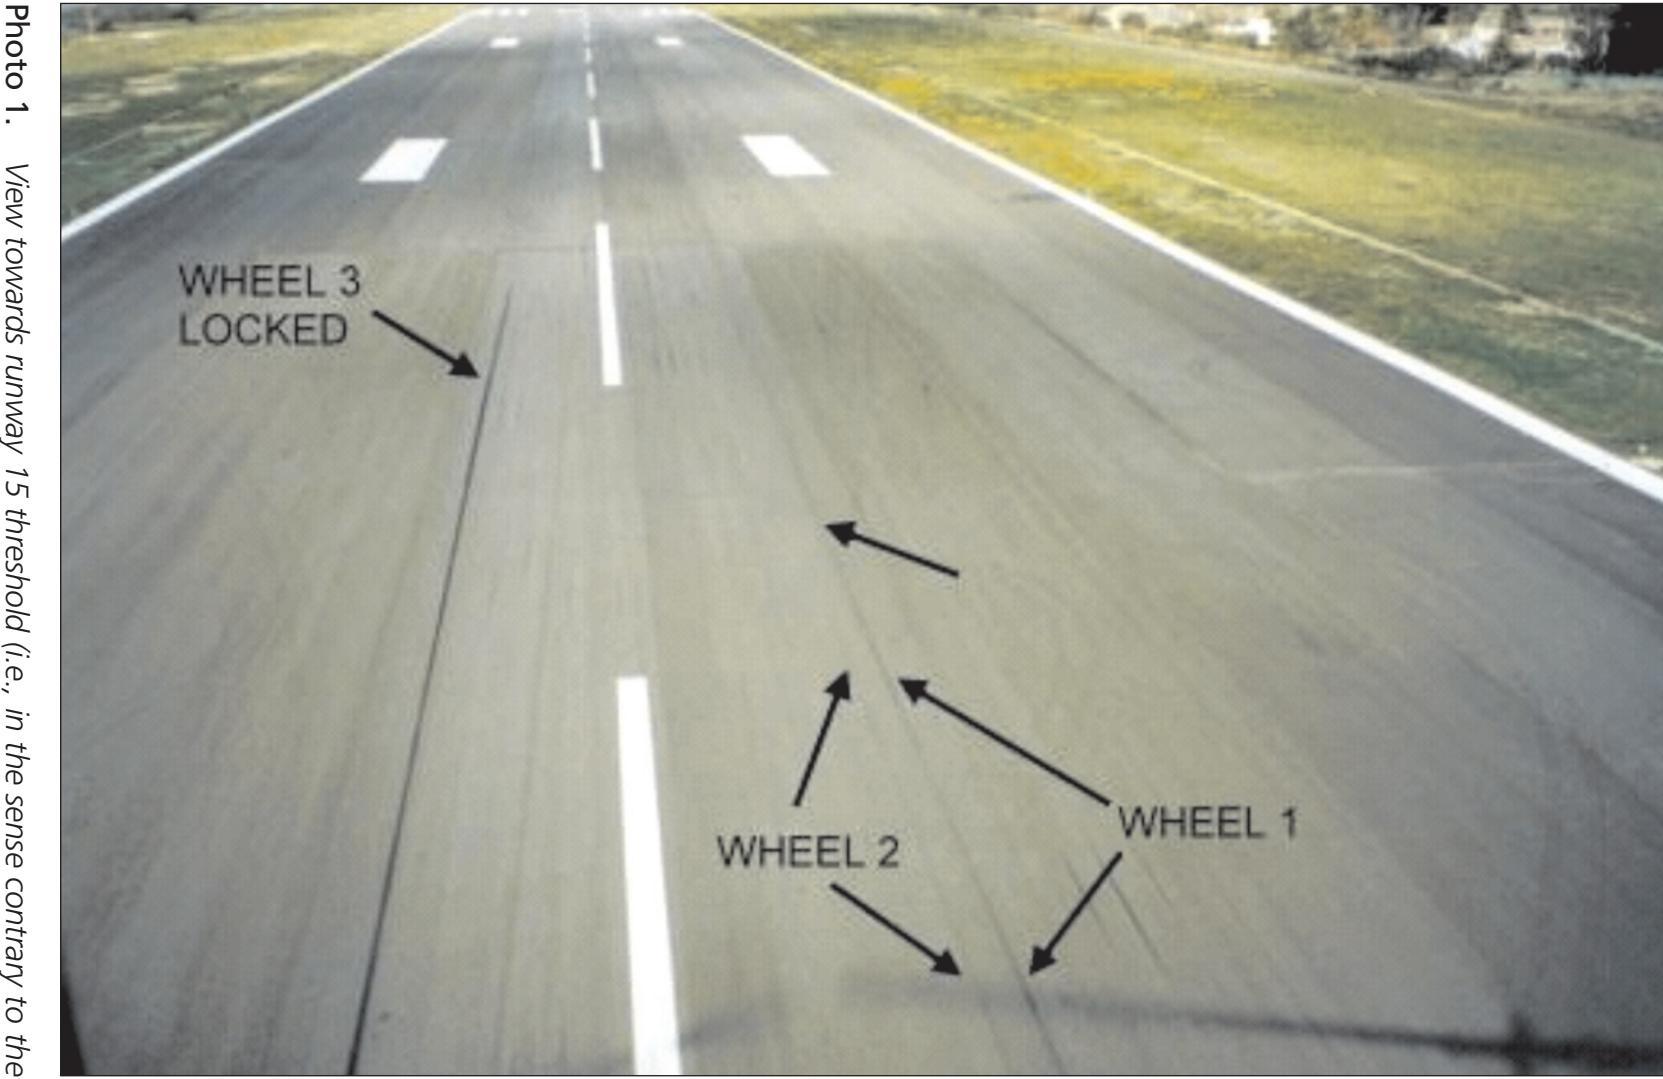
Photo 1. landing roll). Track of wheel 3 clearly marked and showing signs of tire lock View towards runway 15 threshold (i.e., in the sense contrary to the

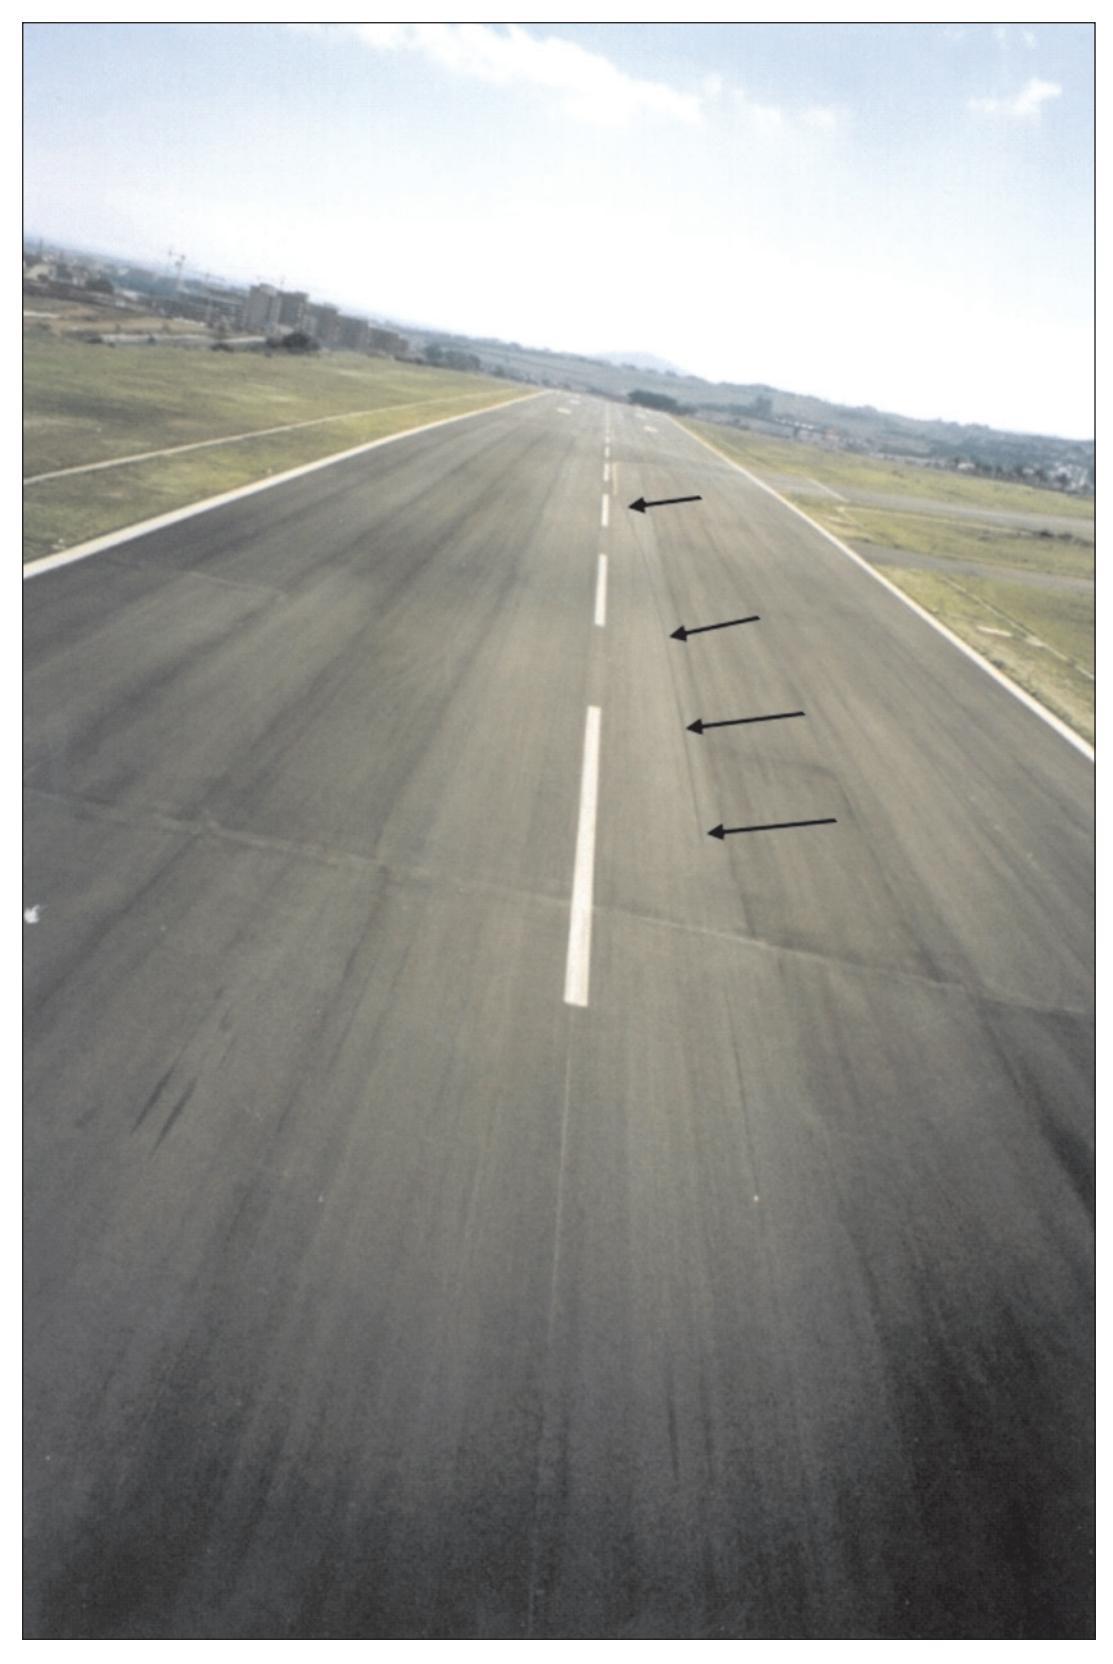
Photo 2. View in the sense of the landing roll. Track of whell 3 crosses the runway axis

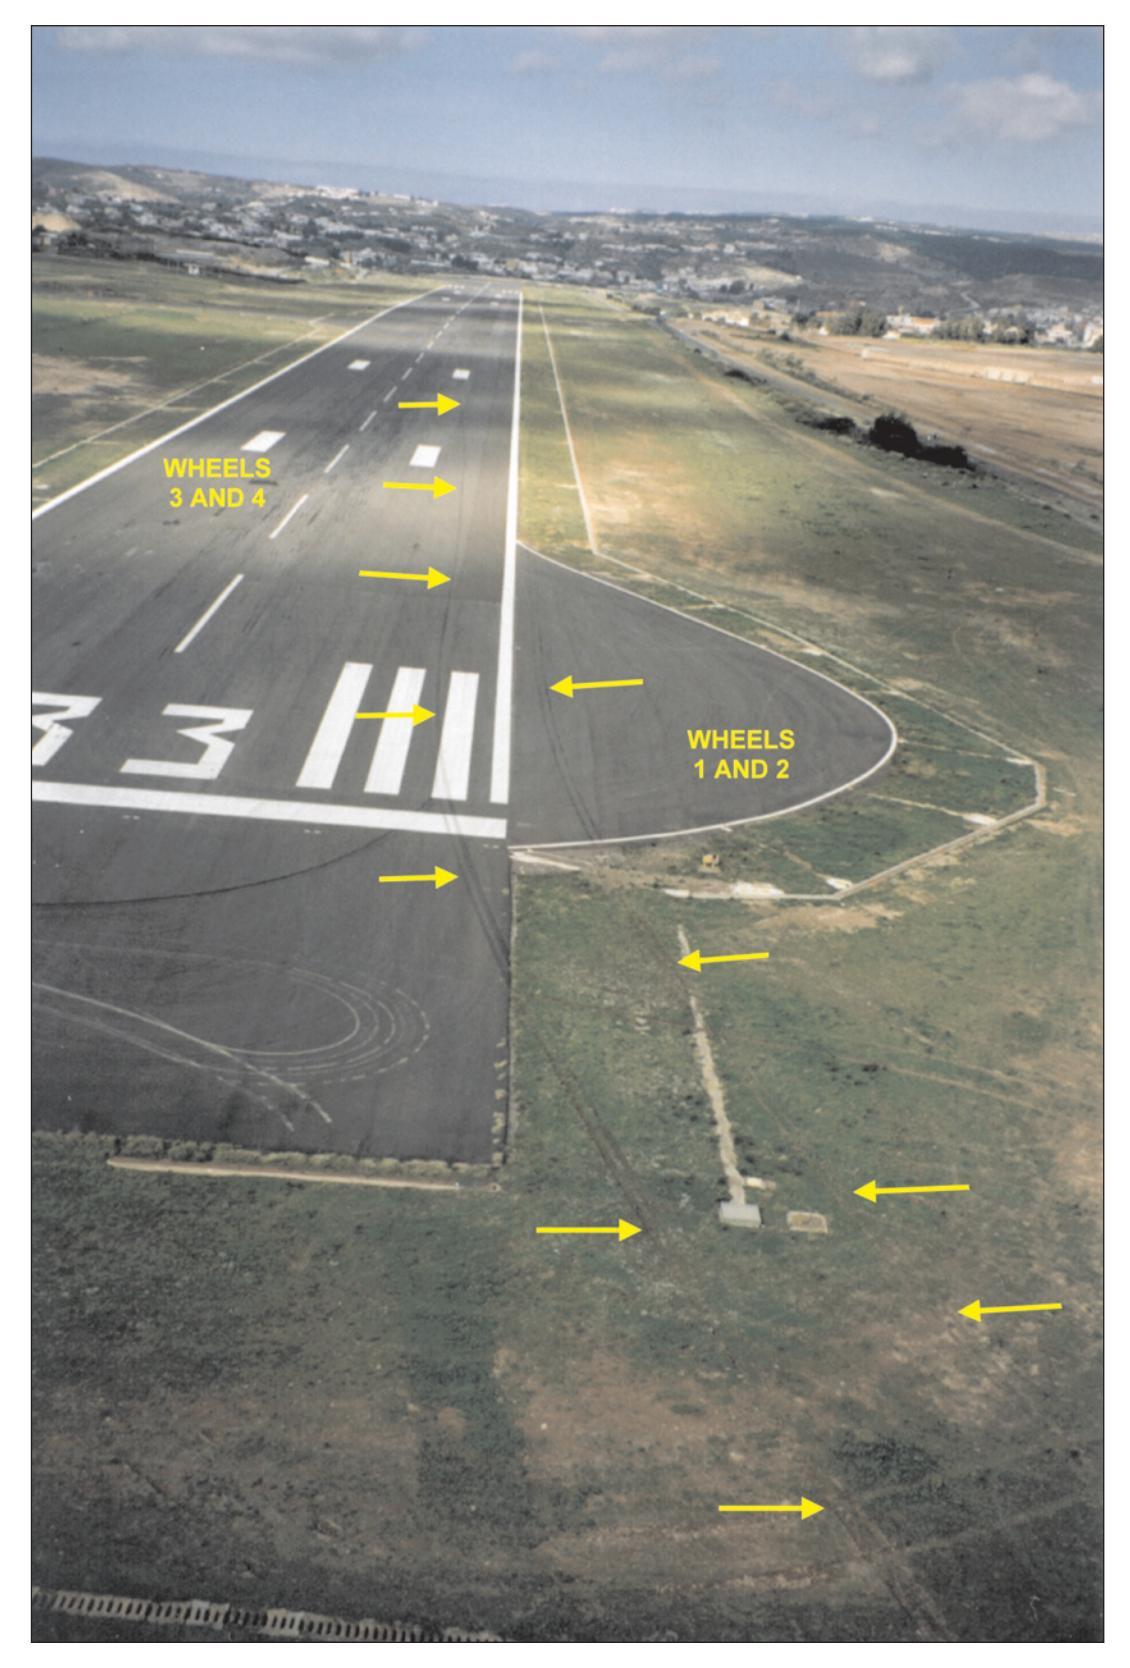
Photo 3. View in the sense contrary to the landing roll. Tracks of wheels 1 and 2 outside the runway

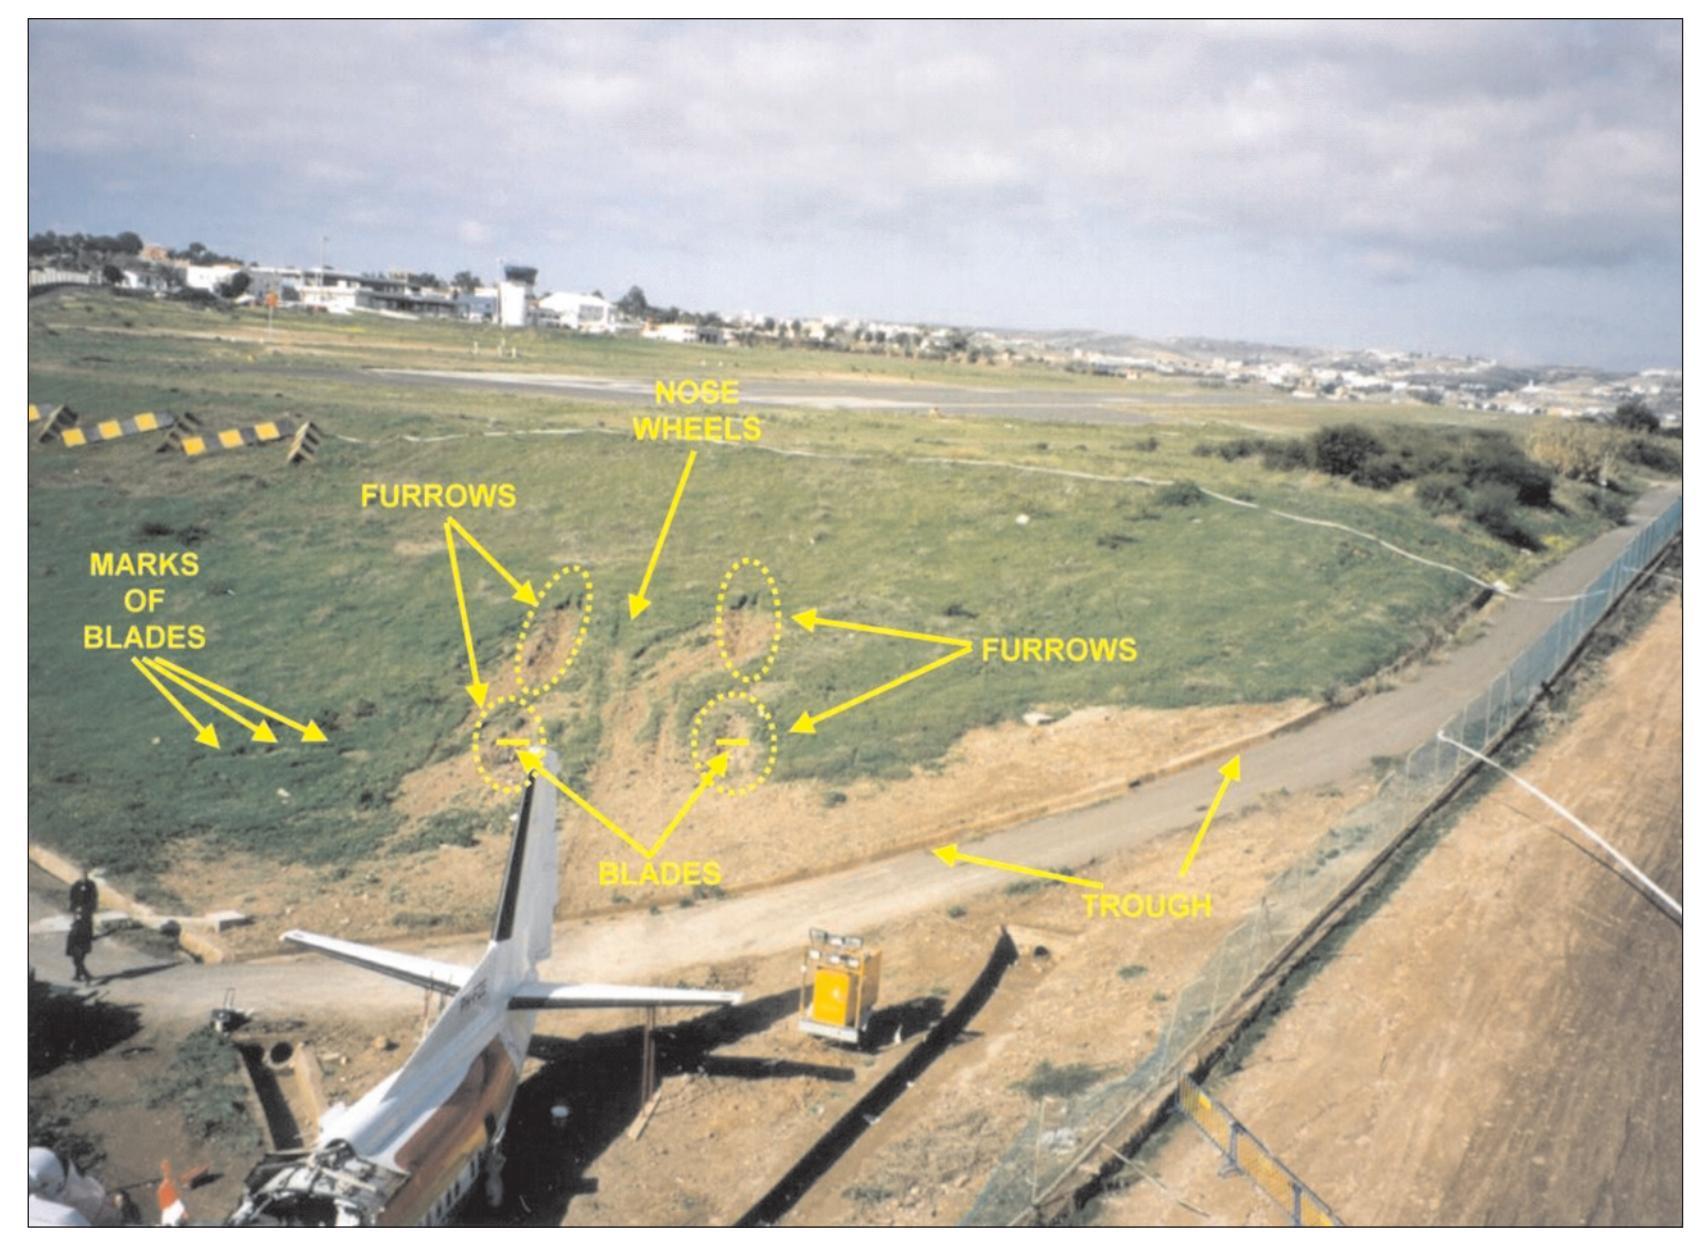
Photo 4. Final position of the aircraft and marks on the terrain of the embankment **APPENDIX D** DFDR graphs
