Ethiopian Airlines B767 (ET-AIZ) Aircraft Accident In the Federal Islamic Republic of the Comoros, in the Indian Ocean on November 23, 1996

AIRCRAFT ACCIDENT INVESTIGATION REPORT

ETHIOPIAN AIRLINES B767 (ET-AIZ) AIRCRAFT ACCIDENT IN THE FEDERAL ISLAMIC REPUBLIC OF THE COMOROS, IN THE INDIAN OCEAN ON NOVEMBER 23,1996

ETHIOPIAN AIRLINES B767-260ER, ET-AIZ AIRCRAFT ACCIDENT IN THE FEDERAL ISLAMIC REPUBLIC OF THE COMOROS, IN THE INDIAN OCEAN ON NOVEMBER 23, 1996. REPORT NO. AI-3/96 RELEASED BY CIVIL AVIATION AUTHORITY, ETHIOPIA

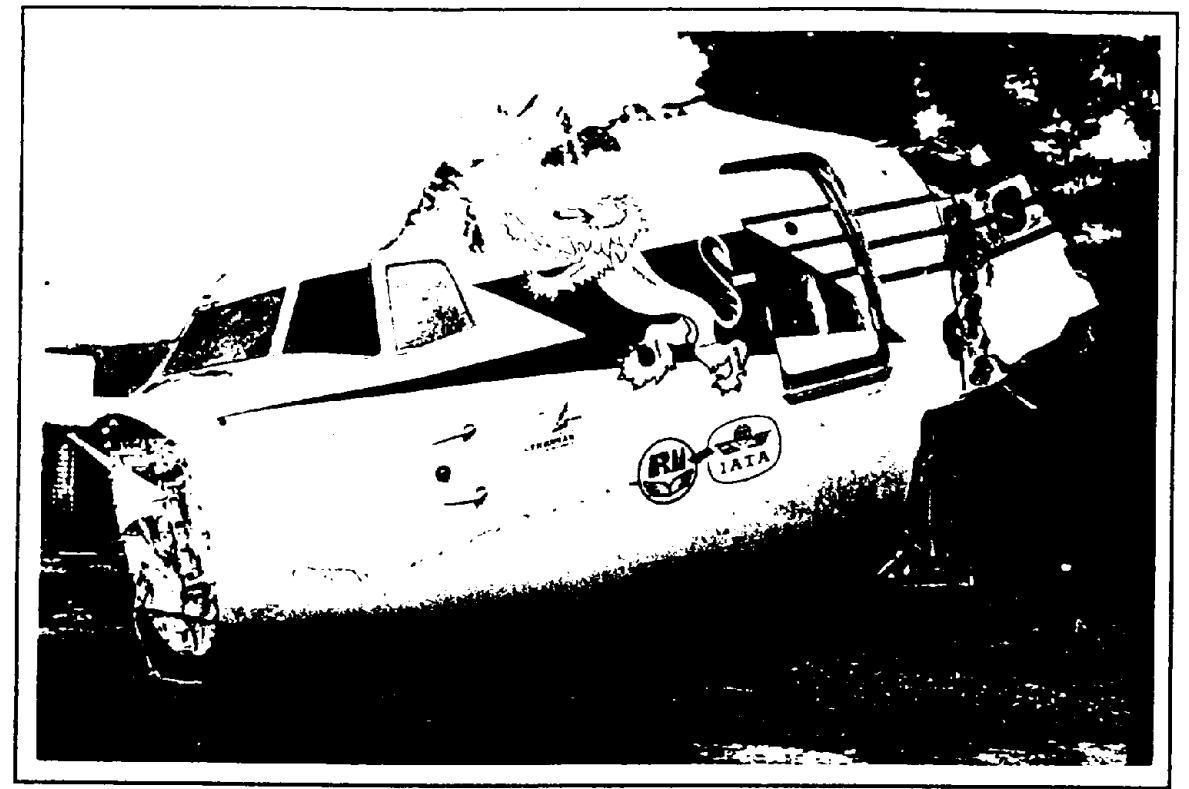
Figure 1. Left side of cockpit.

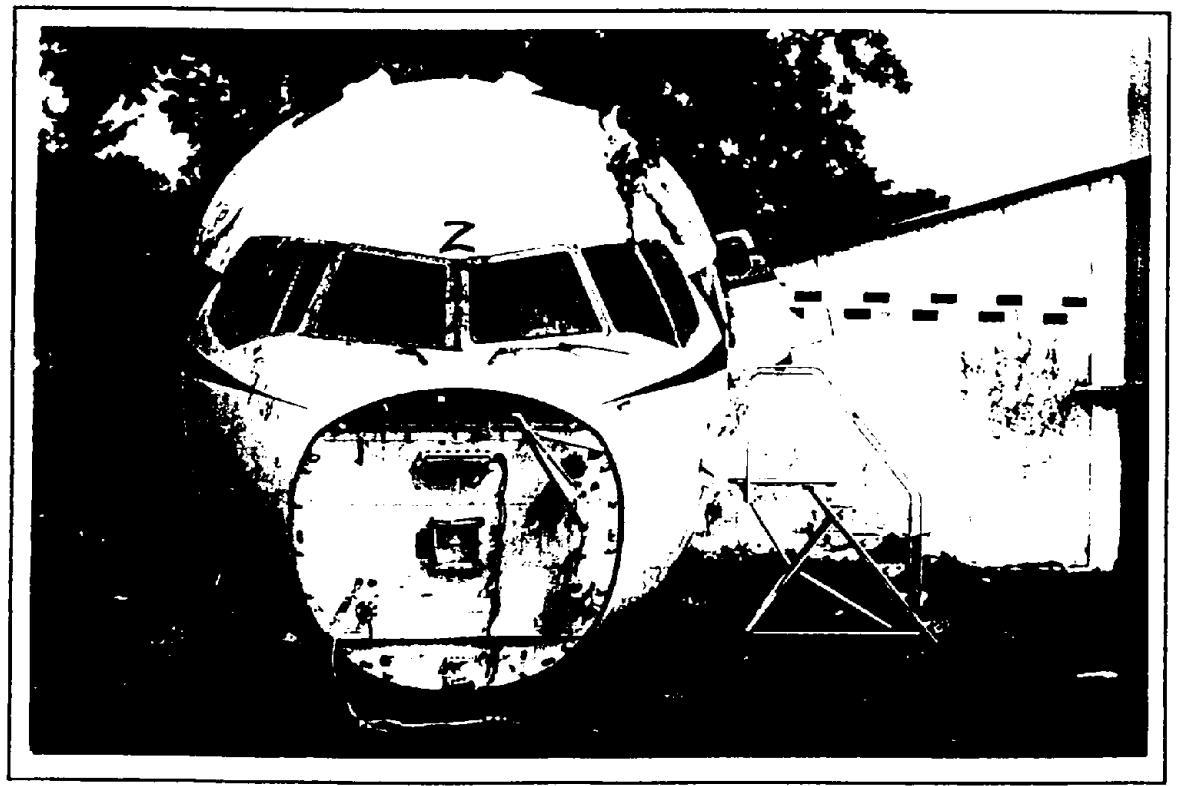
Figure 2. Front side of cockpit.

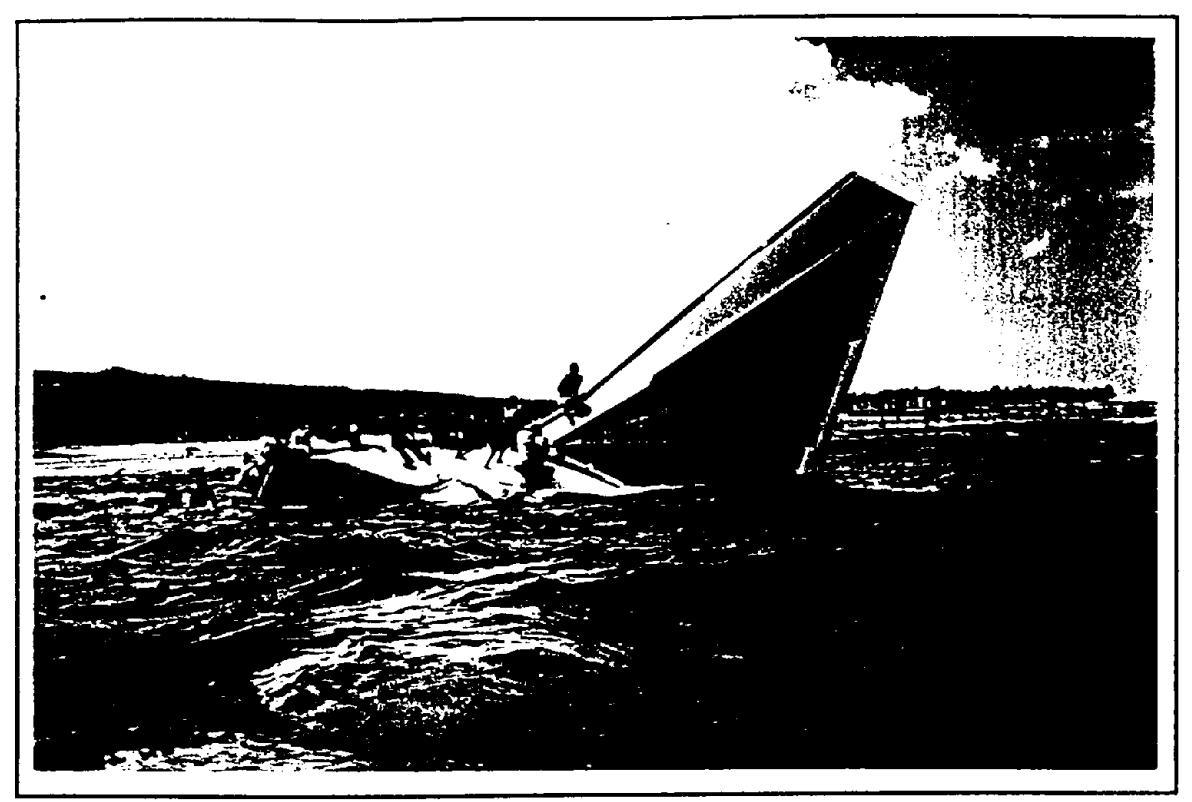
Figure 5. Tail section.

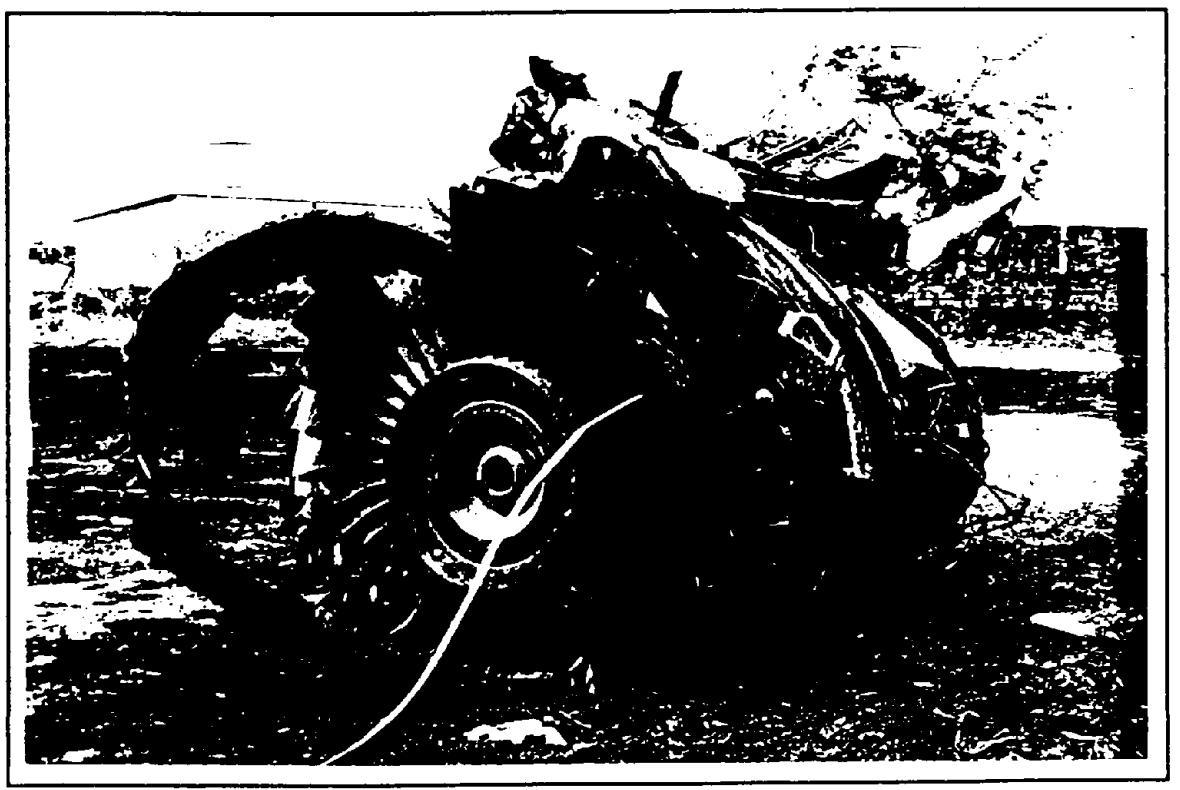
Figure 6. Left engine.

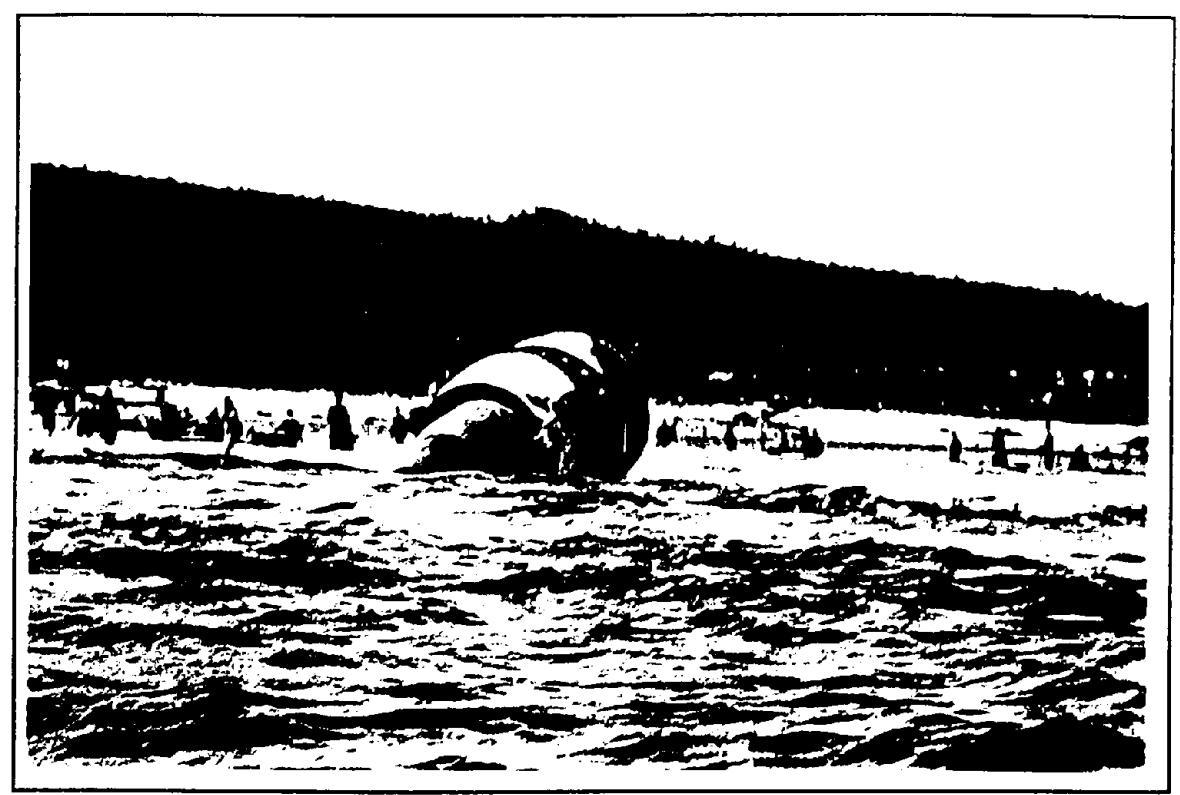
Figure 7. Right engine.

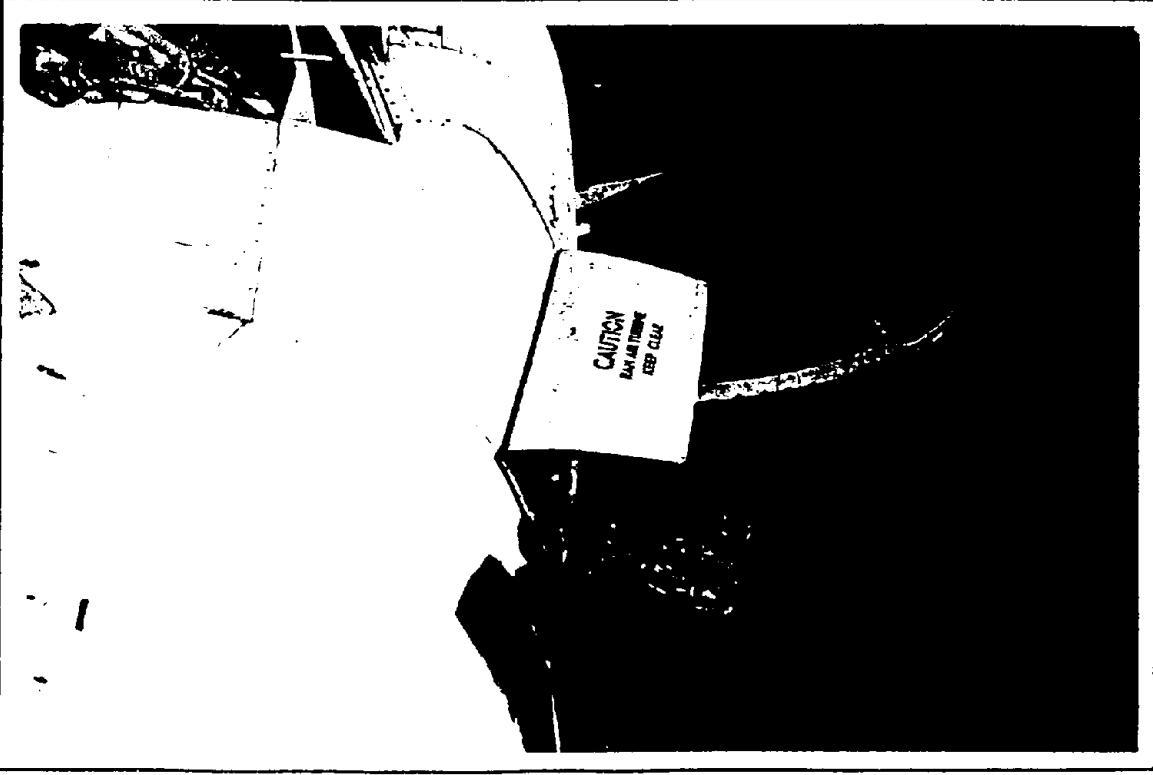
the wing, were found in an area of 400 meters in radius, at the edge of the reef. The right engine was later recovered from the sea. The part of the aircraft from station No. STA 360 up to 615 was not recovered. At the time of the impact, the landing gears were in a retracted position with the doors closed. The RAM Air Turbine was deployed. The wing flaps were up.

Figure 8. Ram Air Turbine deployed.

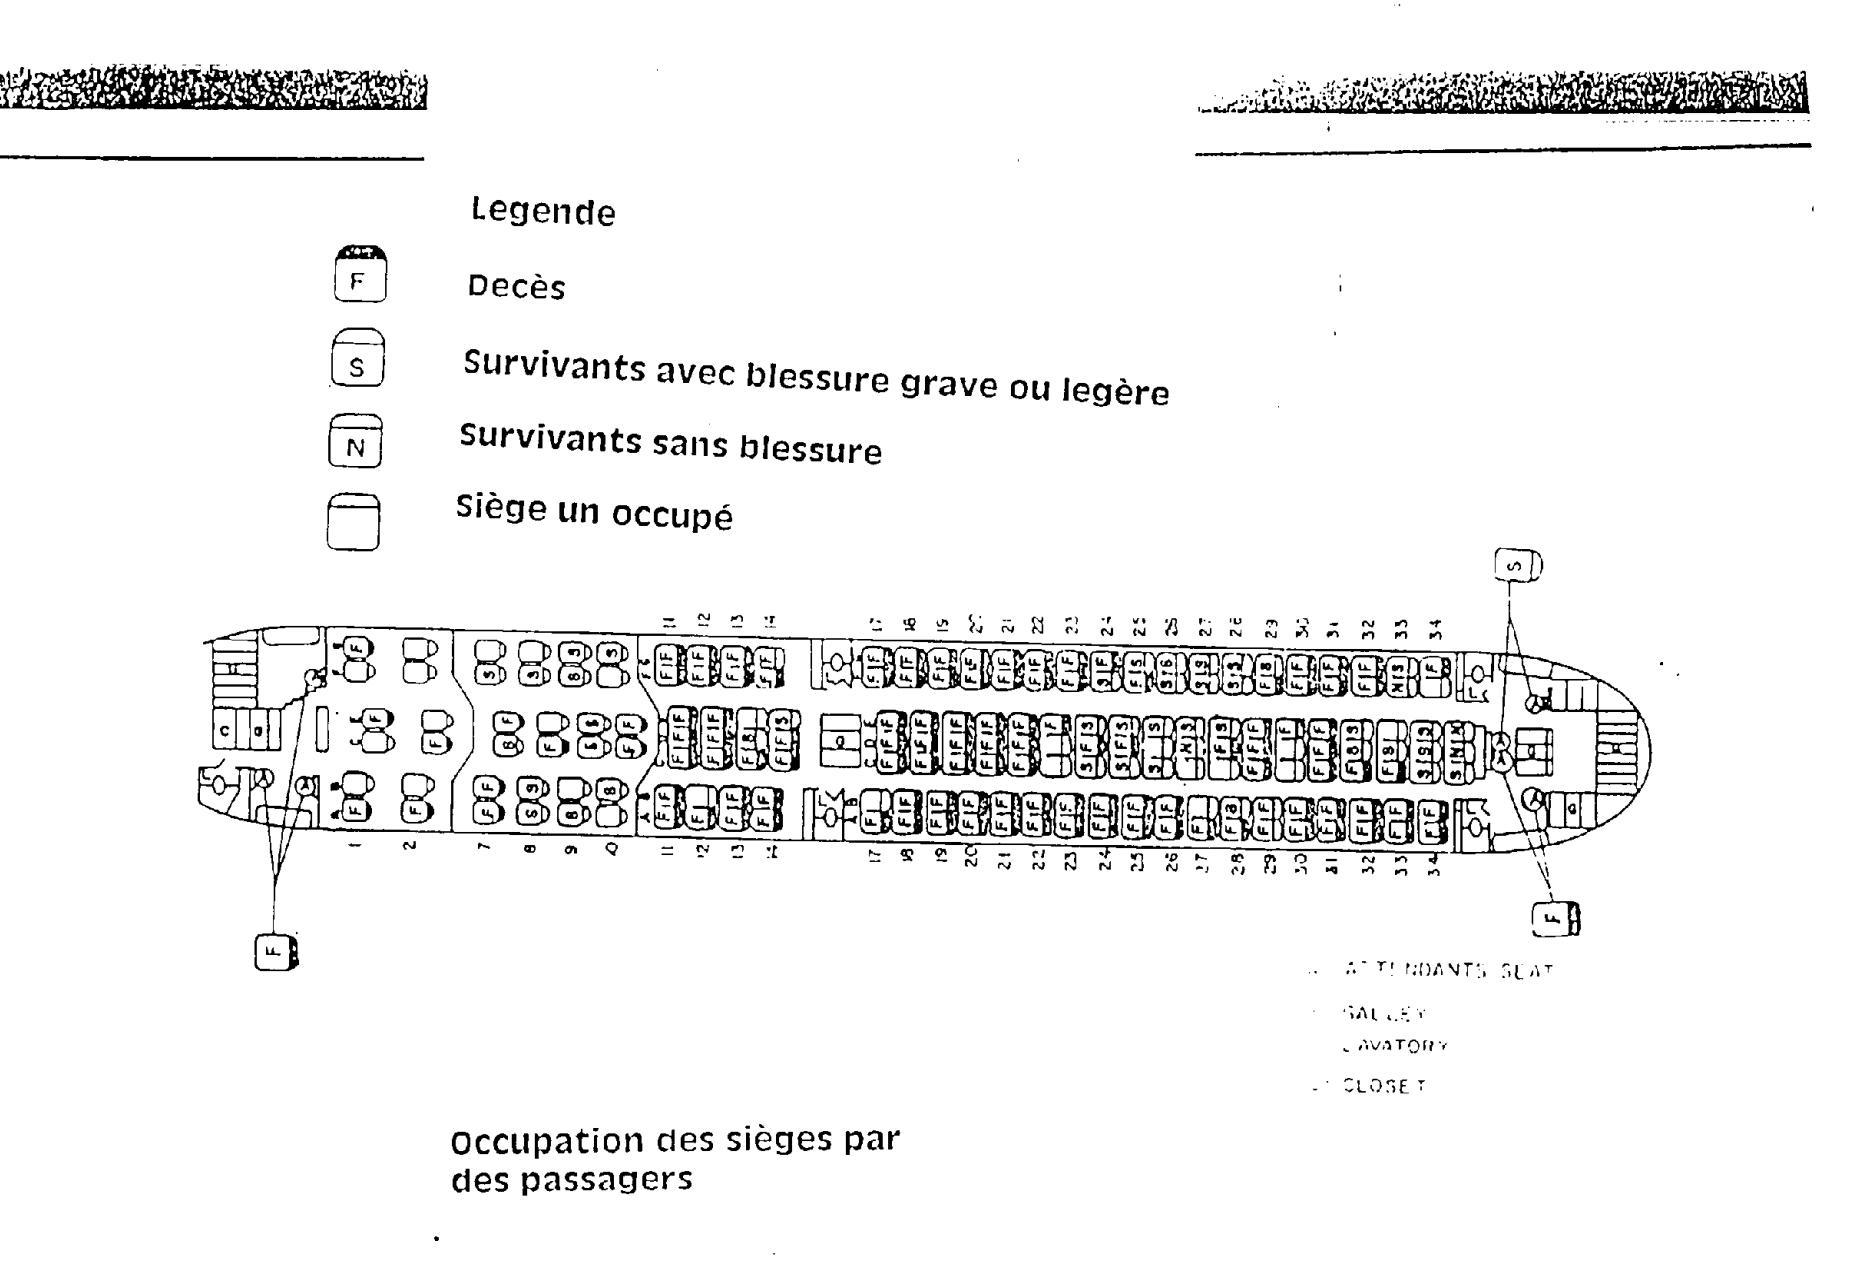
EMPLACEMENTS DES CASSURES DE L'AVION ET – AIZ – B 767-200 ER

The aircraft disintegrated on impact. There were four pieces of main wreckage, the aircraft having broken approximatley at stations No. STA 368, 544 and 1270. Through these openings most of the occupants escaped, although, some eventually drowned.
