# Flight into terrain, United Air Lines, Inc., B-727, N7036U, In Lake Michigan, August 16, 1965

### AIRCRAFT ACCIDENT REPORT

# UNITED AIR LINES, INC. BOEING 727-22, N7036U, in LAKE MICHIGAN AUGUST 16, 1965

Adopted: December 19, 1967

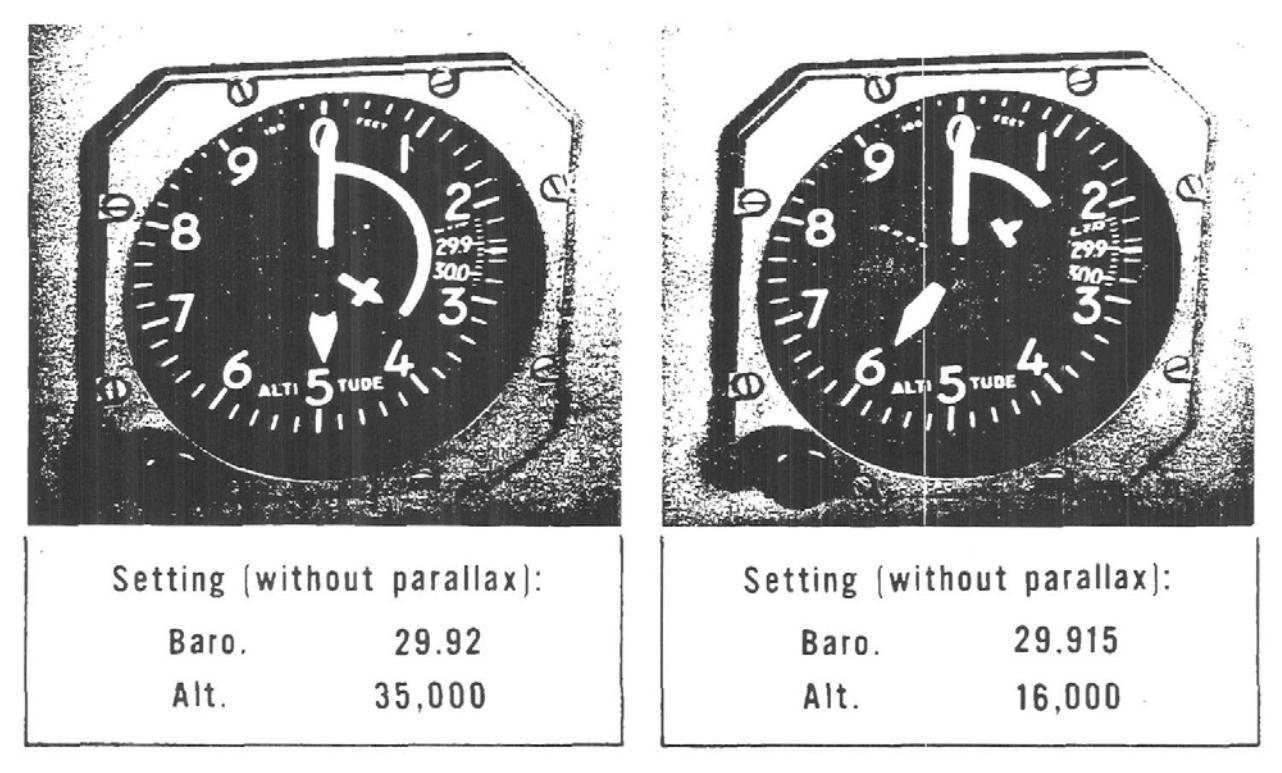
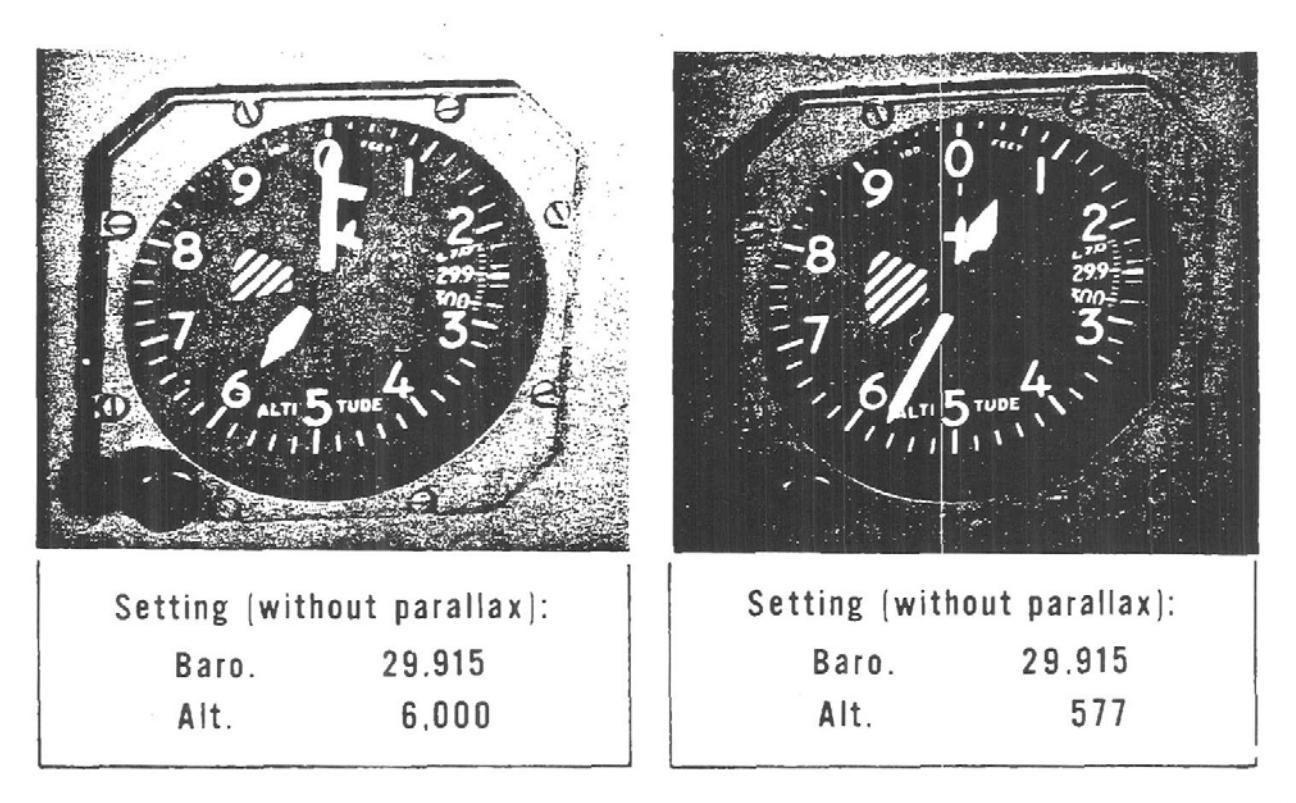
### ATTACHMENT 2

A review of Attachment No. 2 shows the position of the hands of the altimeter could be misinterpreted under certain operating conditions and the crew could have misread 6,000 feet to be 16,000 feet. It is believed the first officer was flying the aircraft. The captain's voice was identified on the air traffic control tapes and it is a normal custom in air carrier operations to have the pilot who is not flying the aircraft make the radio transmissions. If the captain were looking outside the aircraft for traffic or occupied with cockpit duties such as the completion of a checklist, and the first officer misread the altimeter, this error could escape undetected. To have such an error occur, however, it would be necessary for the pilot or pilots to fail to see the gradually increasing display of the cross-hatched warning section of the altimeter and the gradually decreasing display of the

Camera lens: 34'' from dial 22° above and  $15^{\circ}$  to left of altimeter axis
